Lakeville Train Station

Issued: February 23, 2023

CROSSKEY ARCHITECTS, LLC
750 Main Street, Suite 150
Hartford, CT 06103

Structural Condition Assessment

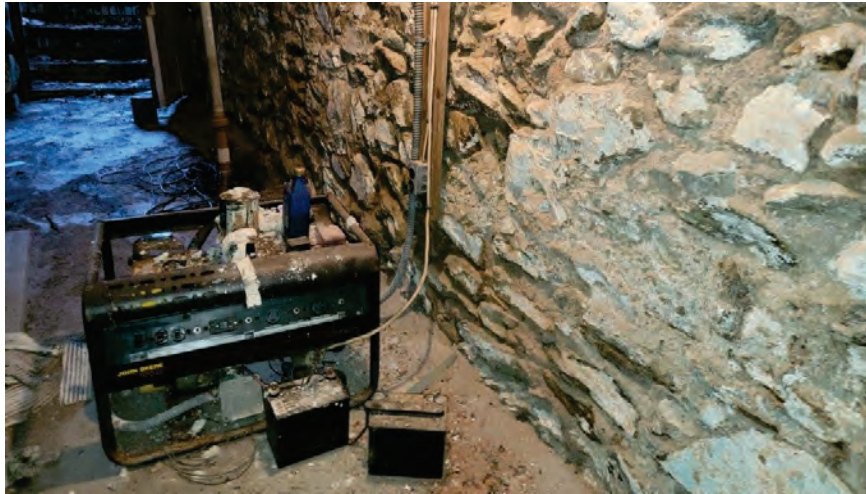
4. Fines deposited at base of foundation wall indicating moisture infiltration.

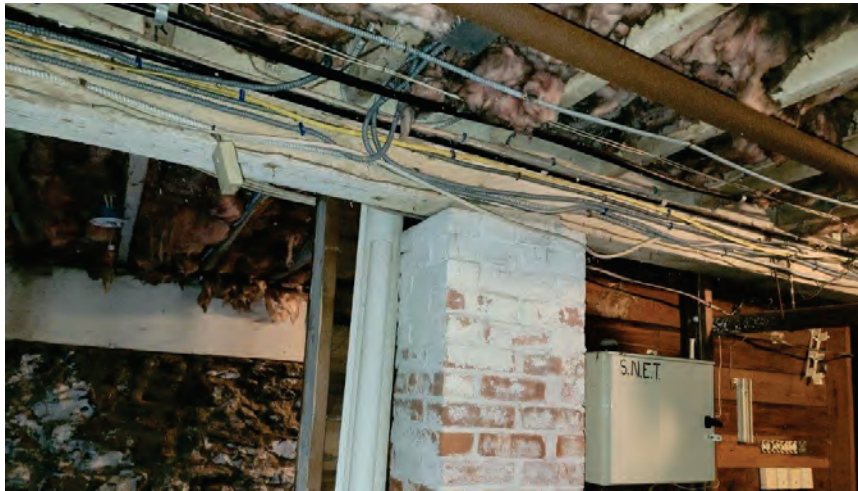
5. Floor joists bearing on center beam and 16" x 16" brick pier.

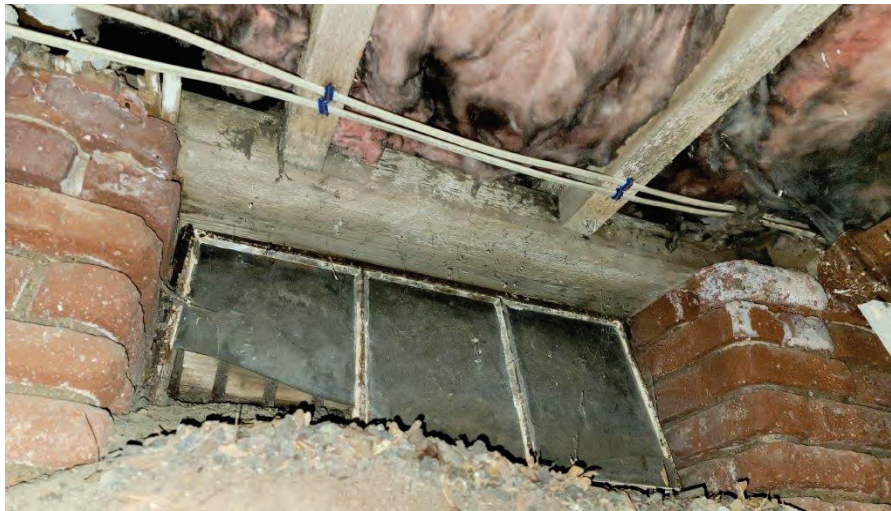
7. Floor joists supported on wood sill plate bearing on brick wall on top of foundation wall.

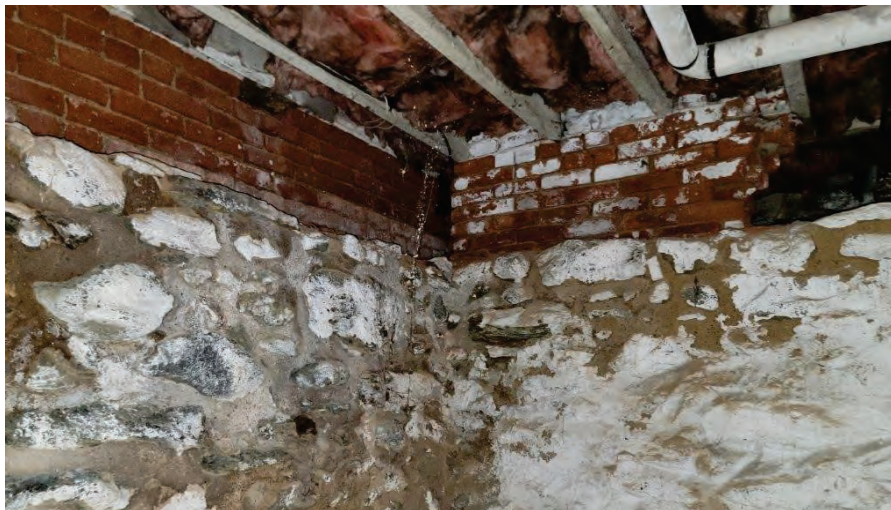
8. Southeast corner of stone foundation with brick on top of wall.

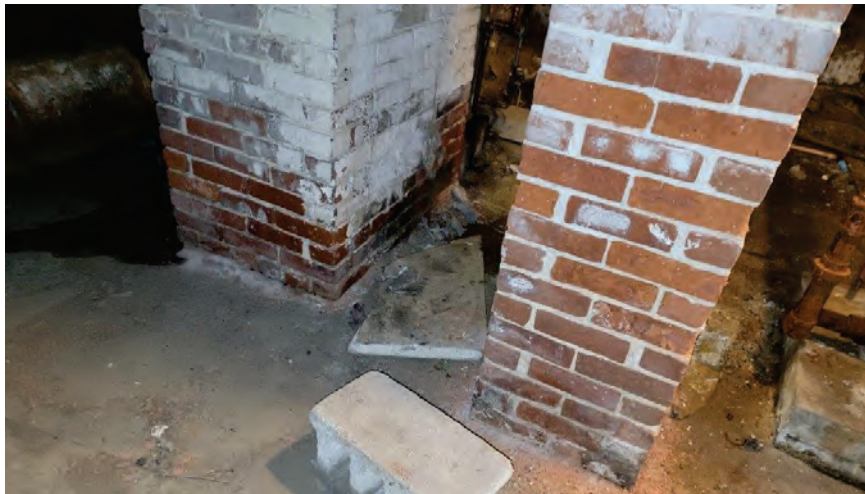
10. Brick piers and chimney base are in very good condition, no deterioration.

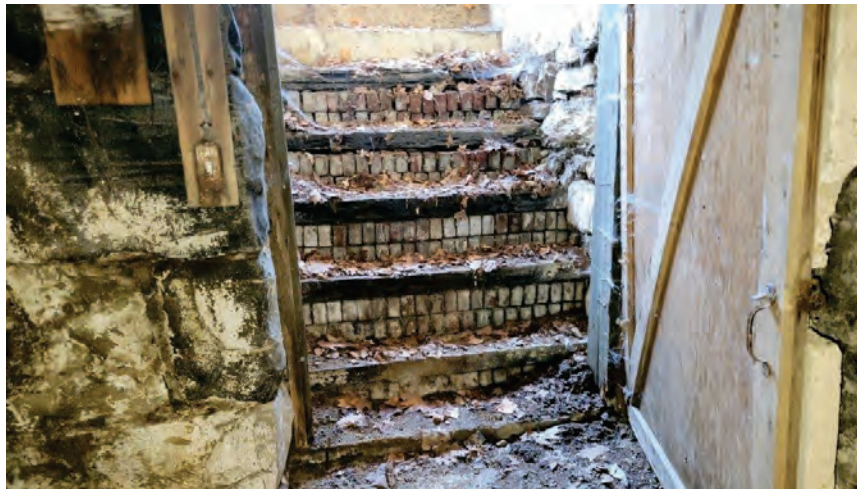
11. Hatchway steps require some resetting of bricks.

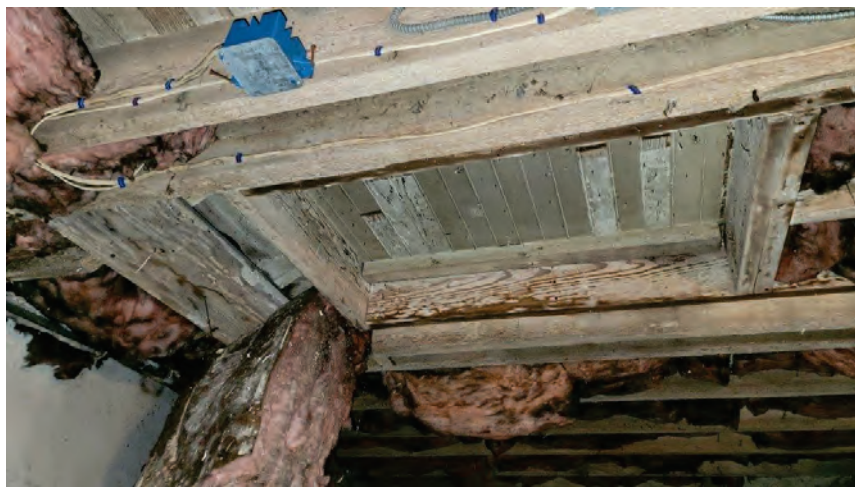
12. A former floor opening has been closed. Minor repairs needed.

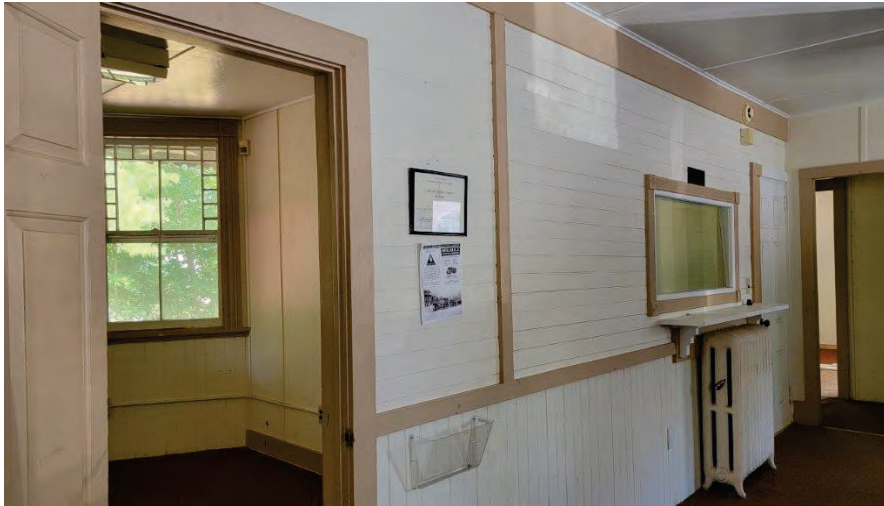
13. Interior walls may be supporting ceiling loads. Investigate before removing or altering.

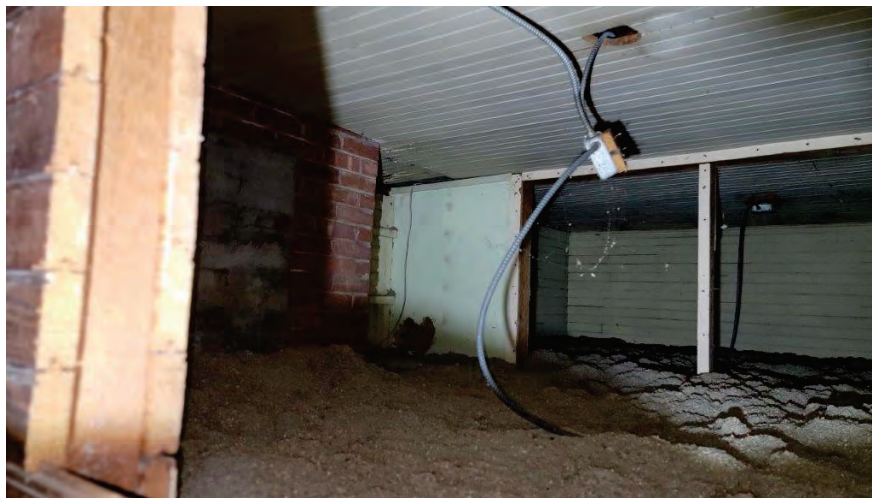
17. Ceiling condition near chimney.

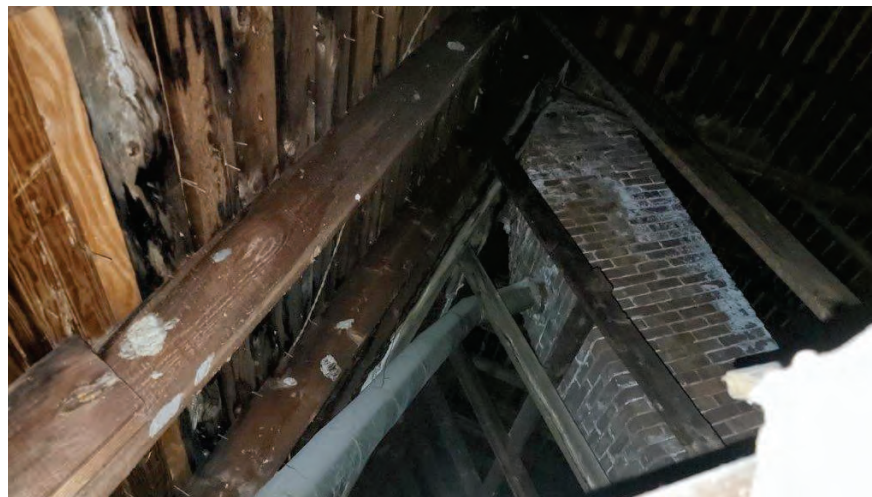
18. Limited view of roof framing. New plywood visible between original furring.

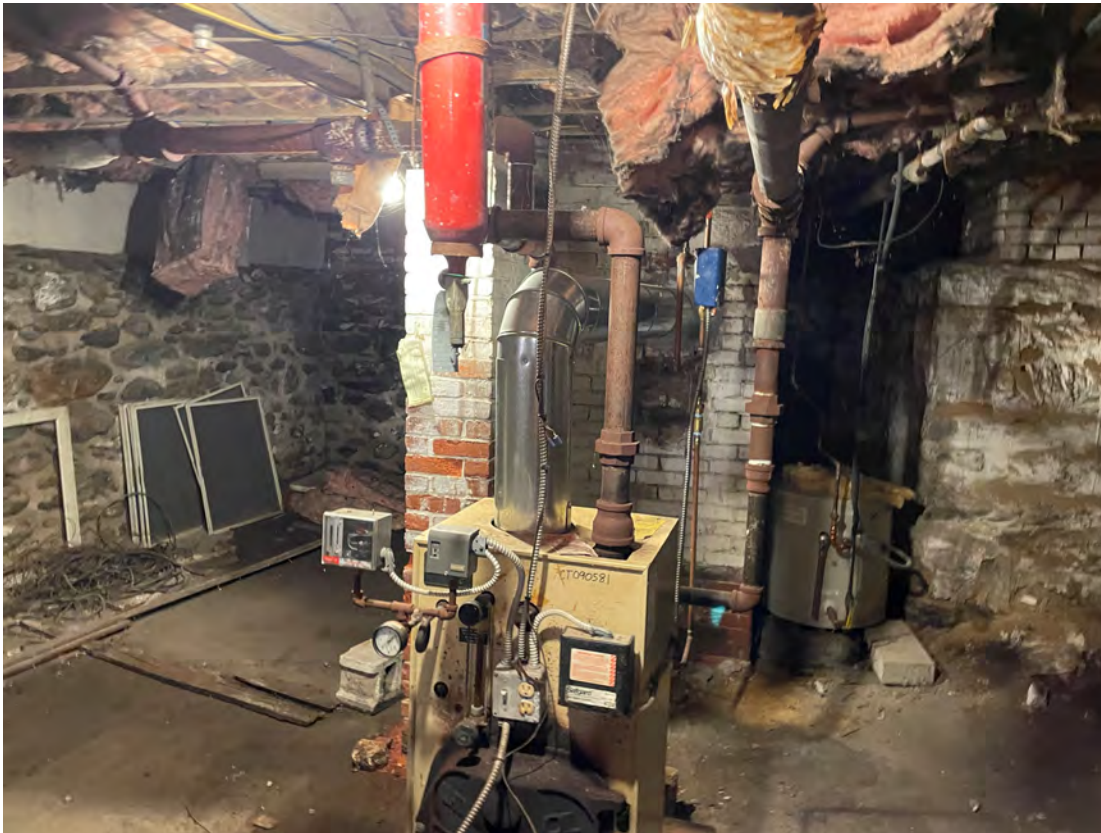
Figure 1 -Boiler

The building is heated but does not have cooling or mechanical ventilation. Cast iron steam radiators are in each room and are fed from a boiler in the basement. The boiler is oil-fired cast iron and steam pipe is two – pipe using a gravity condensate return system. The heating system is in a poor condition, inefficient, and antiquated. It is recommended that this be replaced. We recommend either an all – electric heat pump or LP gas fired central air system. Further, new ductwork, ventilation, energy upgrades to the envelope, and free-standing dehumidification for the basement is recommended.
