LAKEVILLE CNE RAILROAD STATION  
7 Ethan Allen Place  
Lakeville, CT

## Structural Condition Assessment

James K. Grant Associates  
P.O. Box 235  
Collinsville, CT 06022

January 16, 2023

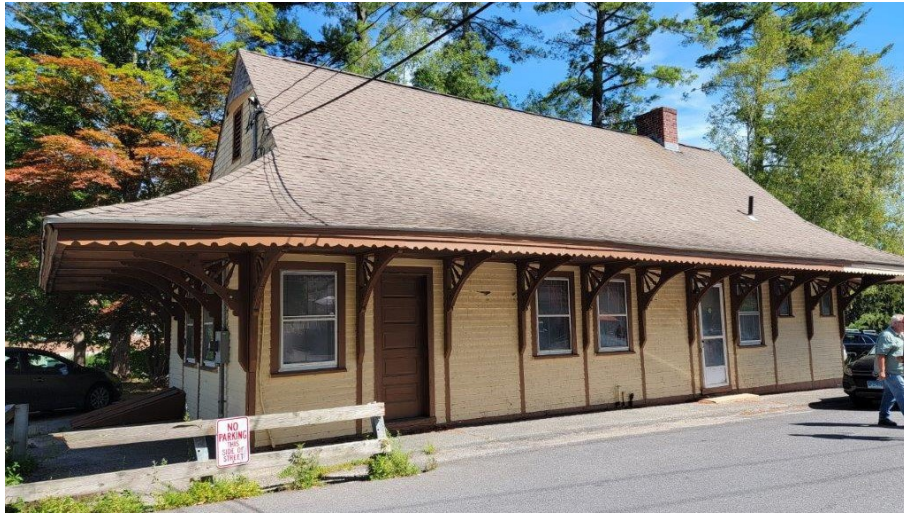
1. South elevation of Lakeville Railroad Station

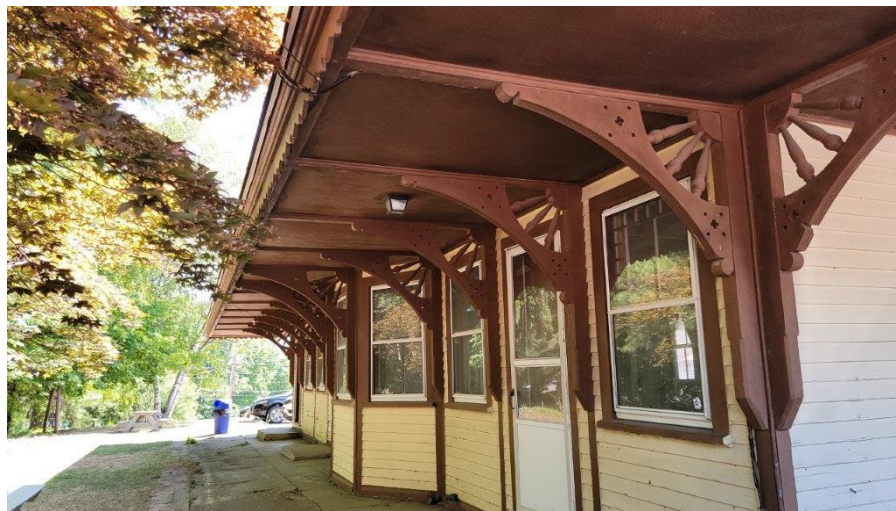
2. North wall of station showing 8 foot overhang and brackets.

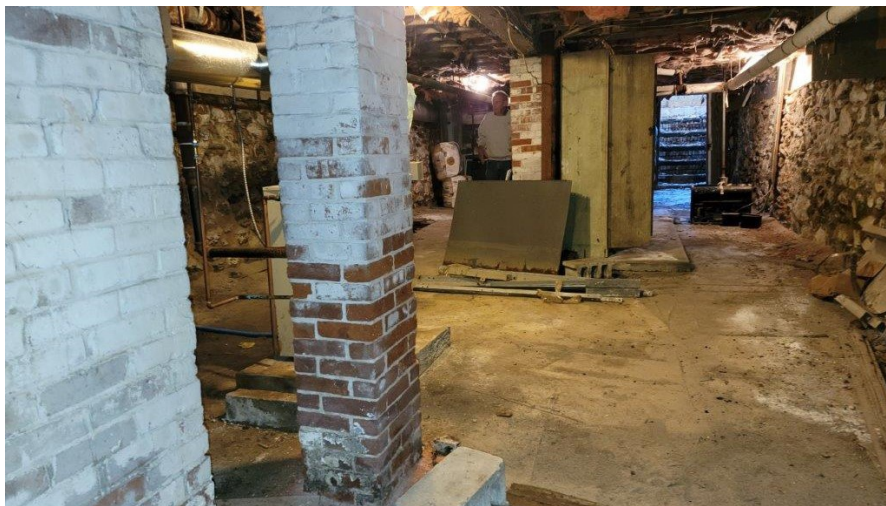
3. Basement view looking west. Brick chimney base and pier in foreground.

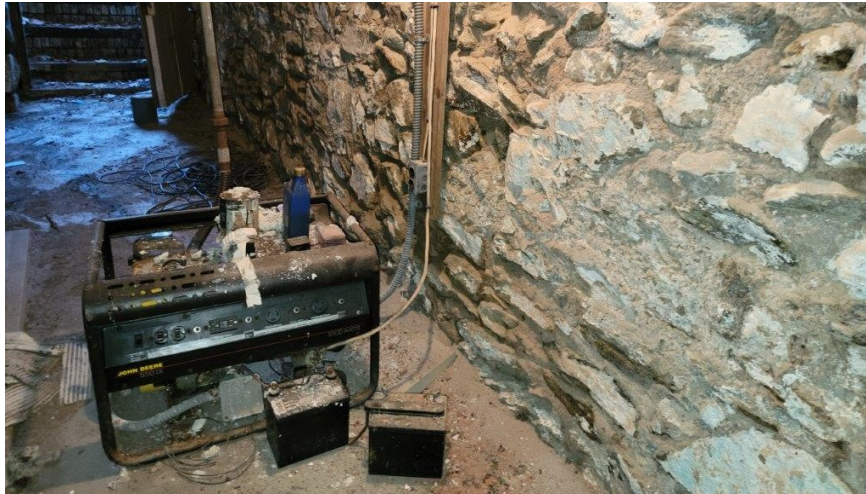
The foundation walls are in good condition. There is no sign of movement in any of the stonework but some of the mortar is newer and there could have been movement or settlement in the past that required re-mortaring. There is moisture infiltration through the walls as evidenced by accumulations of fines at the base of the wall in some locations. These conditions are not significant and no remedial work is called for on the stone walls. Where exposed, the brick walls appear to be in sound condition but there is some mortar loss. The exterior wythes of the brick are buried below grade, however, and may have some deterioration due to moisture. The roof overhangs help minimize the amount of moisture exposure but the west and south sides may be more effected due to grade sloping toward the building. The brick walls should be fully exposed on the interior and exterior faces for a thorough assessment. The brick piers and chimney base are in very good condition and show no deterioration at their bottoms where the effects of rising damp are often found in building of this and older eras. The masonry steps in the hatchway are in fair condition but there is some disturbance of the brick risers, particularly the top two, that could use some resetting. The two wood posts supporting the center beam are in good condition.

4. Fines deposited at base of foundation wall indicating moisture infiltration.

The Lakeville Railroad Station is in very good structural condition. The foundation walls are free of movements but there is moisture infiltration through the mortar joints that is washing fines from the mortar. Exterior drainage improvements should minimize that condition. The floor framing has no visible deficiencies and is sound underfoot. Assessment of the perimeter of the floor was limited, however, and additional inspection should be made by exposing the ends of the joists and the sill plate that supports the joists, as well as the exterior face of the brick wall on top of the foundation wall. The 12 and 14 foot spans of the center floor beam should have columns added at their centers to increase their load capacity to the 100 psf live load capacity of the joists. The roof framing does not have any visually detectable deficiencies

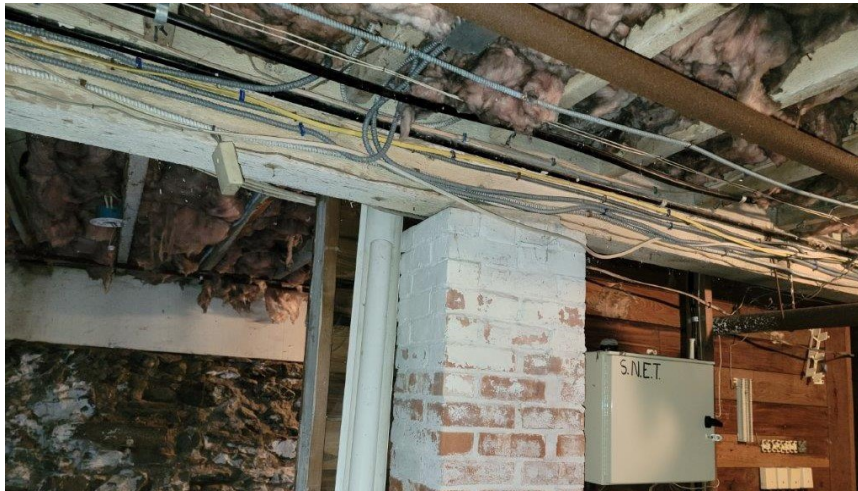
5. Floor joists bearing on center beam and 16" x 16" brick pier.

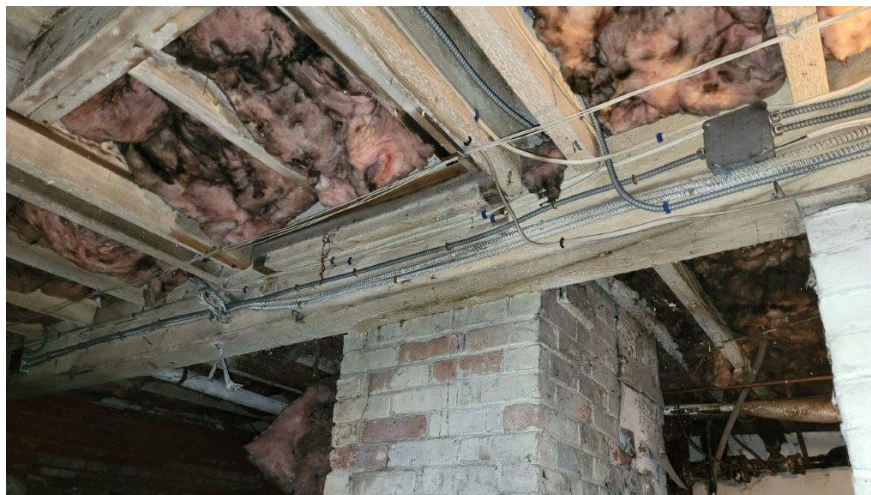
6. Center beam passing by chimney base.

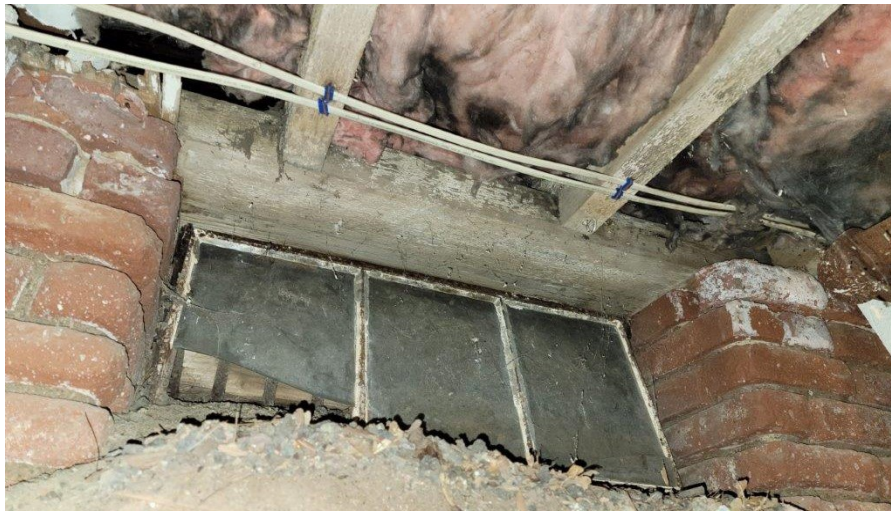
Insulation conceals all but the bottom few inches of the floor joists but the portions that are exposed are in very good condition. The ends of the joists are not visible in most locations and could not be evaluated. Where they penetrate into the brick wall there is a possibility that there may be some rot. Some corrective work should be anticipated. The wood sill plate could not be assessed and could also have need of rot repair in some places. The center beam is in very good condition and shows no sign of distress. A load analysis of the floor framing indicates that the joists have a live load capacity in excess of 100 pounds per square foot (psf), which allows assembly uses. The center beam, however, has two spans of about 14 and 12 feet that will require added columns in order to develop the same capacity.

7. Floor joists supported on wood sill plate bearing on brick wall on top of foundation wall.

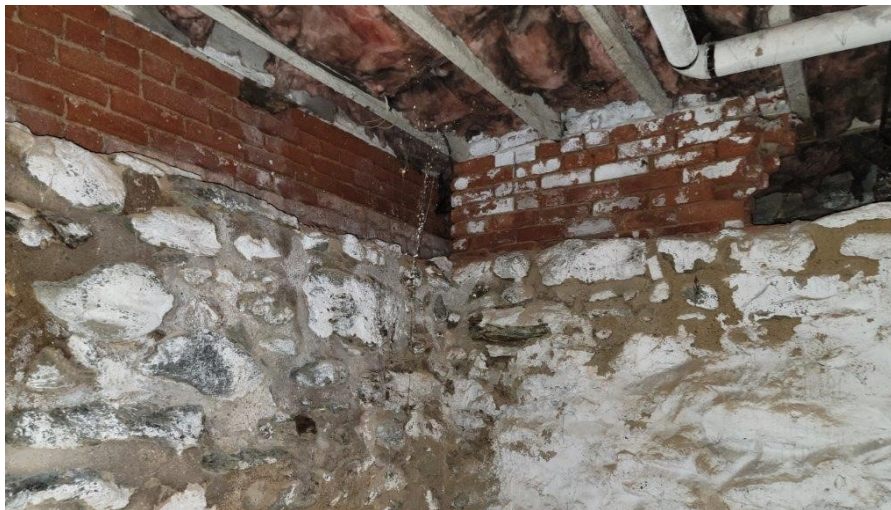
8. Southeast corner of stone foundation with brick on top of wall.

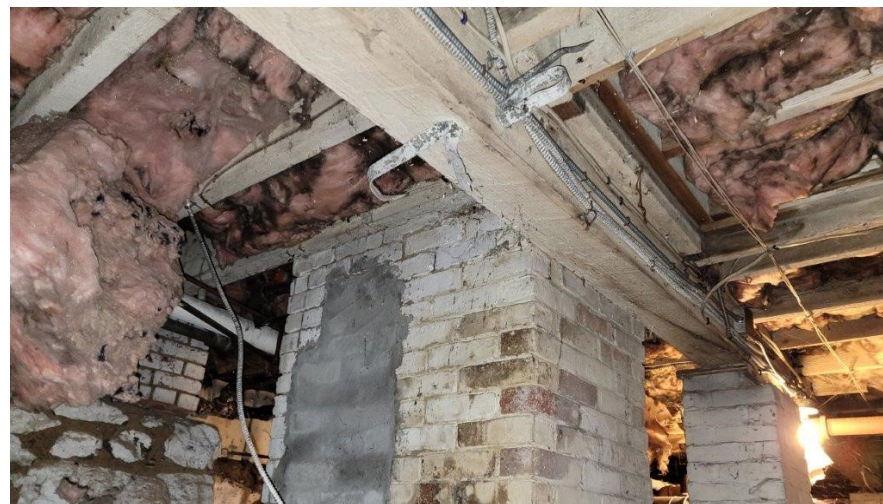
9. View of floor framing at chimney base and brick pier.

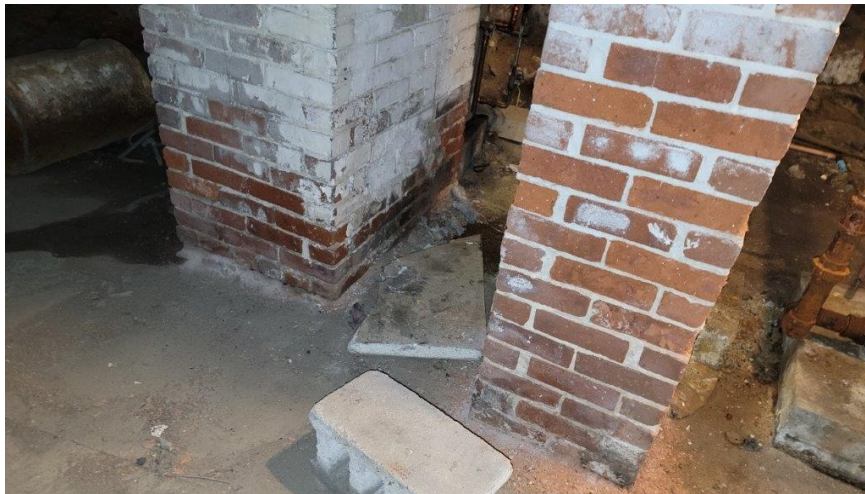
10. Brick piers and chimney base are in very good condition, no deterioration.

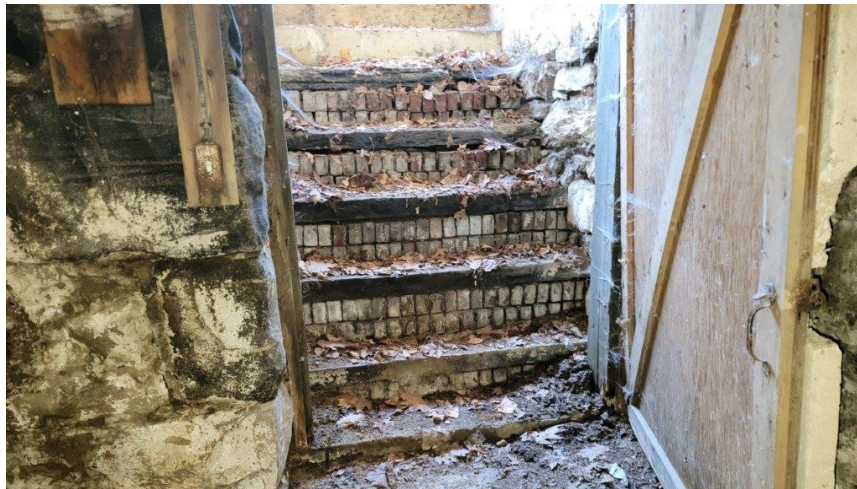
11. Hatchway steps require some resetting of bricks.

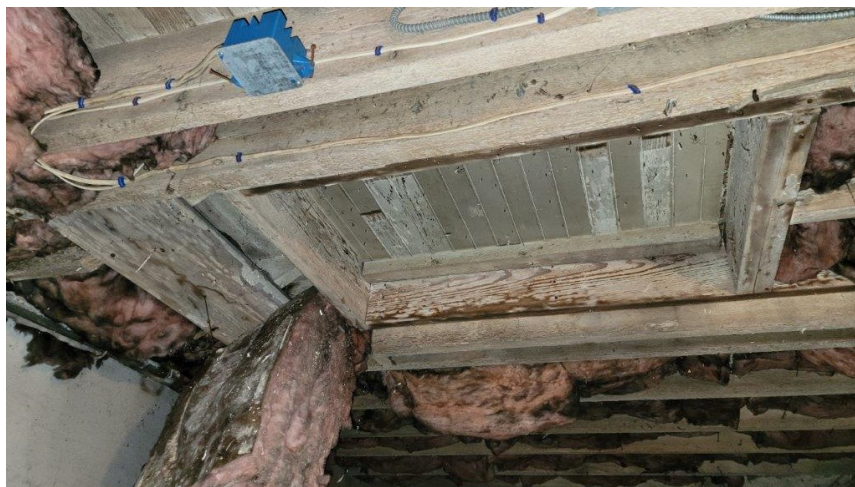
12. A former floor opening has been closed. Minor repairs needed.

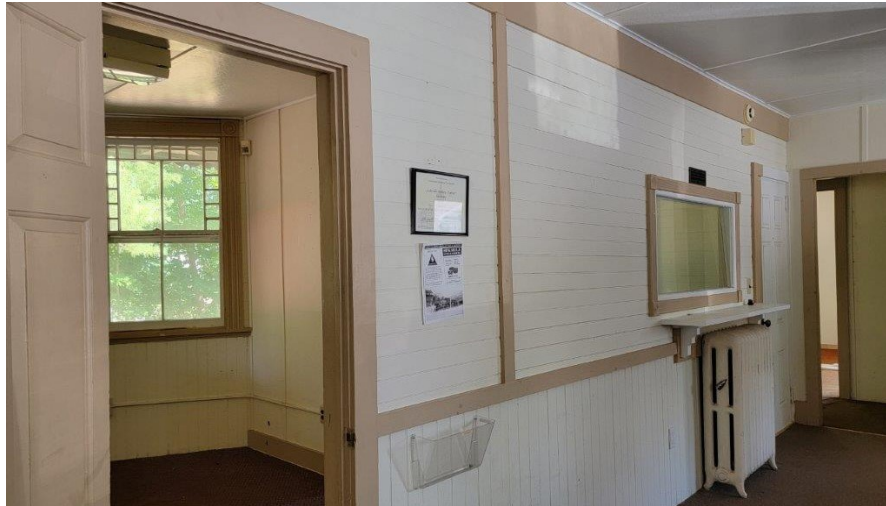
Some of the interior walls may have been added long after the original construction and are not bearing walls unless they are supporting the dropped ceiling that was added later. Some walls may be supporting part of the original ceiling load but it is highly unlikely that any of the interior wall are supporting roof loads. If proposed alterations involve removing walls, investigation should be conducted to be sure that supports are not being removed.

13. Interior walls may be supporting ceiling loads. Investigate before removing or altering.

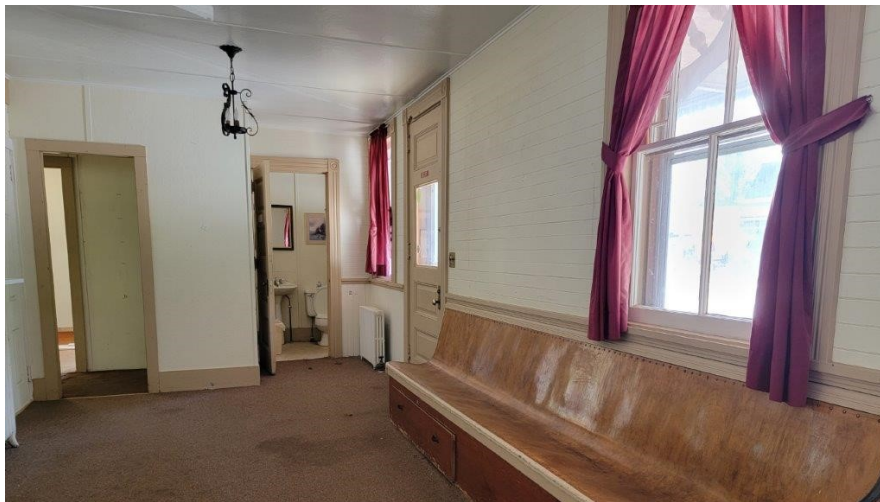
14. Existing dropped ceiling conceals original ornate ceiling.

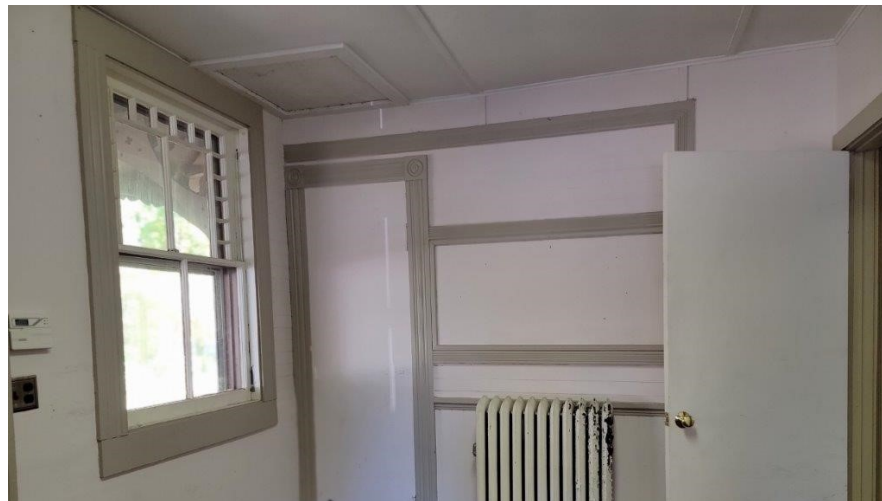
15. Access panel to space above dropped ceiling is in the corner.

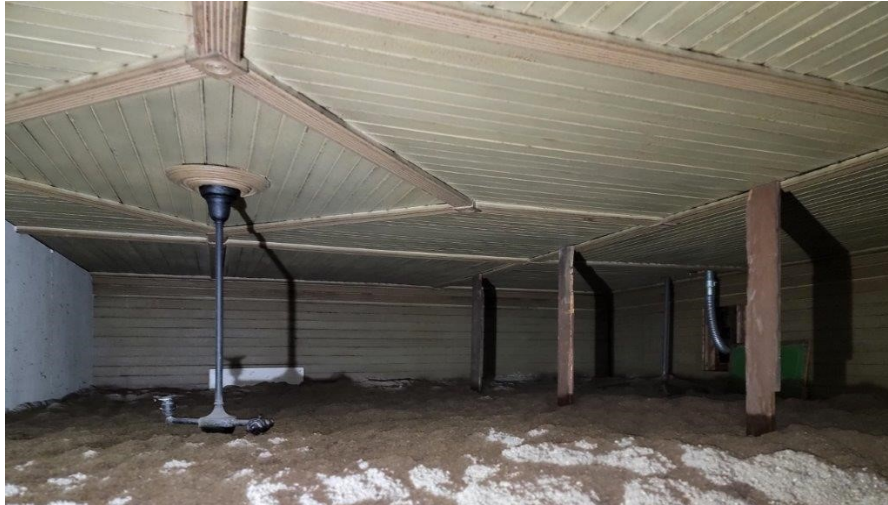
16. Original ceiling and light fixture remains above dropped ceiling.

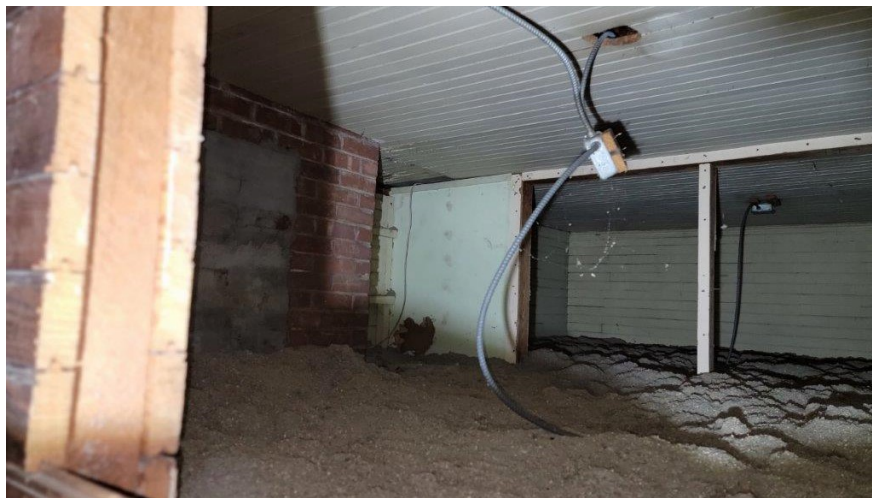
17. Ceiling condition near chimney.

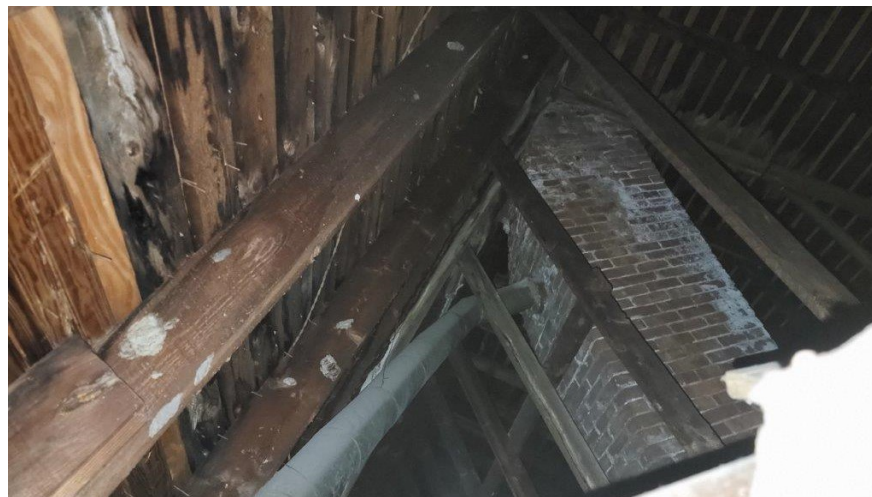
Very little of the roof framing could be seen but based on visual observation of the main ridge line and the edge of the overhang, there is no significant deflection that would raise concerns of

18. Limited view of roof framing. New plywood visible between original furring.
