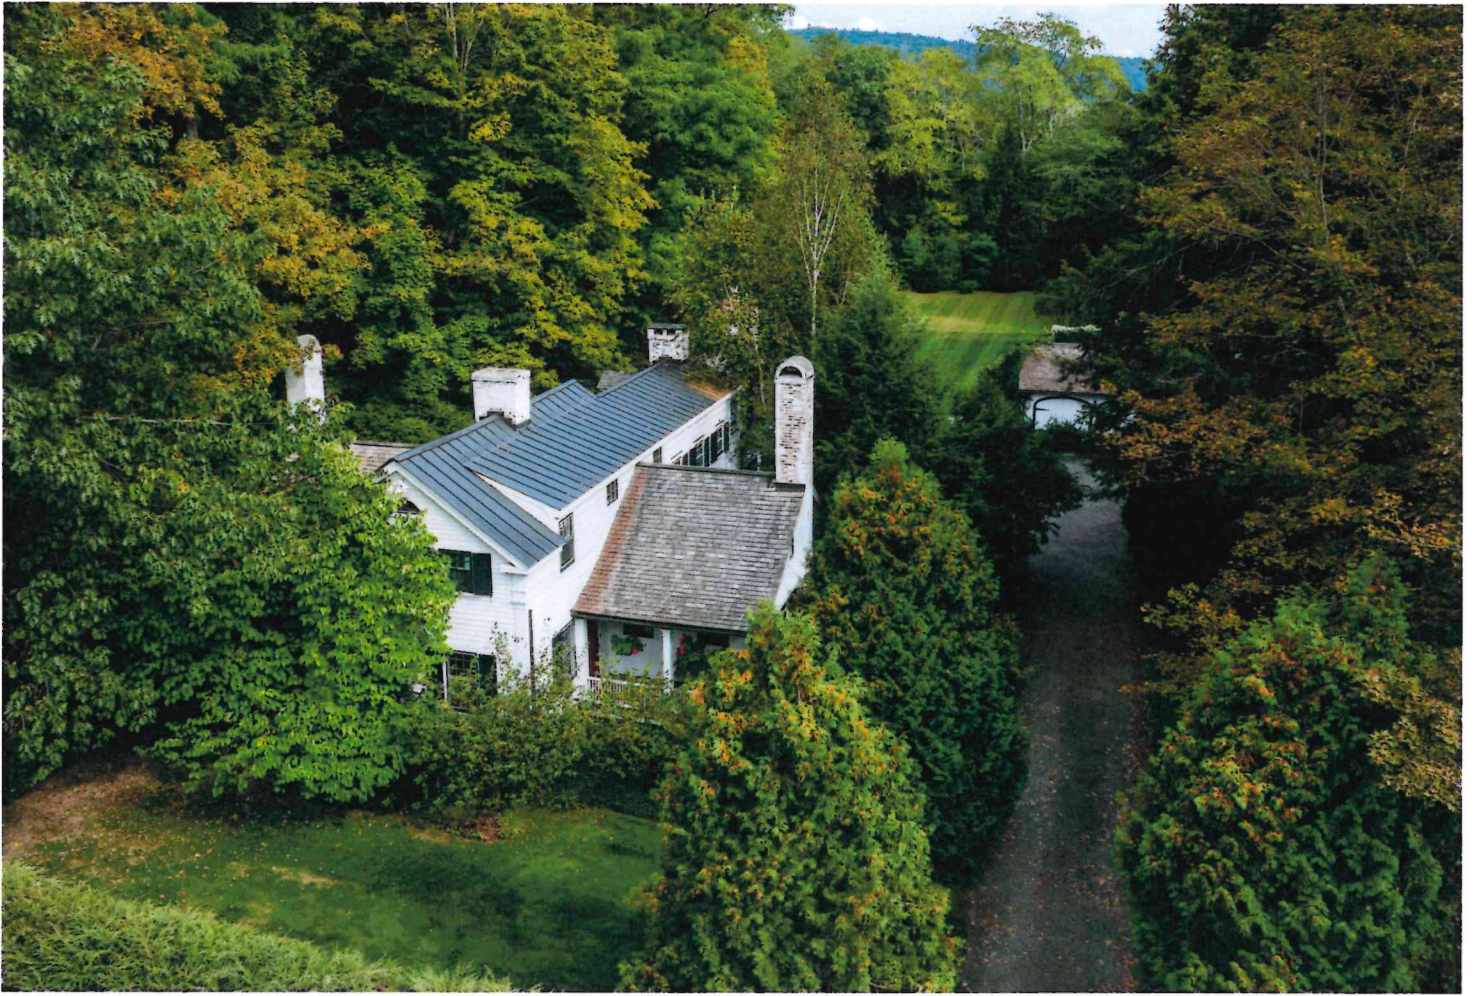
Main house - South facing - metal

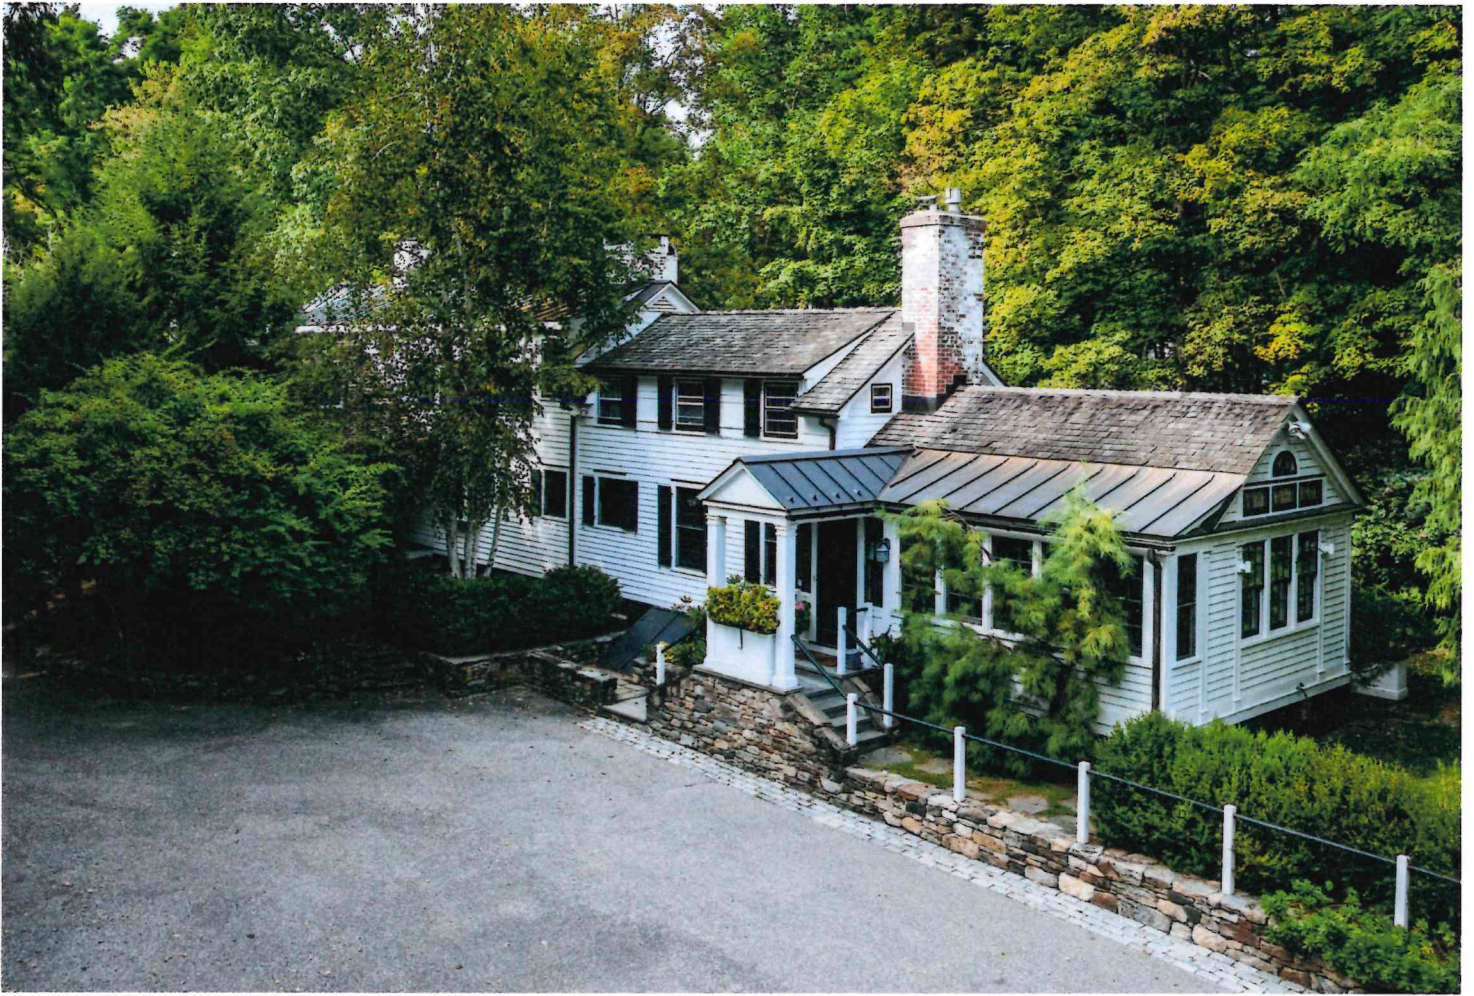
Side entrance - metal / cedar shake

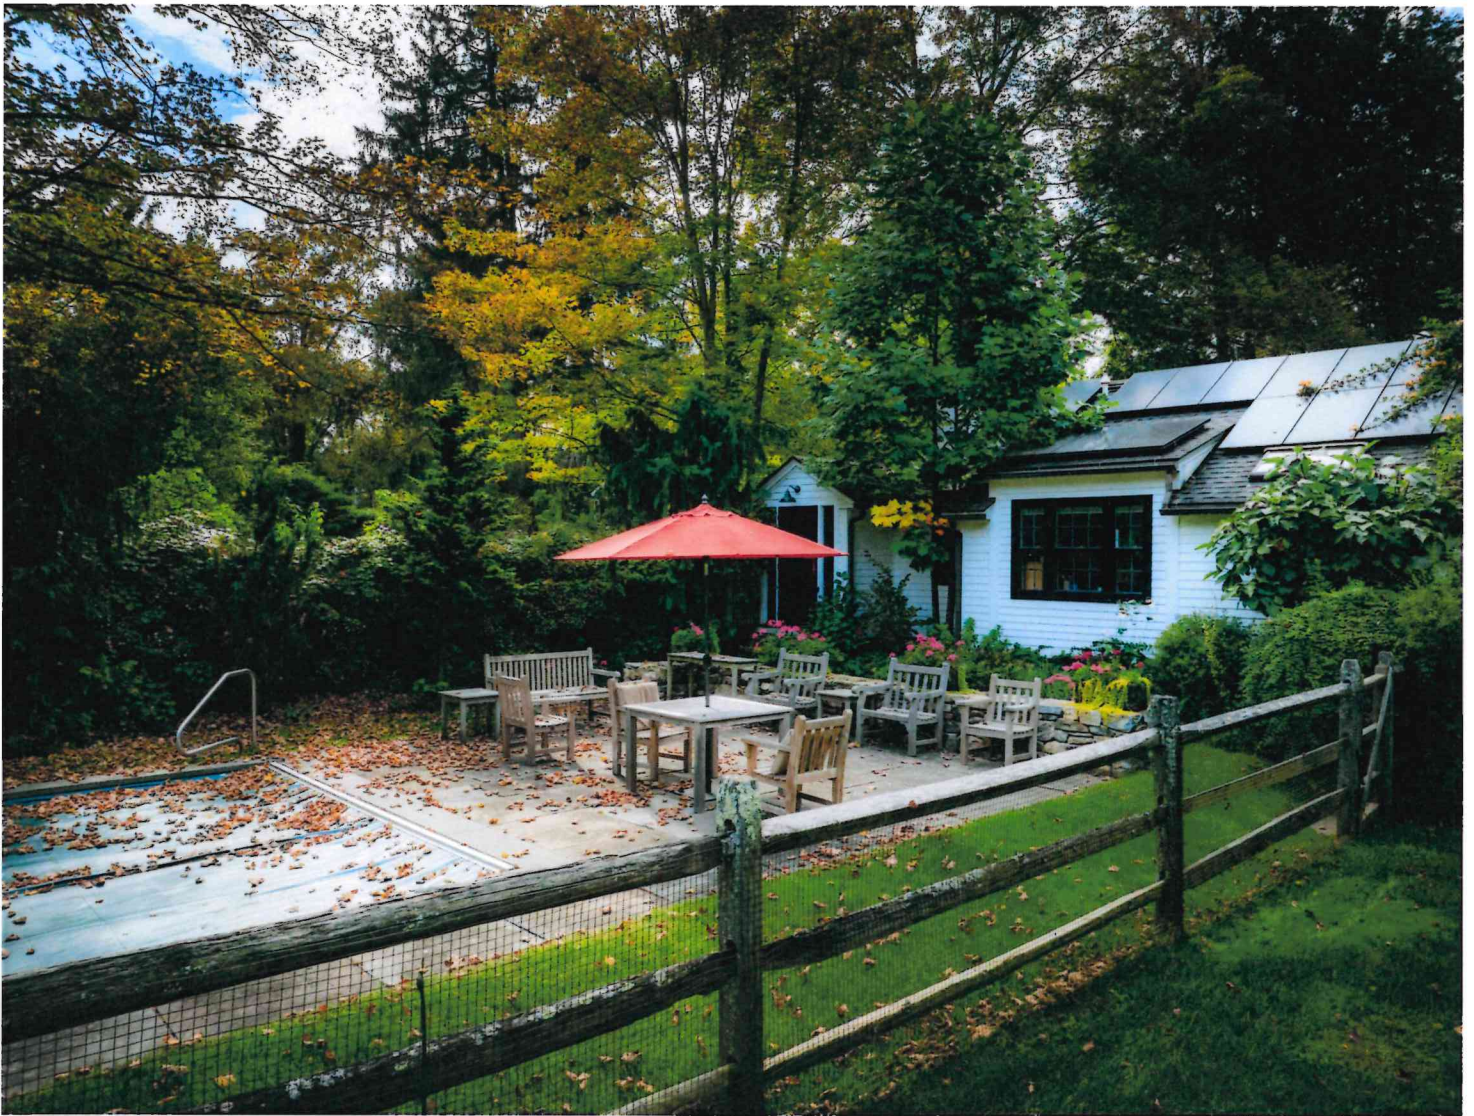
rear pool house - asphalt
shingles
