Memorandum

Re: Traffic Evaluation
Proposed Affordable Housing
11 Holley Street
Salisbury, Connecticut

1 Introduction to Main Street, Salisbury RSA

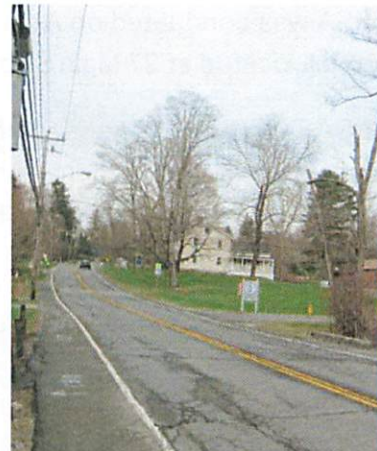
Figure 5. Deteriorating Pavement

- A cyclist was observed on the road.
- The pavement is deteriorating in many places along the corridor. It is heavily cracked. (Figure 5).
- Drainage is a concern, particularly on the south/east side of the culvert. The home owner installed a swale to channel water from the road away from his property and toward the stream (Figure 6).
- The road by the culvert is eroding in places (Figure 7). This is most likely from water draining off of the road into the stream without a positive drainage system.
- The guide rail for the culvert is an old wire rope rail. It appears to not meet current standards (Figure 8).

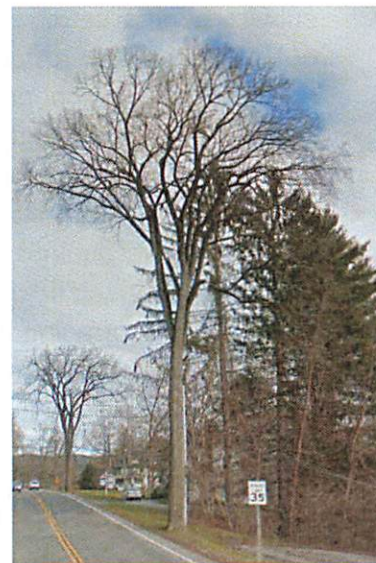
Figure 9. Protected Elm Trees

- The roadway is not always centered in the right-of-way.
- East of the fire station there are large protected Elm trees near the road edge (Figure 9).
- The "Railroad Ramble" rail trail is owned by the town, and parallels this route. It is grass (not paved) and is not maintained in the winter.
- There is access off Brook Street for the rail trail but it is poorly marked. The town recently converted Brook Street to a public way and will soon be designating parking.

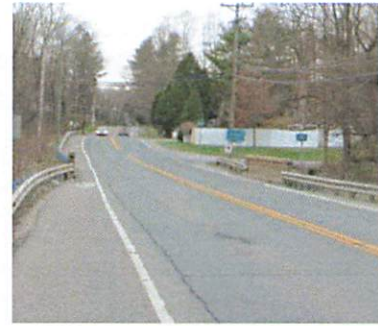
Figure 10. Narrow Bridge Crossing

- There are places along the corridor where old sidewalk beds are visible.
- The Appalachian Trail from the west intersects Cobble Road west of Route 44, and from the east, it intersects Route 44 north of Lions Head. As a result, trail users must use Route 44 between these segments, and must cross the narrow bridge over Moore Brook (Figure 10).

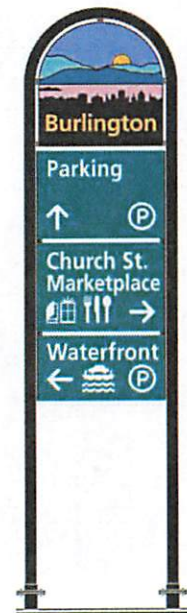
Figure 12. Typical Wayfinding Sign

3. Clear brush to create a pathway connection between Brook Street and the Railroad Ramble.
4. Improve Wayfinding signage related to the town center, nearby landmarks, the Appalachian Trail, the Railroad Ramble, Lakeville, educational facilities, etc (Figure 12).

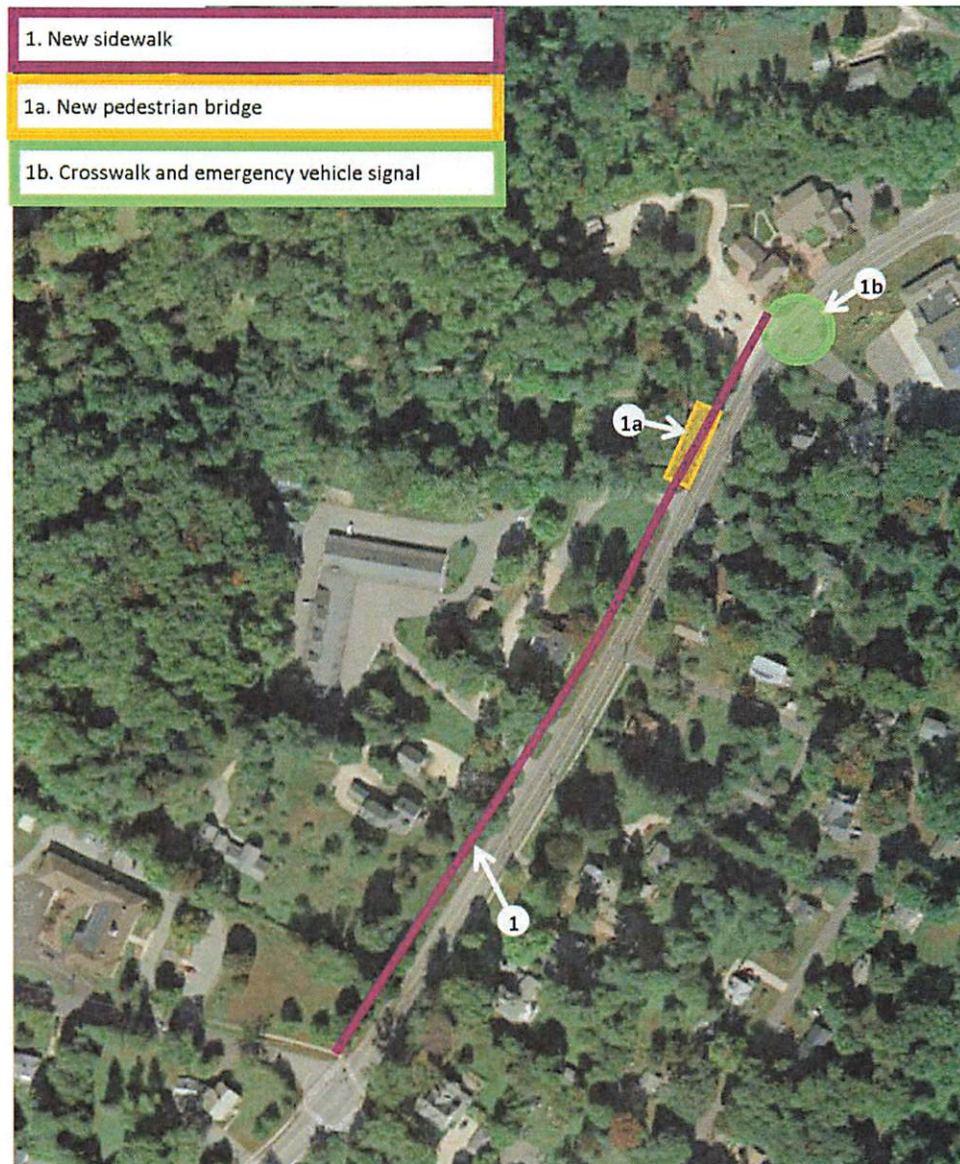
Figure 14. Medium Term Recommendations

1. Connect the school and emergency shelter with a sidewalk on the North side of the road if research shows a signal is possible.
 - a. Add pedestrian bridge over the brook.
 - b. Install actuated pedestrian signal and crosswalk in conjunction with emergency vehicle signal.
2. Improve Rail Trail crossing on Salmon Kill Road (signing, striping, some grading and clearing).

Figure 14 depicts some of the recommendations along Main Street.

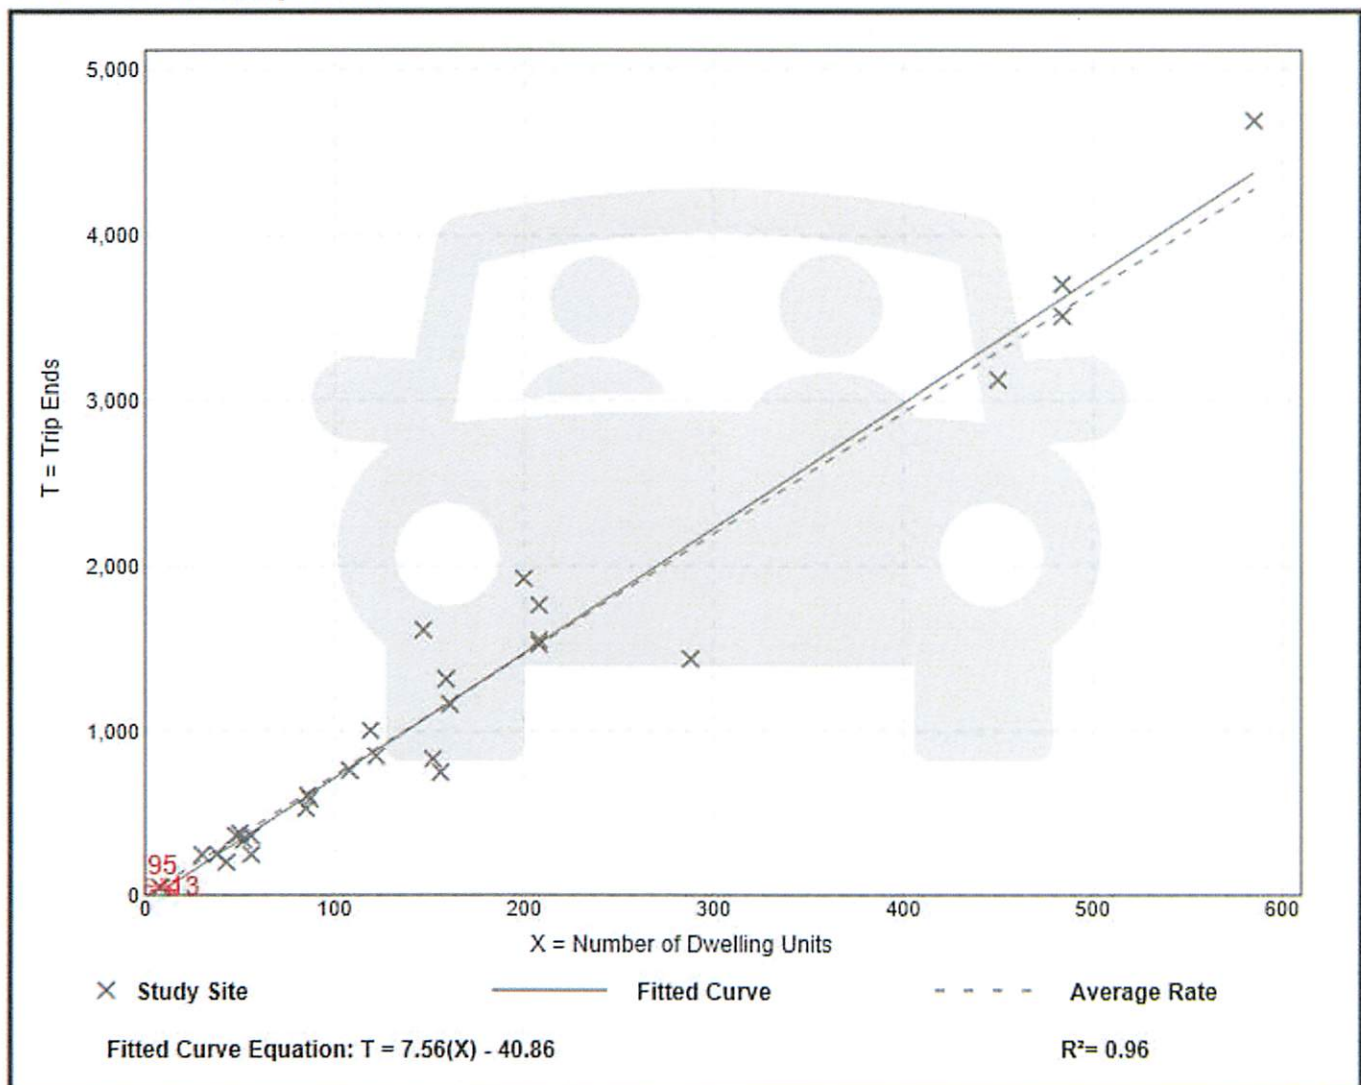
Average Rate	Range of Rates	Standard Deviation
7.32	4.45 - 10.97	1.31

Multifamily Housing (Low-Rise)

The Institute of Transportation Engineers (ITE) *Trip Generation Manual, 10th Edition* was used to estimate vehicle trips to be generated by the proposed development. ITE land use code (LUC) 220 "Multifamily Housing (Low-Rise)" was used to estimate vehicle trips for all peak hours.

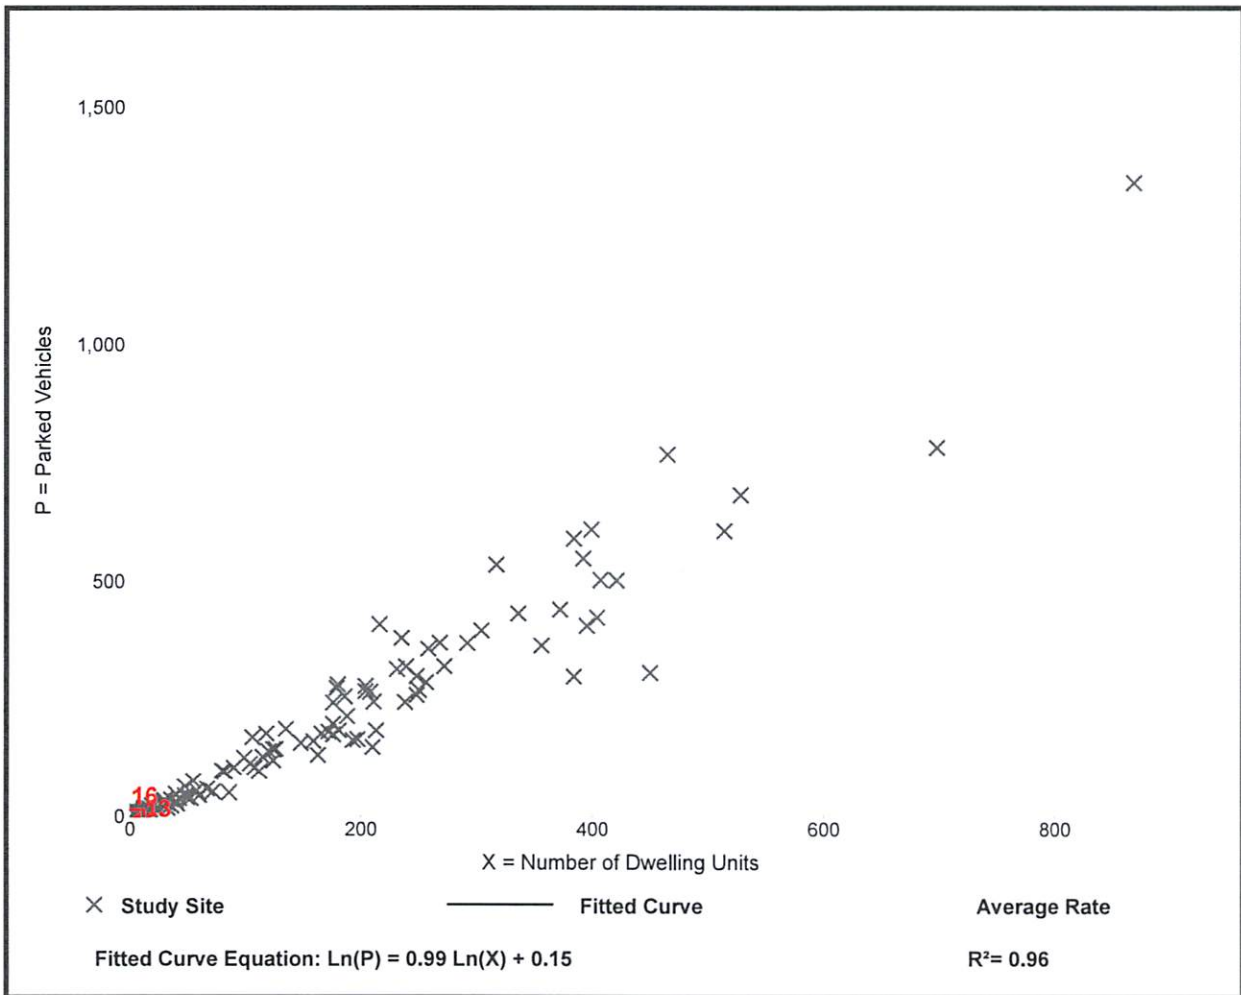
Peak Period Parking Demand vs: Dwelling Units
On a: Weekday (Monday - Friday)
Setting/Location: General Urban/Suburban (no nearby rail transit)
Peak Period of Parking Demand: 11:00 p.m. - 6:00 a.m.
 Number of Studies: 119
 Avg. Num. of Dwelling Units: 156

Average Rate	Range of Rates	33rd / 85th Percentile	95% Confidence Interval	Standard Deviation (Coeff. of Variation)
1.21	0.58 - 2.50	1.03 / 1.52	1.16 - 1.26	0.27 (22%)

The proposed site plan shows 24 parking spaces on site supporting the 13 units of housing which exceeds the minimum zoning requirements. A review the Institute of Transportation Engineers (ITE) Parking Generation Manual, 5th edition for Multi-Family Low Rise residential use with no access to transit indicates a maximum of 16 parking spaces will be utilized for the proposed development during peak parking demand for residents and visitors. This is based upon parking surveys for over 119 other developments.
