Salisbury Pathways Committee

Seventieth Meeting

Route 44 Salisbury to Lakeville – Road Safety Audit

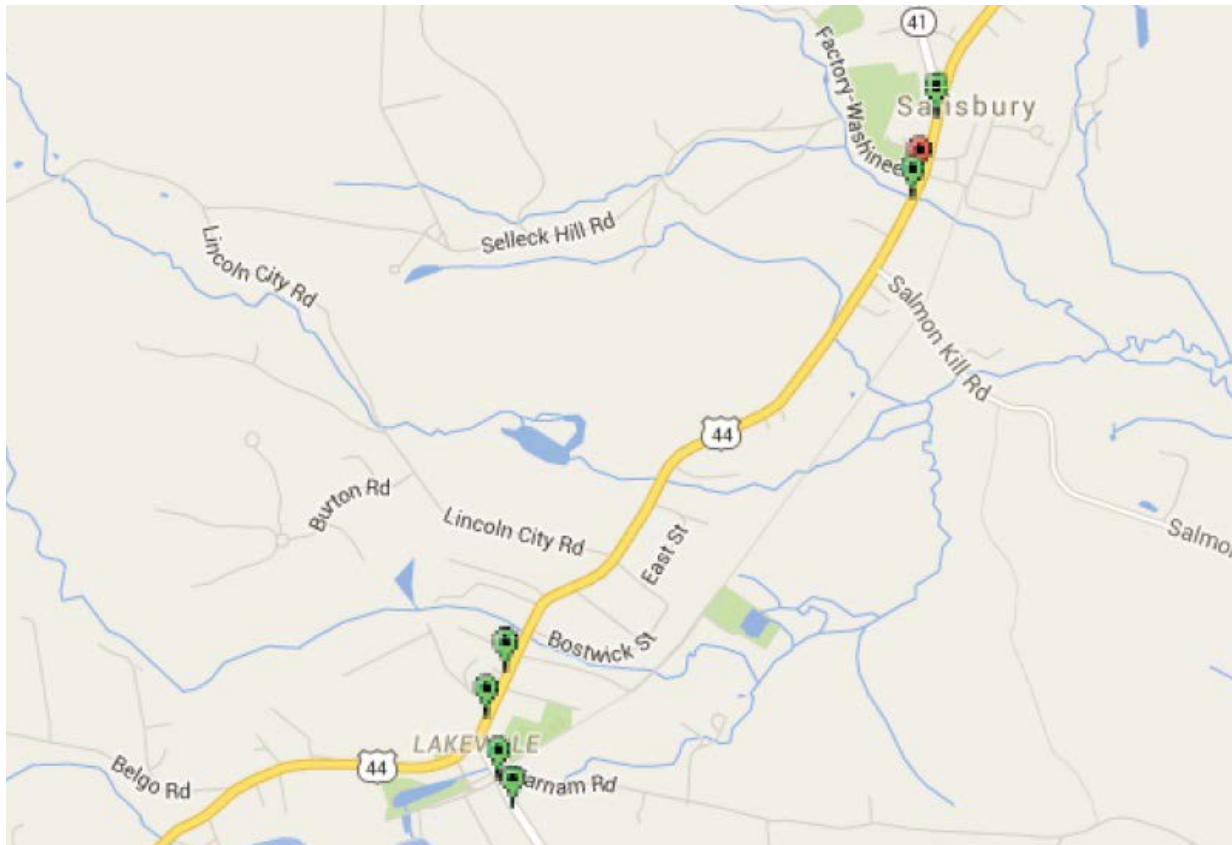
Figure 3. Crashes that Occurred in 2015 (Connecticut Crash Data Repository)

Although the crash history in this area is relatively low, there were two accidents involving pedestrians and two involving bicyclists between 2012 and 2014. **Error! Reference source not found.** Figure 3 displays crashes that occurred in this area during 2015.

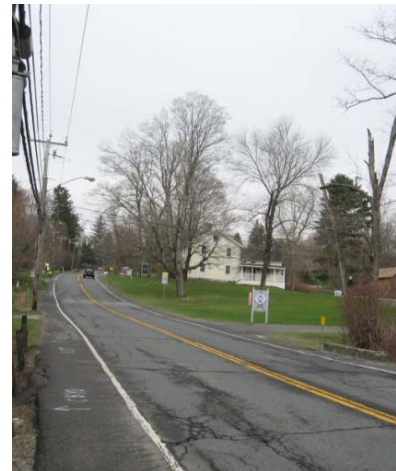
Figure 5. Deteriorating Pavement

- A cyclist was observed on the road.
- The pavement is deteriorating in many places along the corridor. It is heavily cracked. (Figure 5).
- Drainage is a concern, particularly on the south/east side of the culvert. The home owner installed a swale to channel water from the road away from his property and toward the stream (Figure 6).
- The road by the culvert is eroding in places (Figure 7). This is most likely from water draining off of the road into the stream without a positive drainage system.
- The guide rail for the culvert is an old wire rope rail. It appears to not meet current standards (Figure 8).

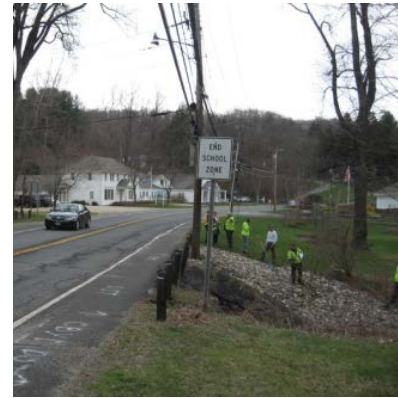
Figure 7. Eroding Roadway at Culvert

- When a fire truck leaves the station, someone must stand out at the Brook Street intersection to direct traffic.
- The headwall of the culvert and crib walls are old and falling apart.

1. Install missing sidewalk between Salisbury center and Brook Street.
2. Install missing sidewalk between Meadow Street and Brook Street, including the reconstruction of the culvert over Pettee Brook.

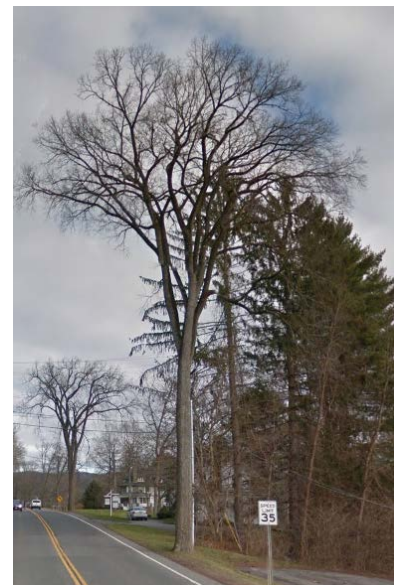
Figure 9. Protected Elm Trees

- The roadway is not always centered in the right-of-way.
- East of the fire station there are large protected Elm trees near the road edge (Figure 9).
- The "Railroad Ramble" rail trail is owned by the town, and parallels this route. It is grass (not paved) and is not maintained in the winter.
- There is access off Brook Street for the rail trail but it is poorly marked. The town recently converted Brook Street to a public way and will soon be designating parking.

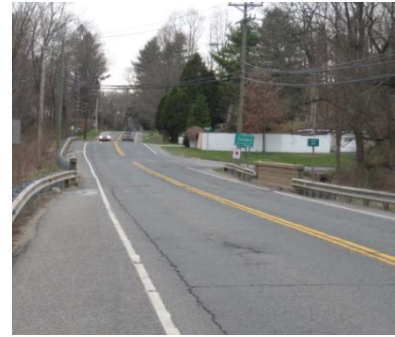
Figure 10. Narrow Bridge Crossing

- There are places along the corridor where old sidewalk beds are visible.
- The Appalachian Trail from the west intersects Cobble Road west of Route 44, and from the east, it intersects Route 44 north of Lions Head. As a result, trail users must use Route 44 between these segments, and must cross the narrow bridge over Moore Brook (Figure 10).

3. Complete the portion of the Appalachian Trail along Canaan Road (Route 44) between Cobble Road and the easterly trail head, and pedestrian crossing of Canaan Road. This will require the crossing of Moore Brook, either by widening the existing Route 44 structure or building an additional structure adjacent to the roadway.
