December 11, 2023

**RE:**     **WETLANDS ASSESSMENT: Summary of Findings**  
          **Dresser Woods**, Railroad Street, Salisbury, CT

*REMA Job # 14-1729-SLS2*

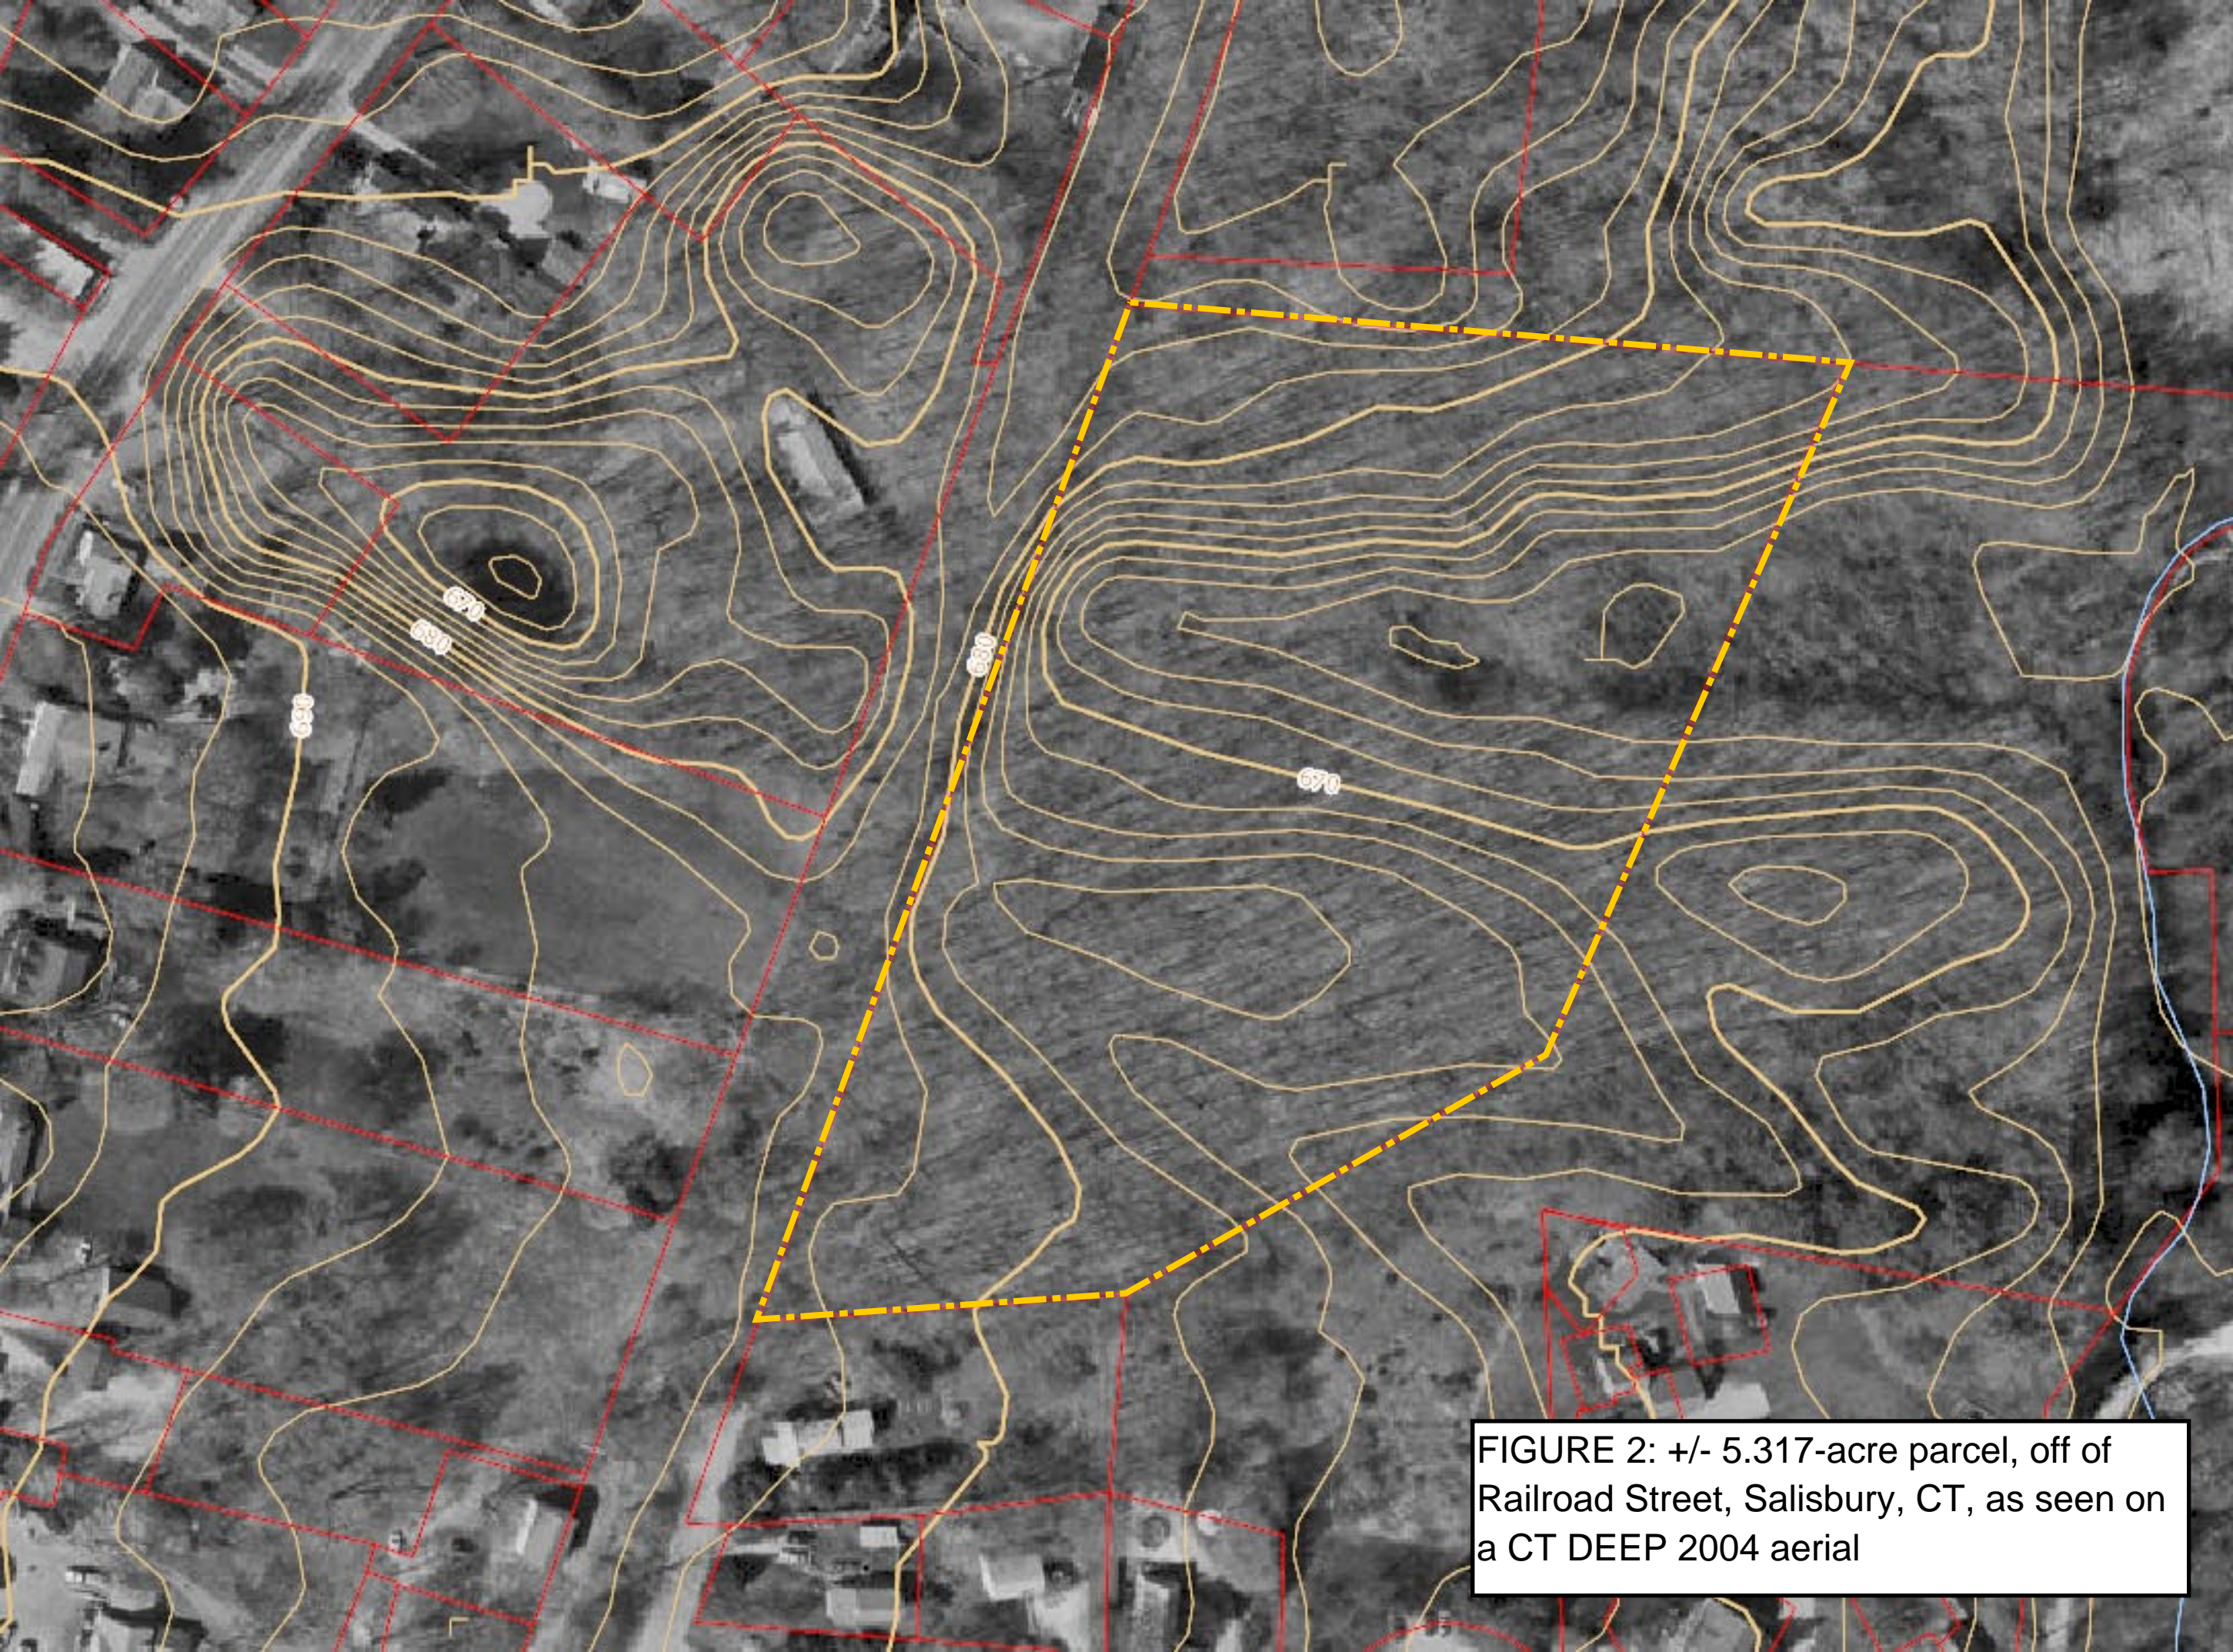
FIGURE 2: +/- 5.317-acre parcel, off of Railroad Street, Salisbury, CT, as seen on a CT DEEP 2004 aerial

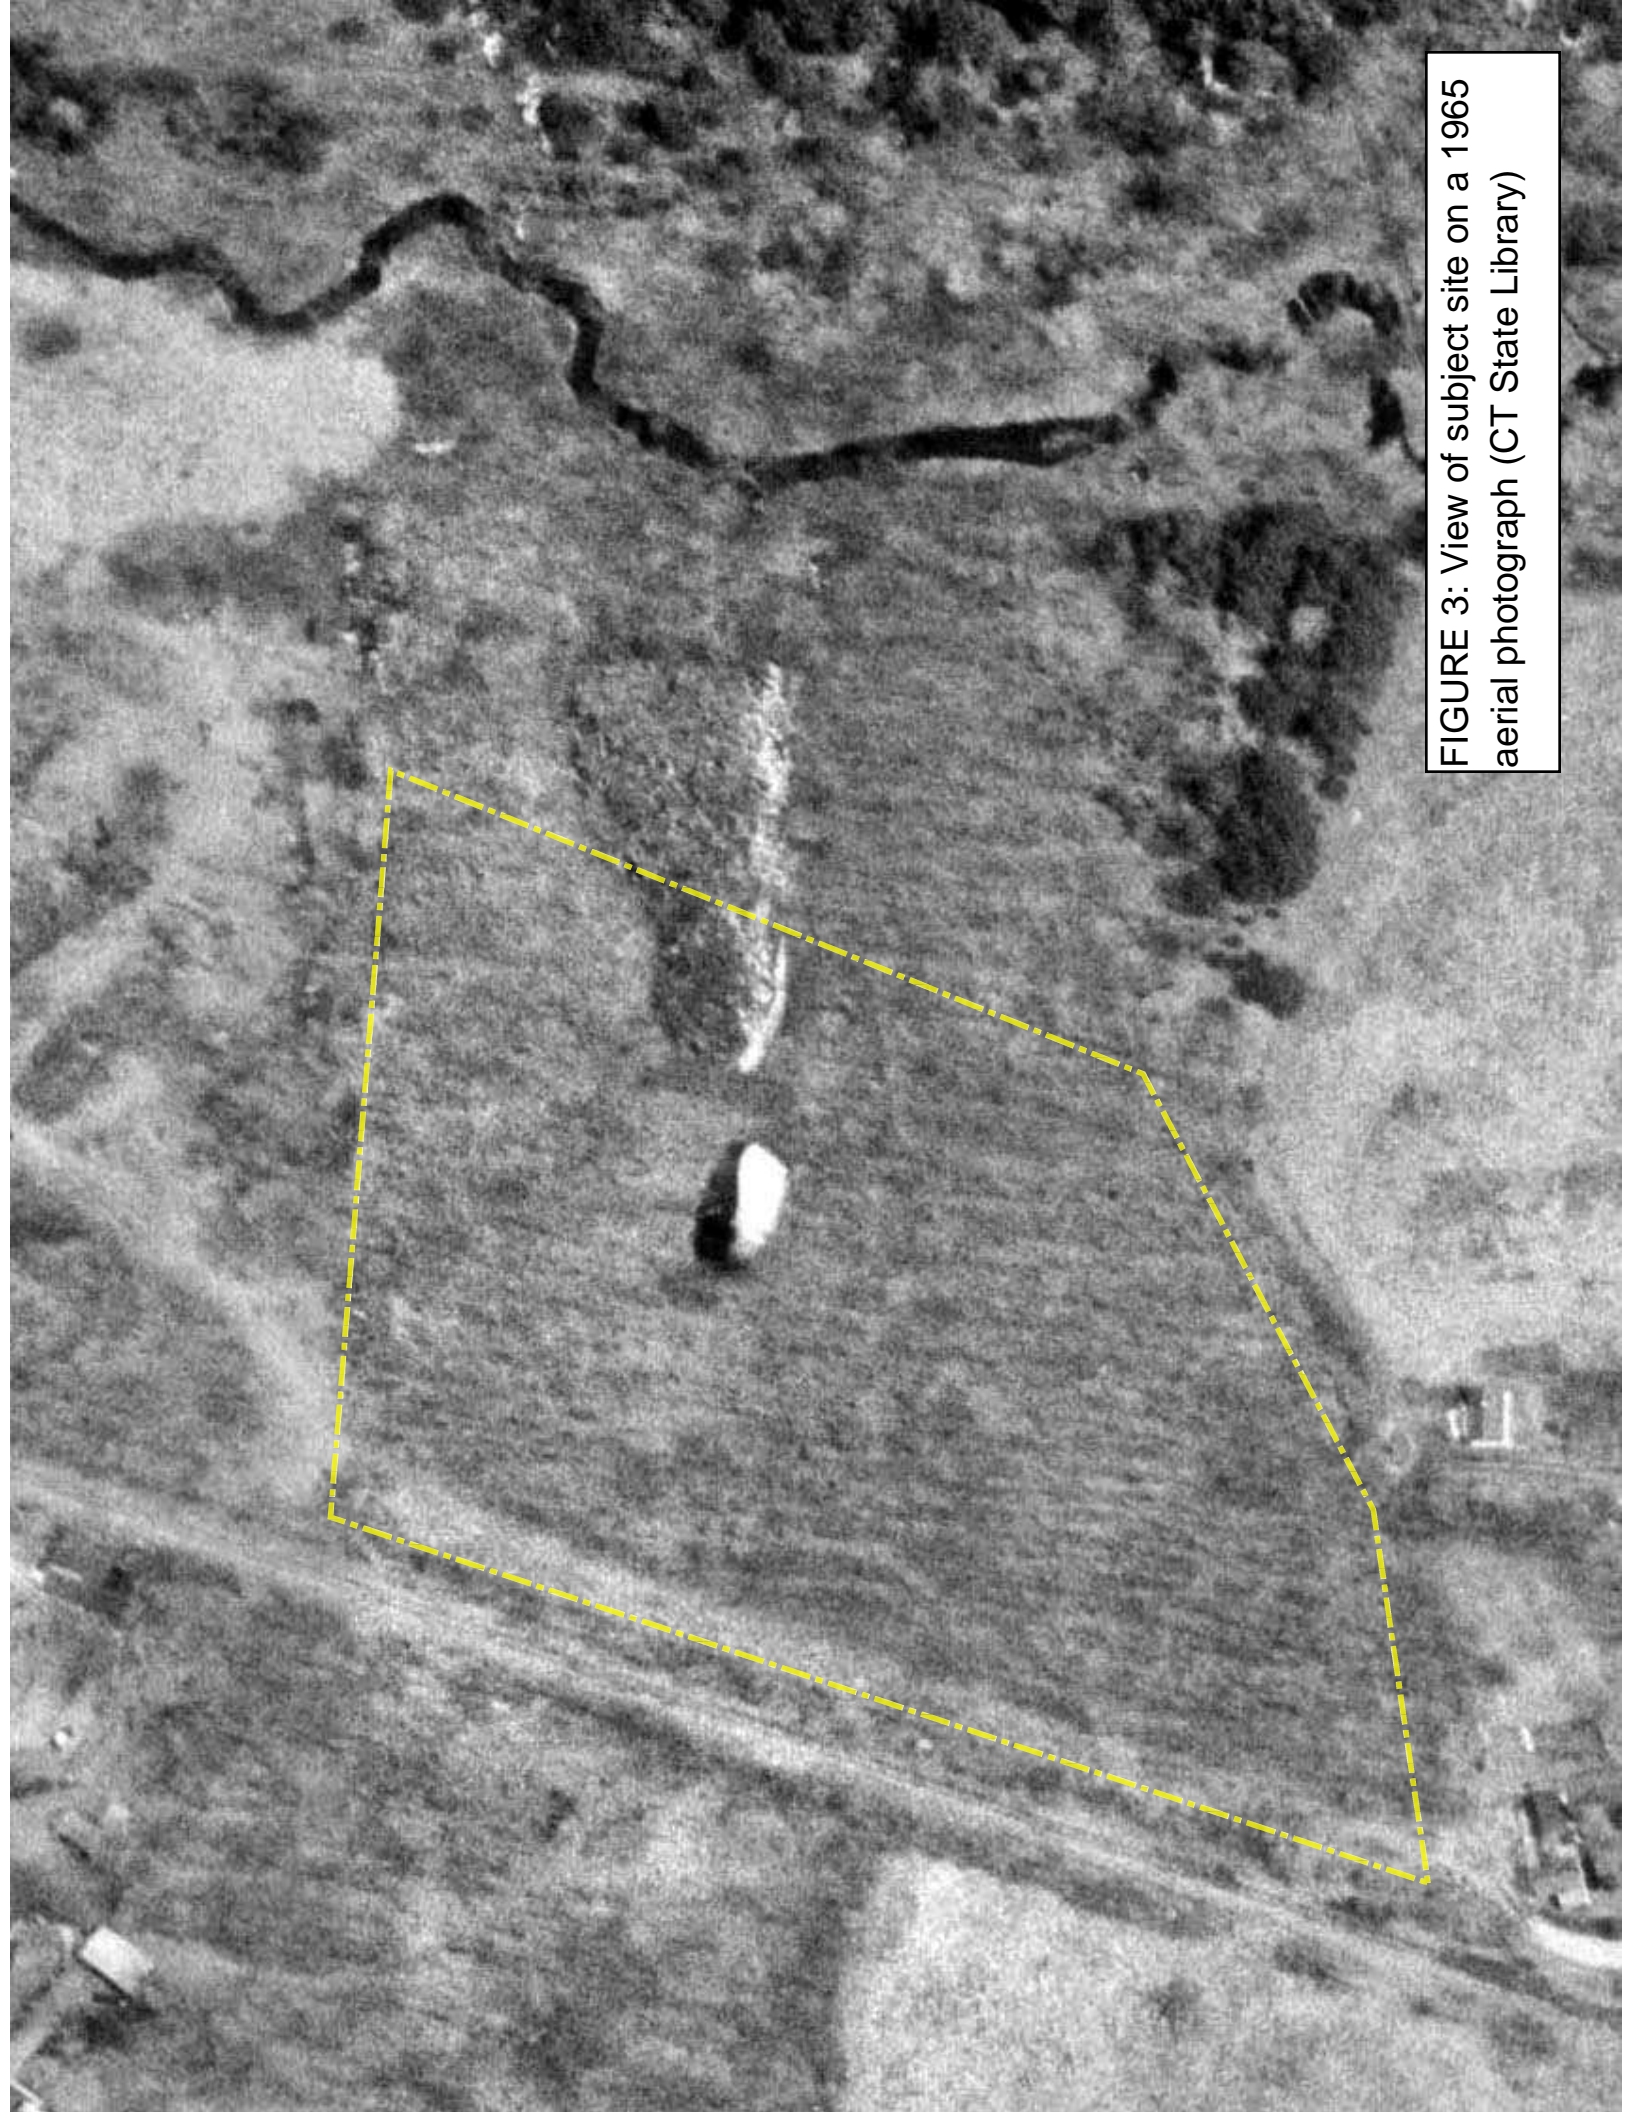
FIGURE 3: View of subject site on a 1965  
aerial photograph (CT State Library)

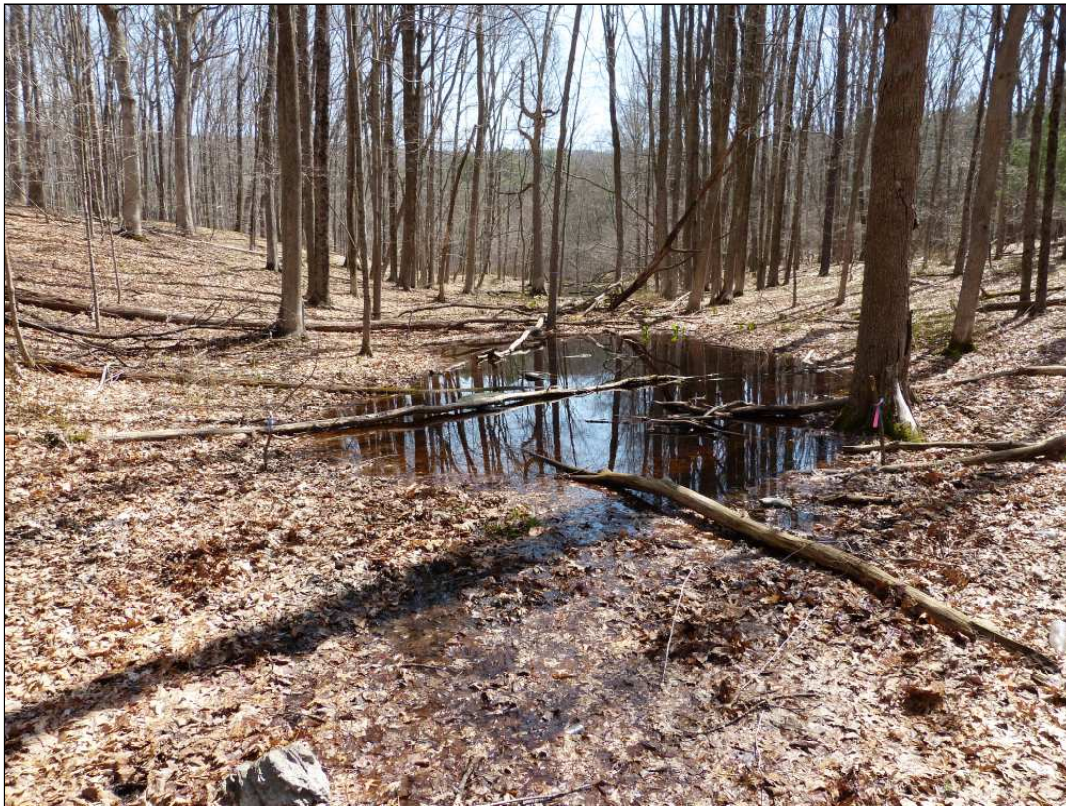
*Photo 1: Vernal Pool #1; facing southeasterly*

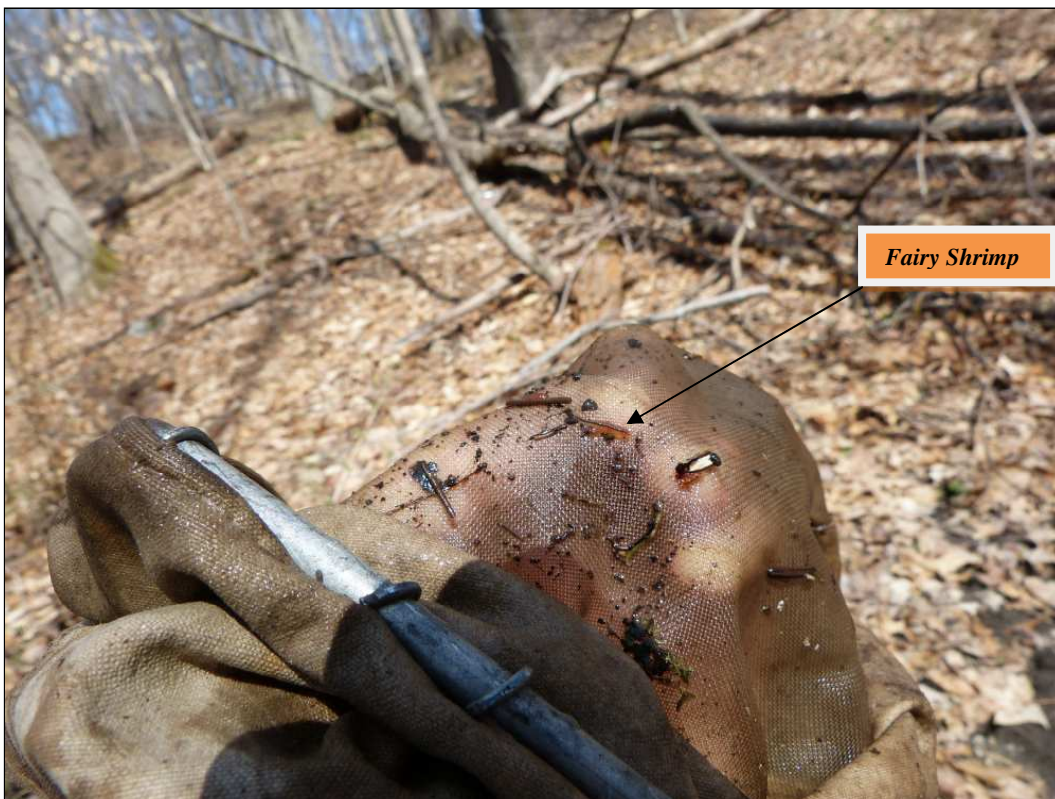
*Photo 2: Vernal Pool #1 only contained fairy shrimp as an obligate species.*

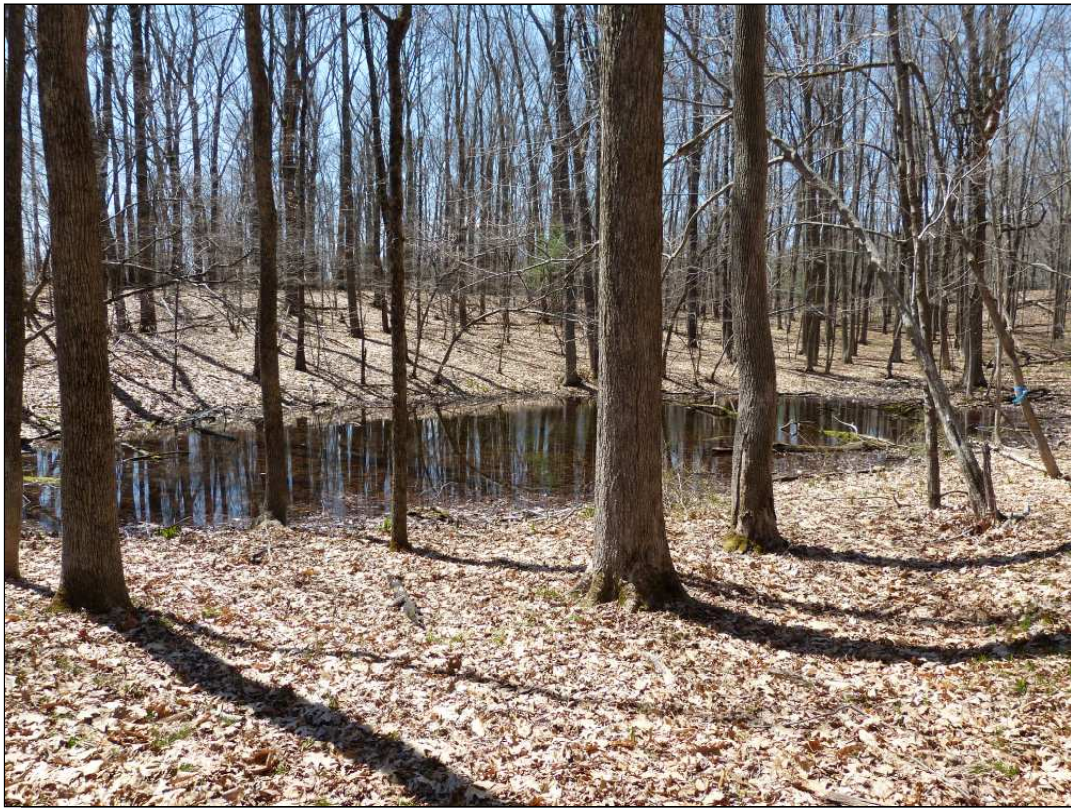
*Photo 3: Vernal Pool #2; facing westerly*

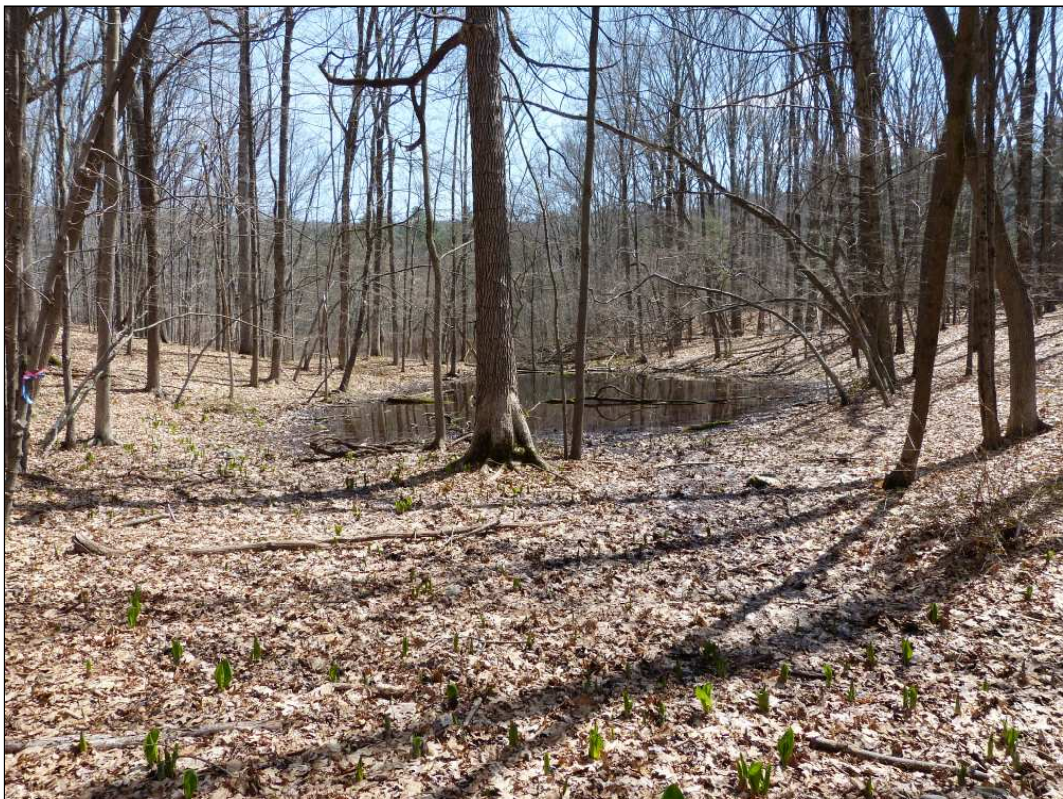
*Photo 4: Vernal Pool #2; wetlands in foreground; facing easterly*

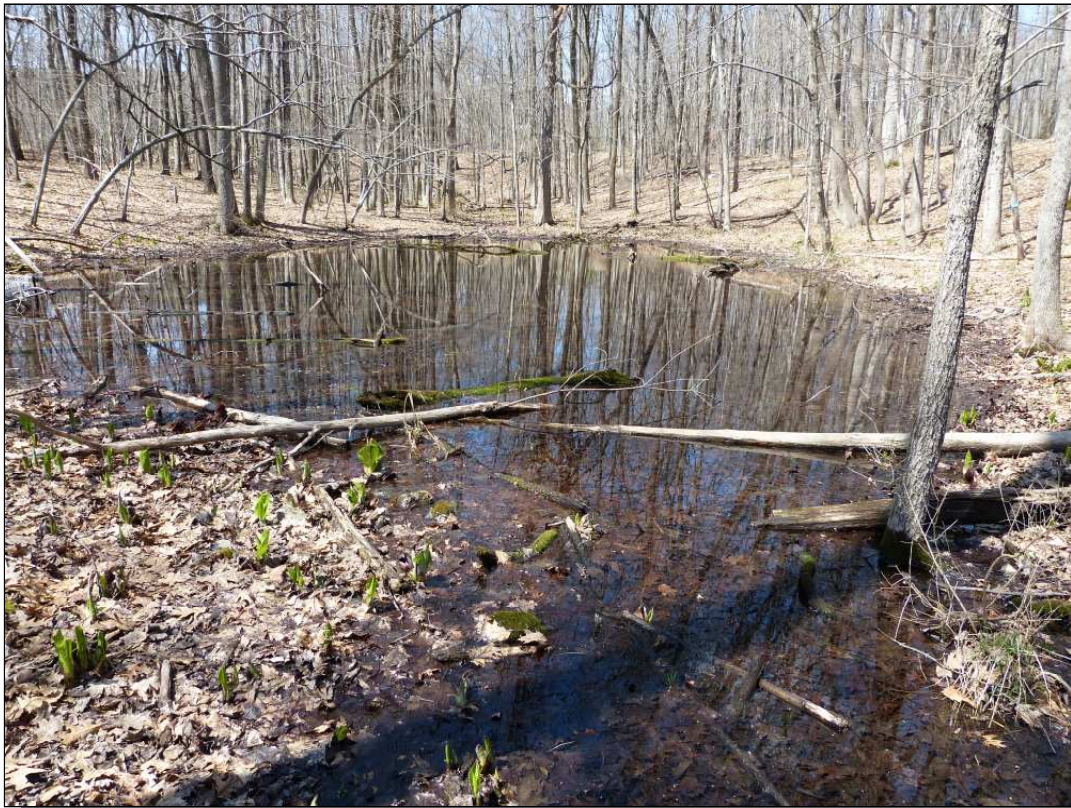
*Photo 5: Vernal Pool #2; diffuse outlet during spring high water; facing westerly*

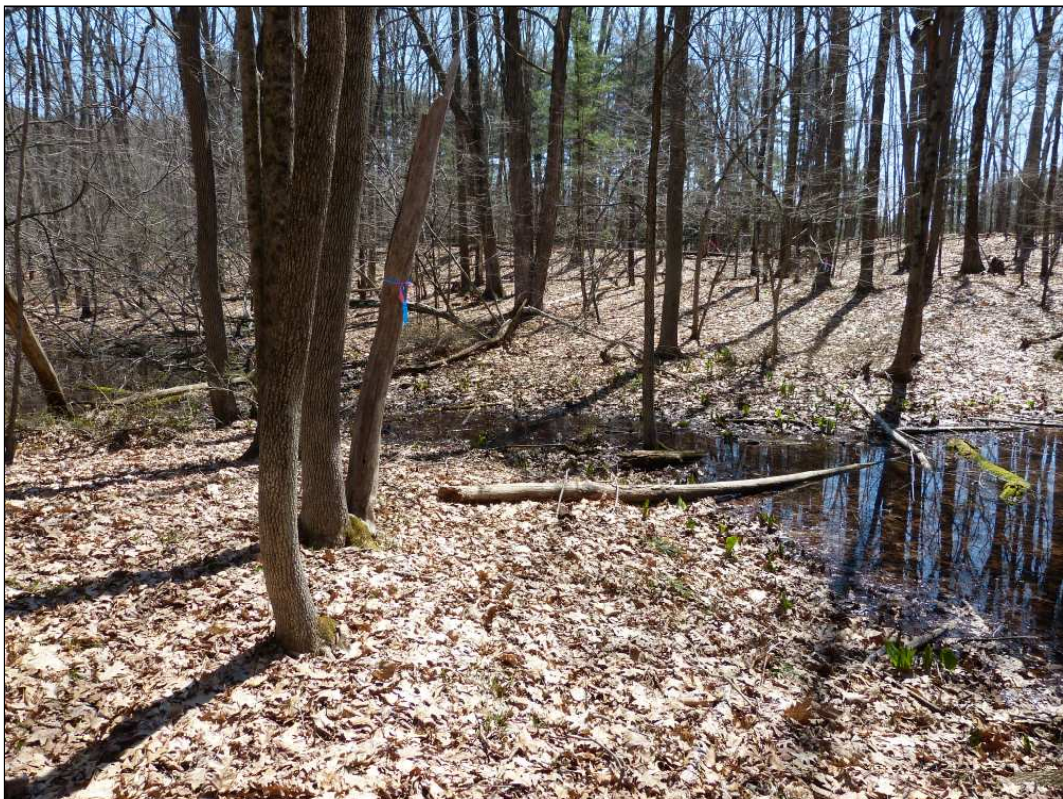
*Photo 6: Vernal Pool #2; diffuse outlet/overflow to Vernal Pool #3 (and swamp); facing southerly*

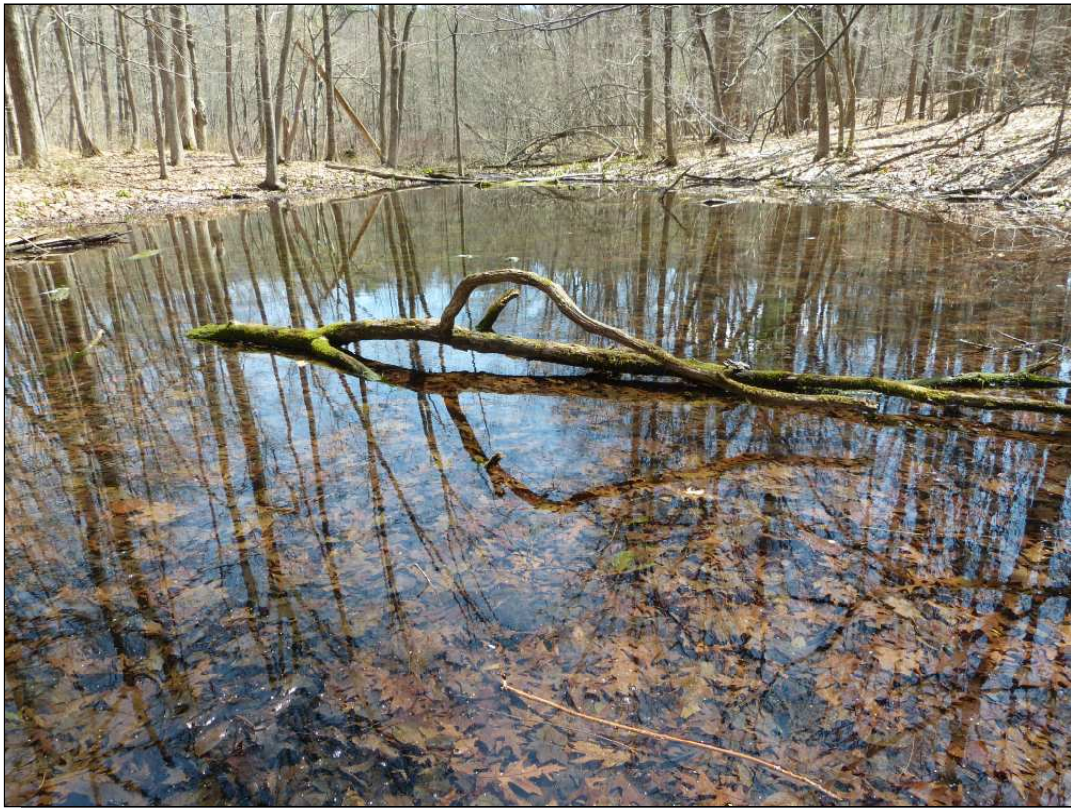
*Photo 7: Vernal Pool #2; only about 3-5 inches of water over leaf litter over organics; facing easterly*

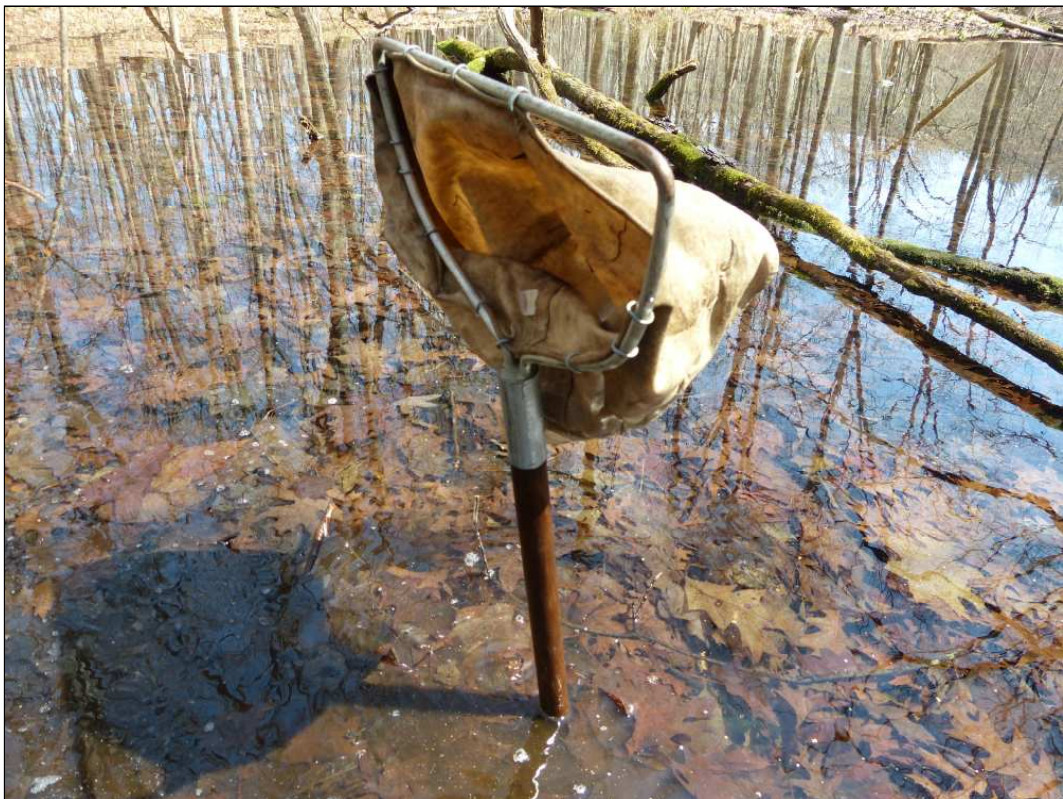
*Photo 8: Vernal Pool #2; 3 to 4 feet of organics are typical; this was likely an old "ice pond" that has filled in over the years*

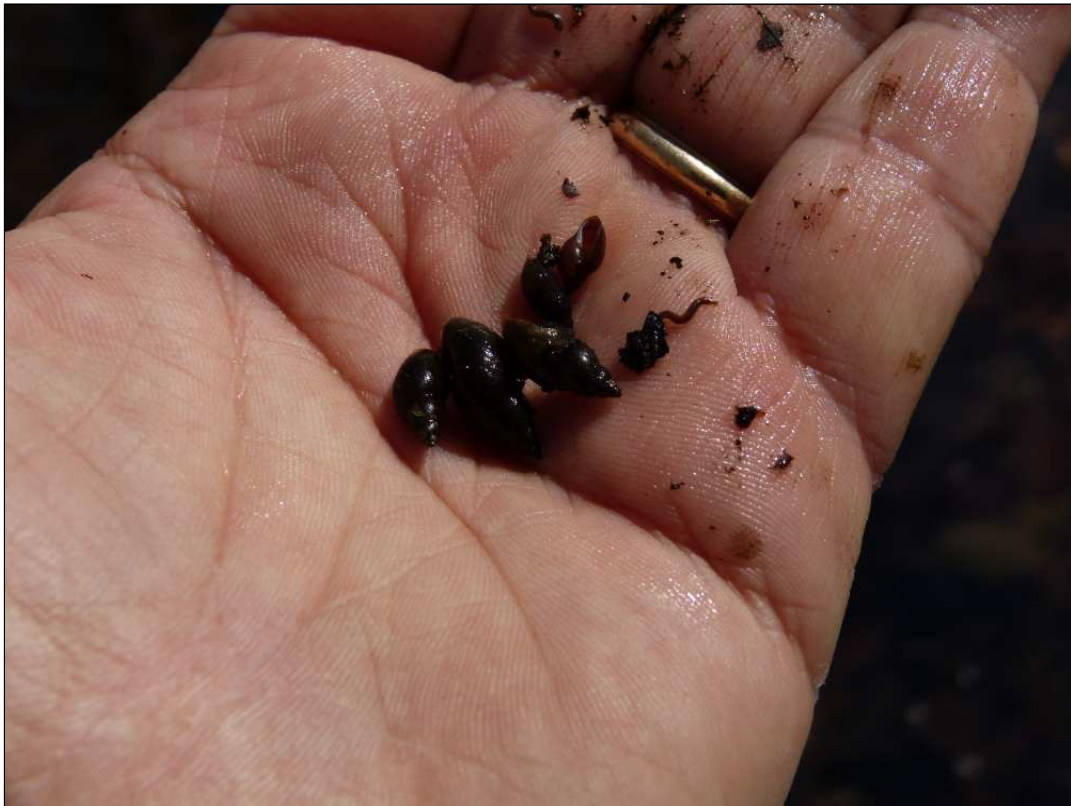
*Photo 9:* Primary productivity is high in Vernal Pool #2; thousands of snails (*Physa* spp.) seen grazing on leaf litter

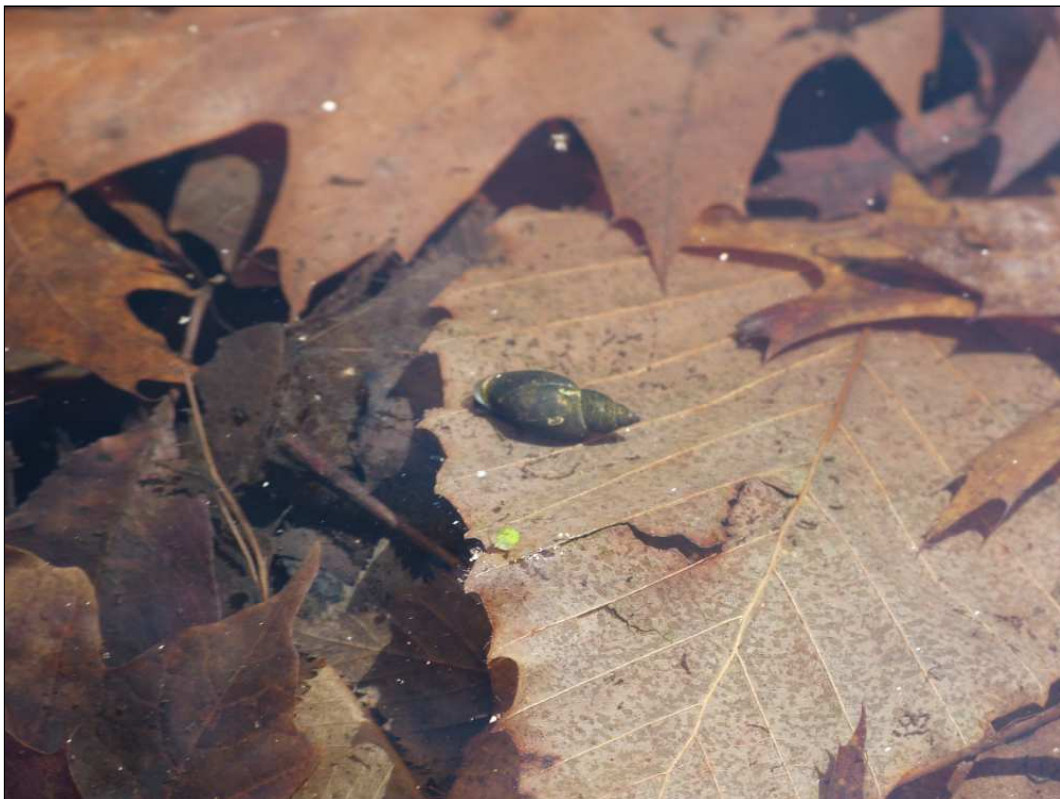
*Photo 10:* Vernal Pool #2; *Physa* snail grazing algae on leaf litter in just 2-3 inches of water.

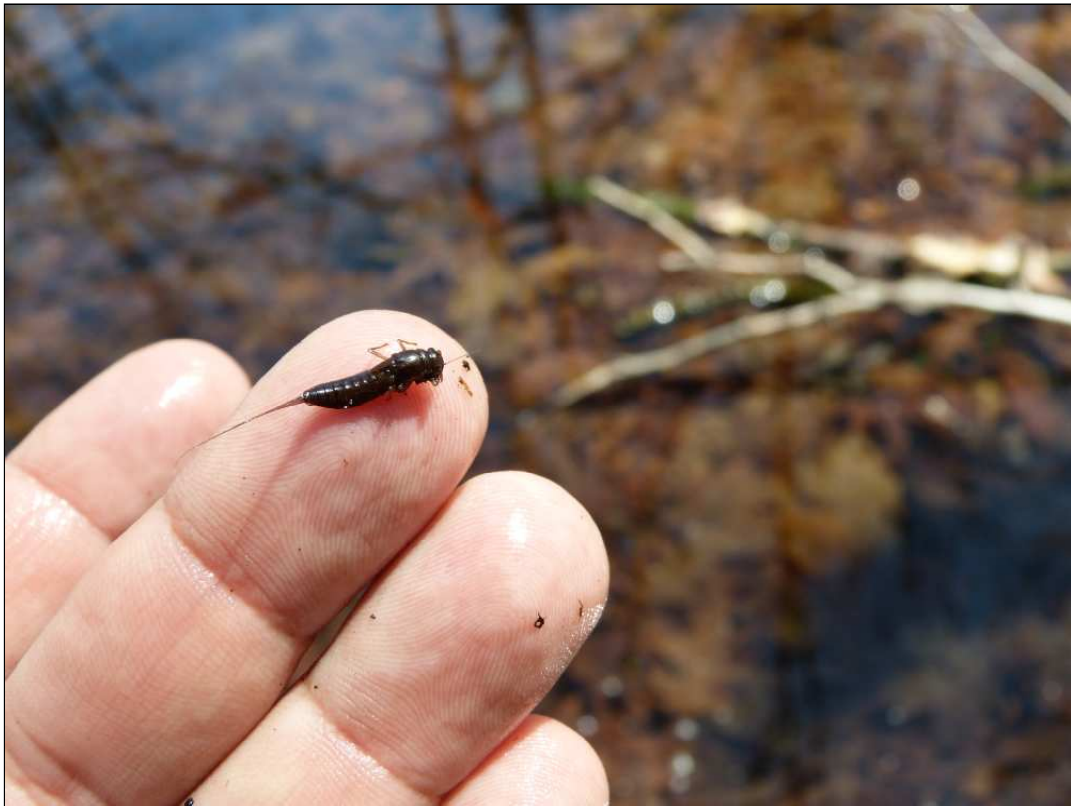
Photo 11: A mayfly (family Batidae) grazing on leaf litter within Vernal Pool #2; an indication that water persists through most if not all of the season

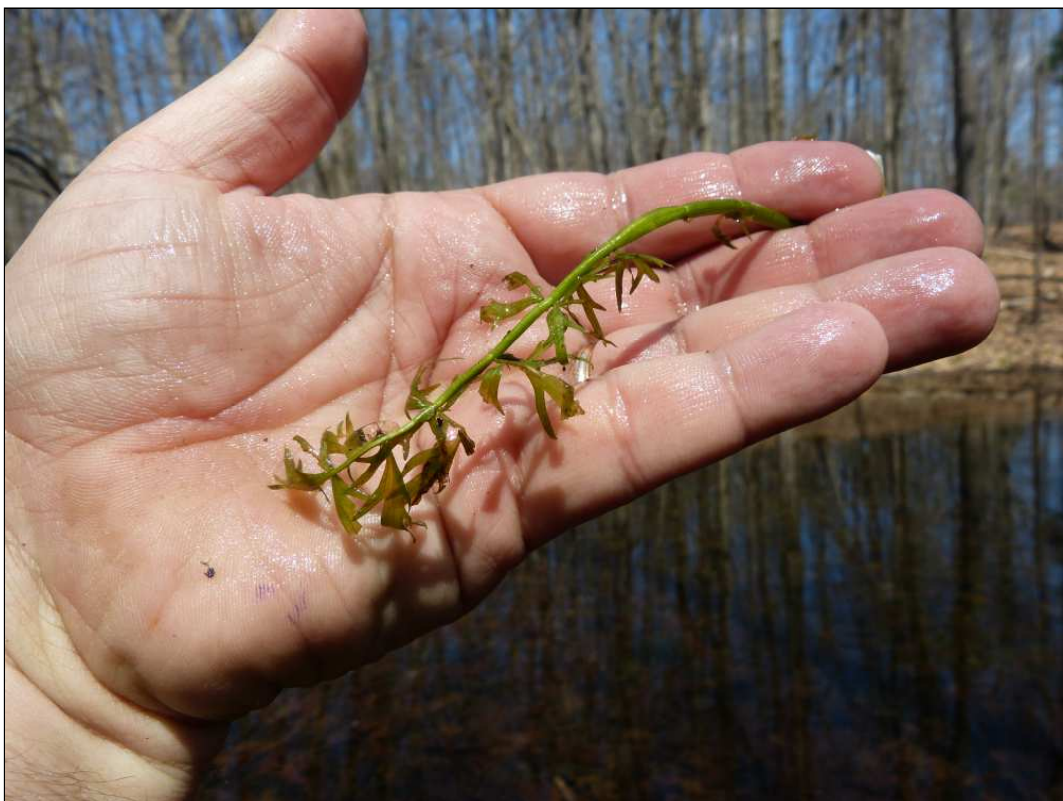
Photo 12: Vernal Pool #2; one of several aquatic plants, likely *Ranunculus flabellaris* (a buttercup) found here; too early in season to identify

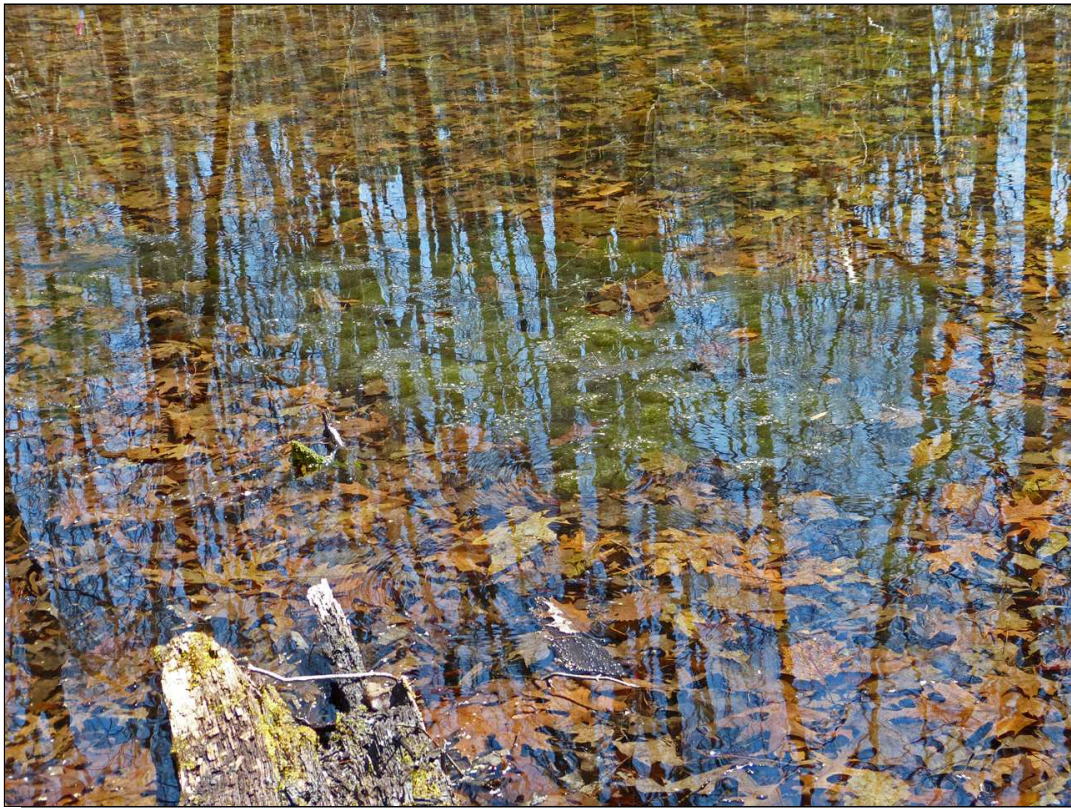
*Photo 13:* Vernal Pool #2; a large (+/- 130) wood frog egg mass raft in oly 3-5 inches of water

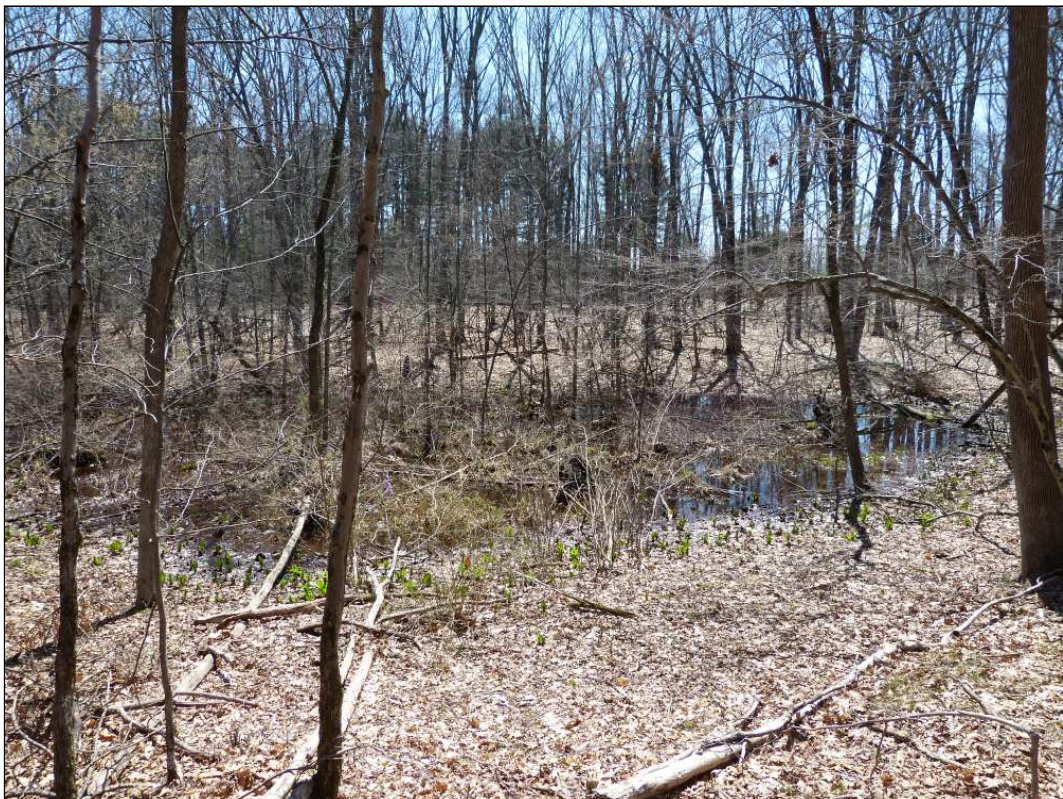
*Photo 14:* Vernal Pool #3; partially off-site; with embedded vernal pool type habitat; facing southerly

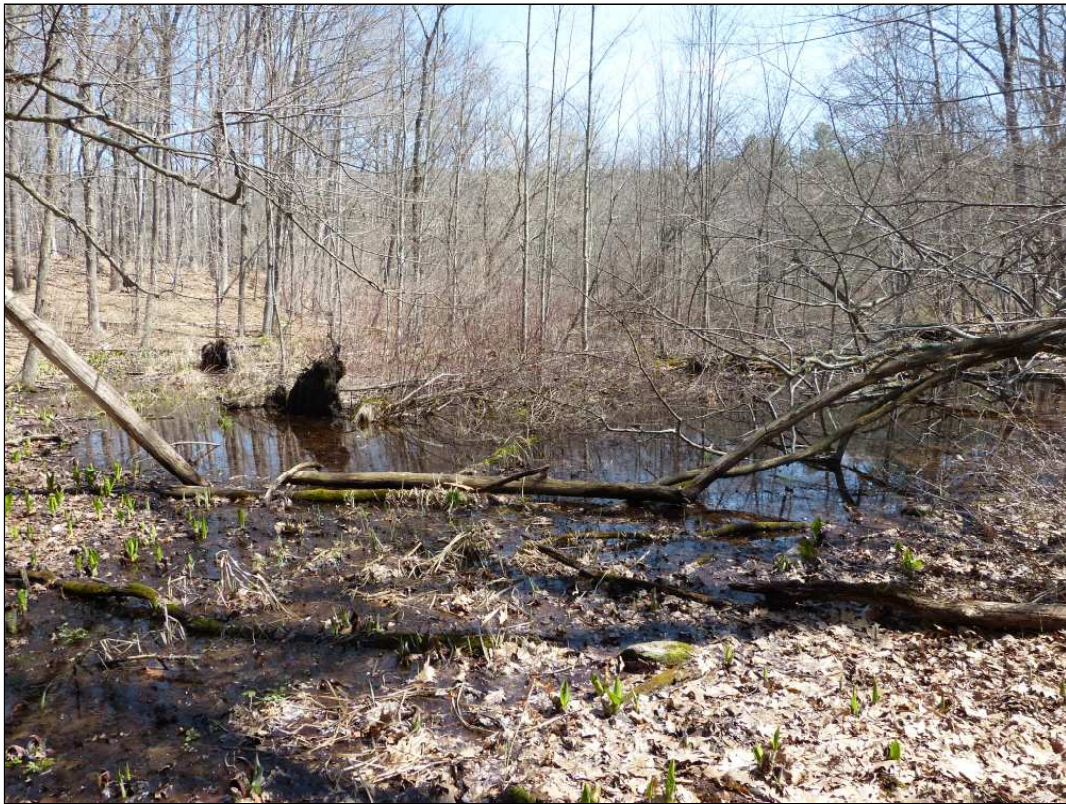
*Photo 15: Vernal Pool #3; view from the west; overflow from Vernal Pool #3 in forefront to the left*

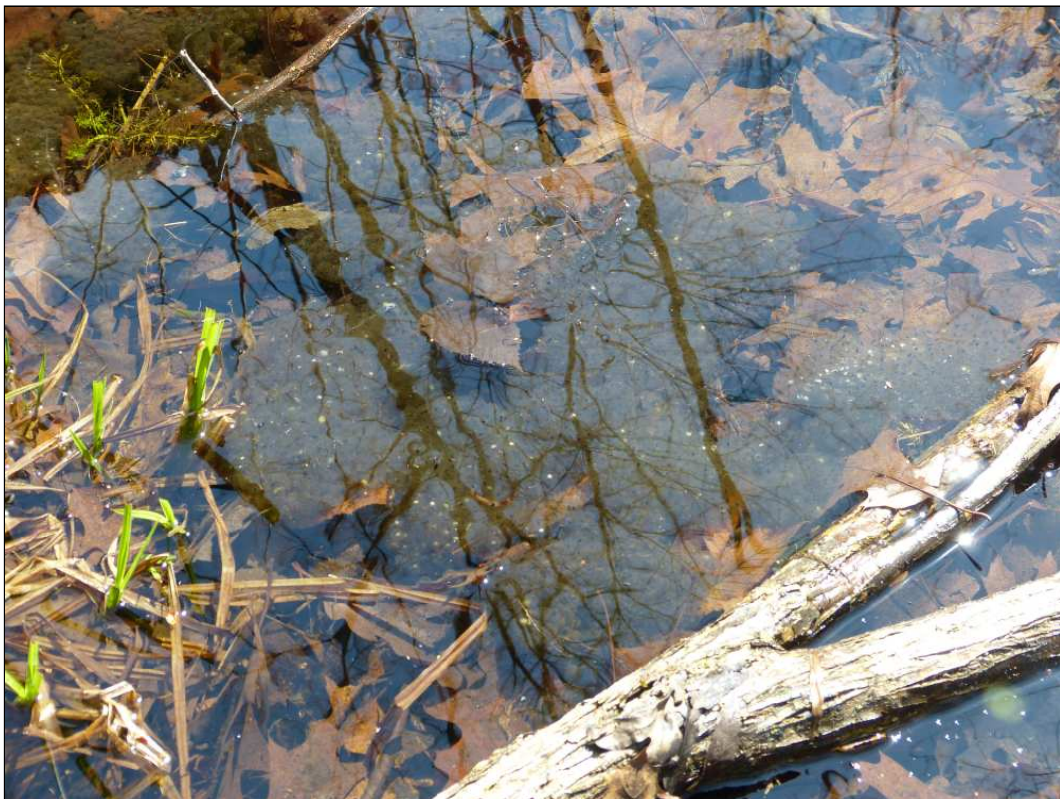
*Photo 16: Vernal Pool #3; one of three wood frog egg mass rafts in only a few inches of water.*

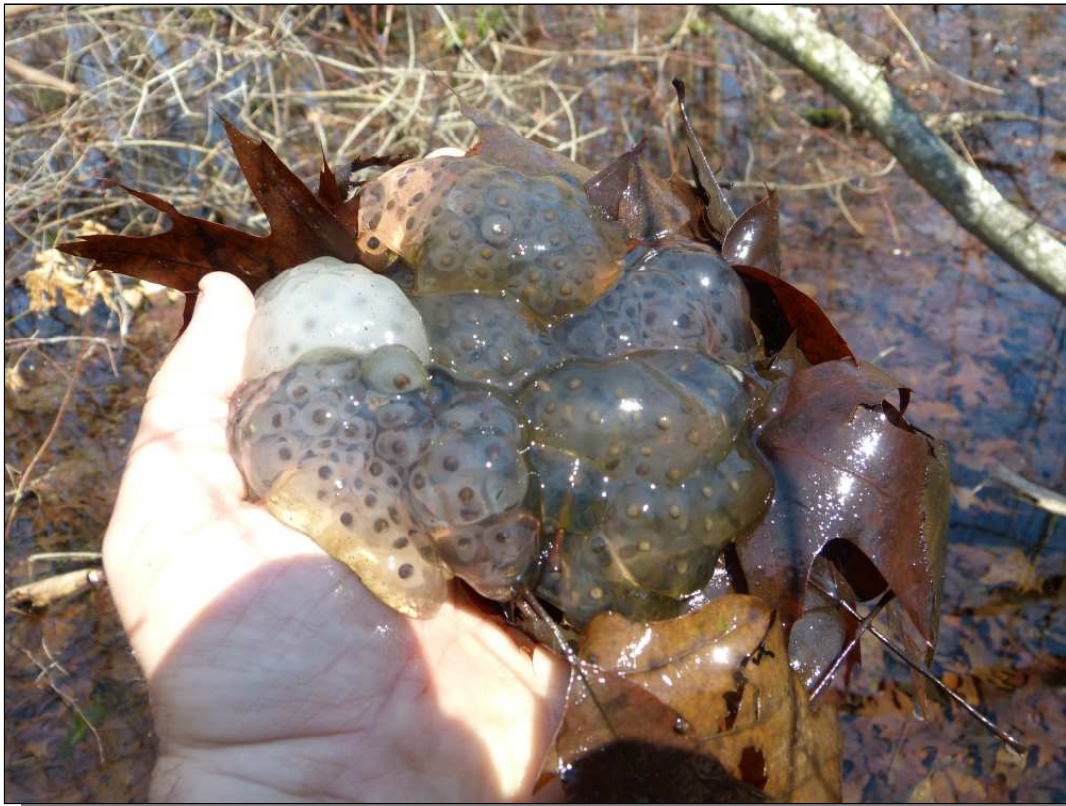
*Photo 17: Vernal Pool #3; Spotted Salamander egg masses; the only found in the 3-pool cluster, indicating marginal hydrology for this species.*

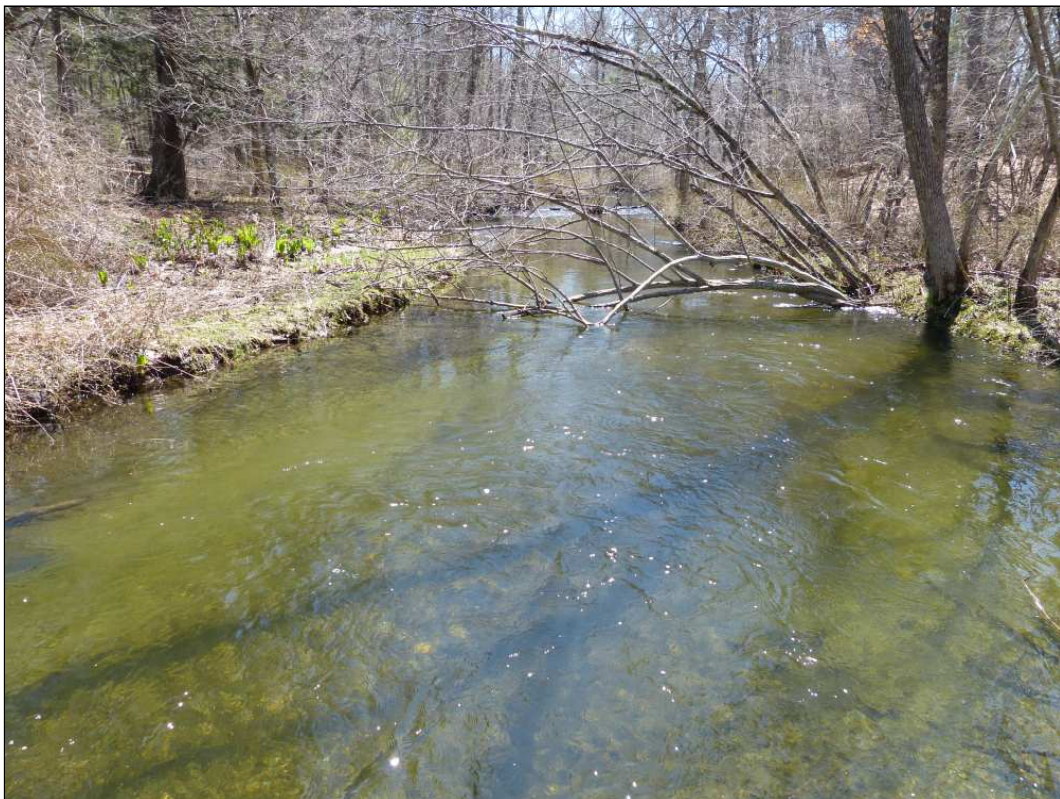
*Photo 18: Spruce Swamp Creek to the east of site; site's wetlands drain here; coloration of water due to limestone/marble/schist bedrock geology of area.*
