December 11, 2023

**RE:**     **WETLANDS ASSESSMENT: Summary of Findings**  
          **Dresser Woods**, Railroad Street, Salisbury, CT

*REMA Job # 14-1729-SLS2*

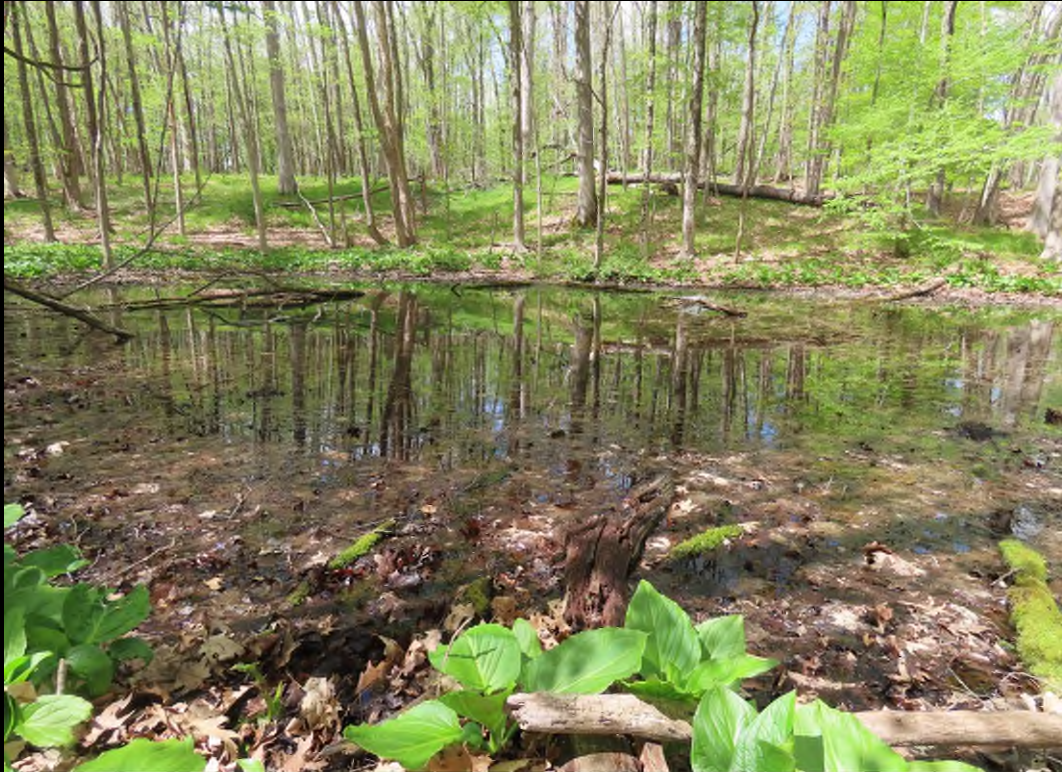
| <b>DATE:</b> May 13, 2022 | <b>FACING:</b> SOUTHERLY | <b>PHOTO NO.:</b> 1 | |

| | | <b>Wetland WB1 (VP2).</b> Vernal pool with robust breeding by woodfrog. Tadpole density was high. Depth up to 2.5 feet. Immature hardwood forest with moderately well drained soils to the south. | |

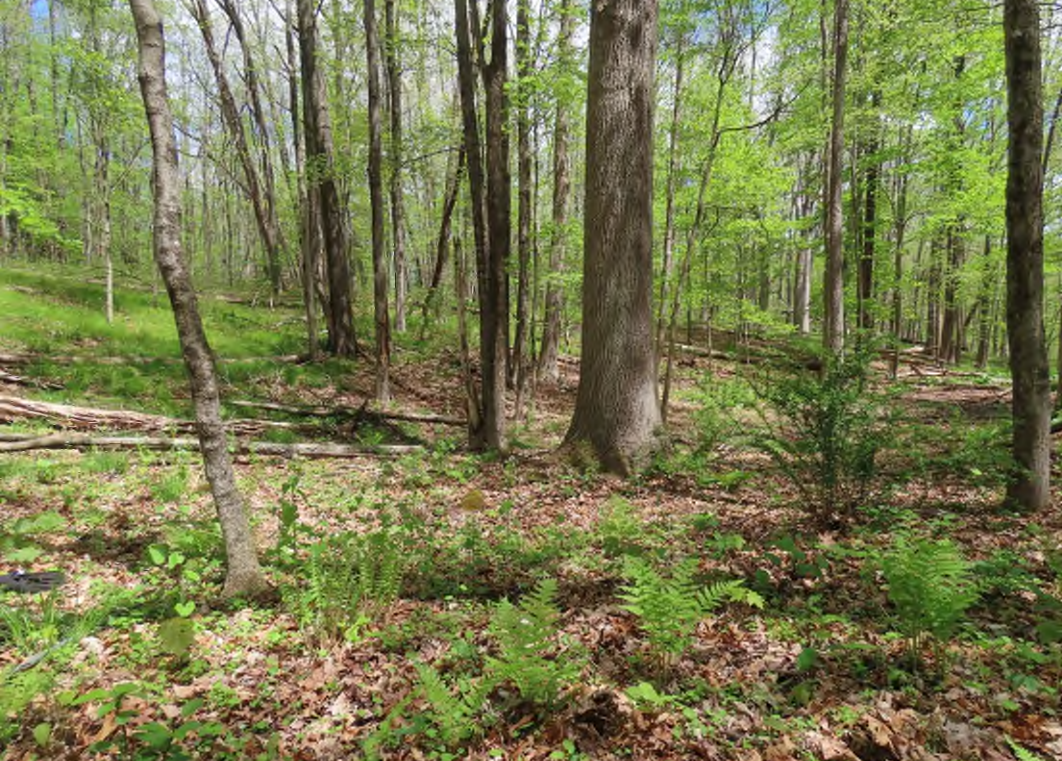
| <b>DATE:</b> May 13, 2022 | <b>FACING:</b> NORTHERLY | <b>PHOTO NO.:</b> 2 | |

| | | Hardwood forest near rail trail to the south of the wetland corridor. Forest is dominated by sugar maple, with some tulip tree and Athyrium ferns in the foreground. Penn sedge patch is at upper left. Note occasional Japanese barberry, which will spread if not controlled. | |

<sup>2</sup> REMA would also recommend the eradication of the scattered Japanese barberry on the property.

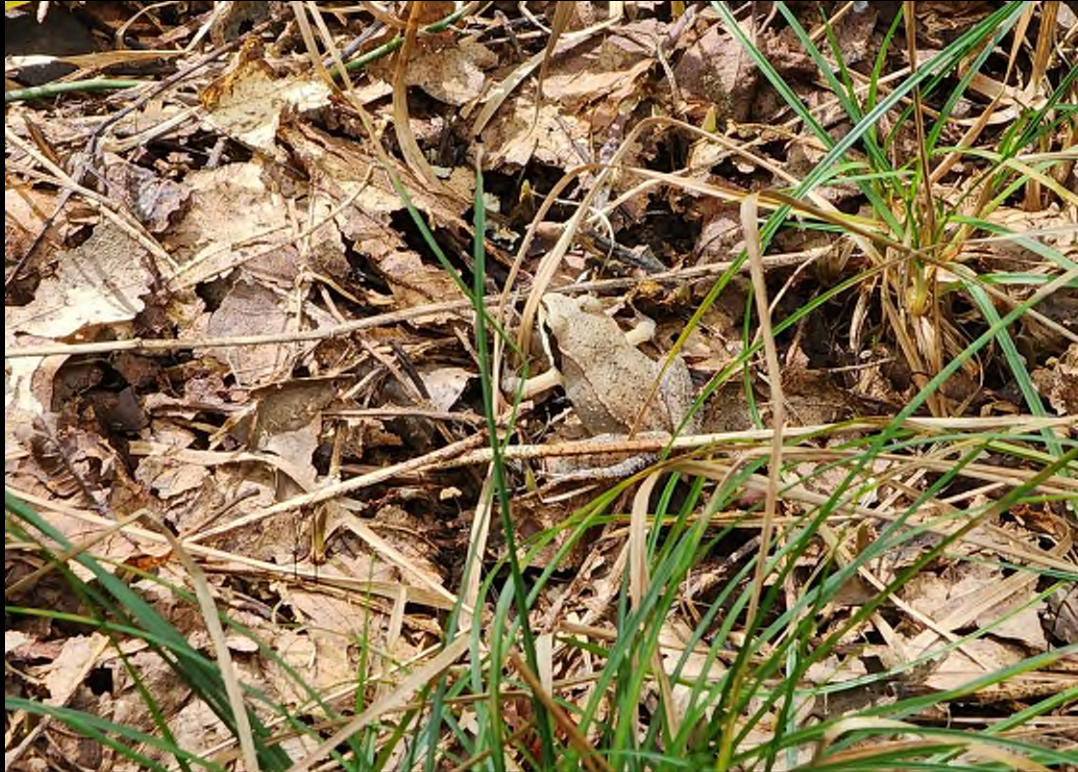
| <b>DATE:</b> September 28, 2022 | <b>FACING:</b> n/a | <b>PHOTO NO.:</b> 3 | |

| | | Wood frog, well-camouflaged in the leaf litter. Over a dozen small, recently metamorphosed wood frogs were observed in hardwood forest to the south of Vernal Pool 2, within about 100 feet, testimony to successful breeding. | |

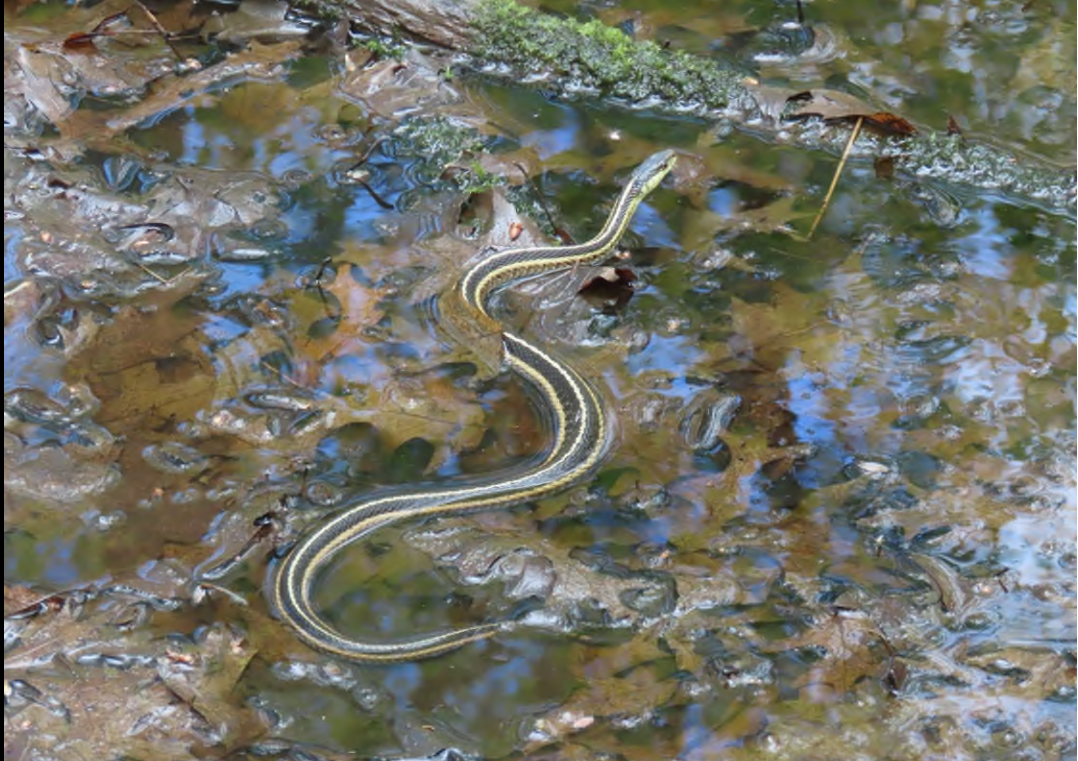
| <b>DATE:</b> May 13, 2022 | <b>FACING:</b> n/a | <b>PHOTO NO.:</b> 4 | |

| | | <i>Wetland A. Garter snake was feeding on fairy shrimp, concentrated by the drawdown in Vernal Pool 1 . On May 13, only two to three inches of water remained in this small pool, fed by surface water.</i> | |

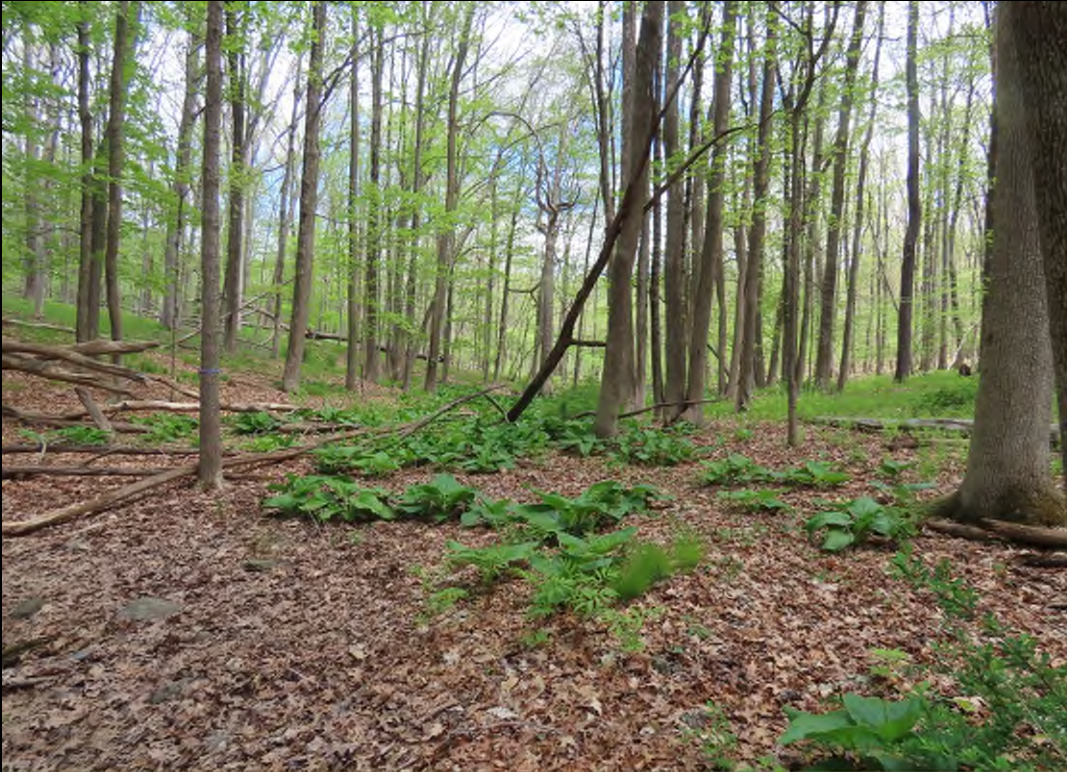
| <b>DATE:</b> May 13, 2022 | <b>FACING:</b> NORTHERLY | <b>PHOTO NO.:</b> 5 | |

| | | <i>Moist forest just to the southwest of Vernal Pool 1 (WA), with low density skunk cabbage and woody debris. This area will be preserved.</i> | |

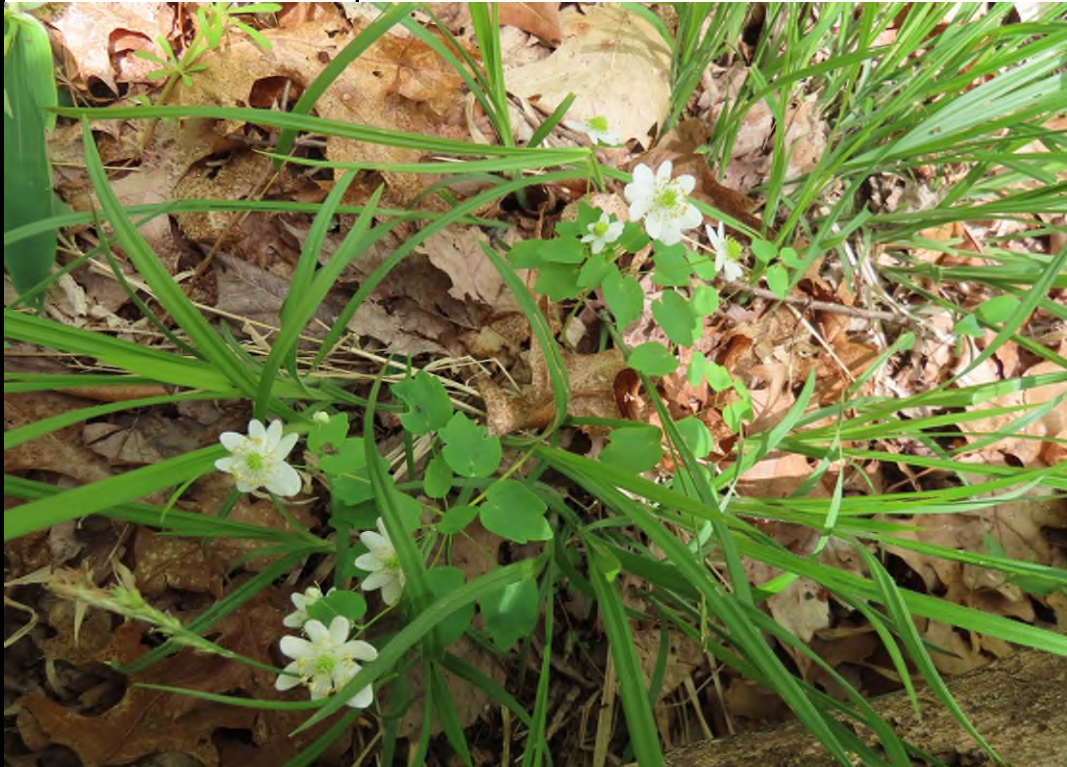
| <b>DATE:</b> May 13, 2022 | <b>FACING:</b> CLOSE-UP | <b>PHOTO NO.:</b> 6 | |

| | | <i>Thalictrum thalictoides, was one of several ephemeral spring wildflowers observed in moderately well-drained soil west of Vernal Pool 1.</i> | |

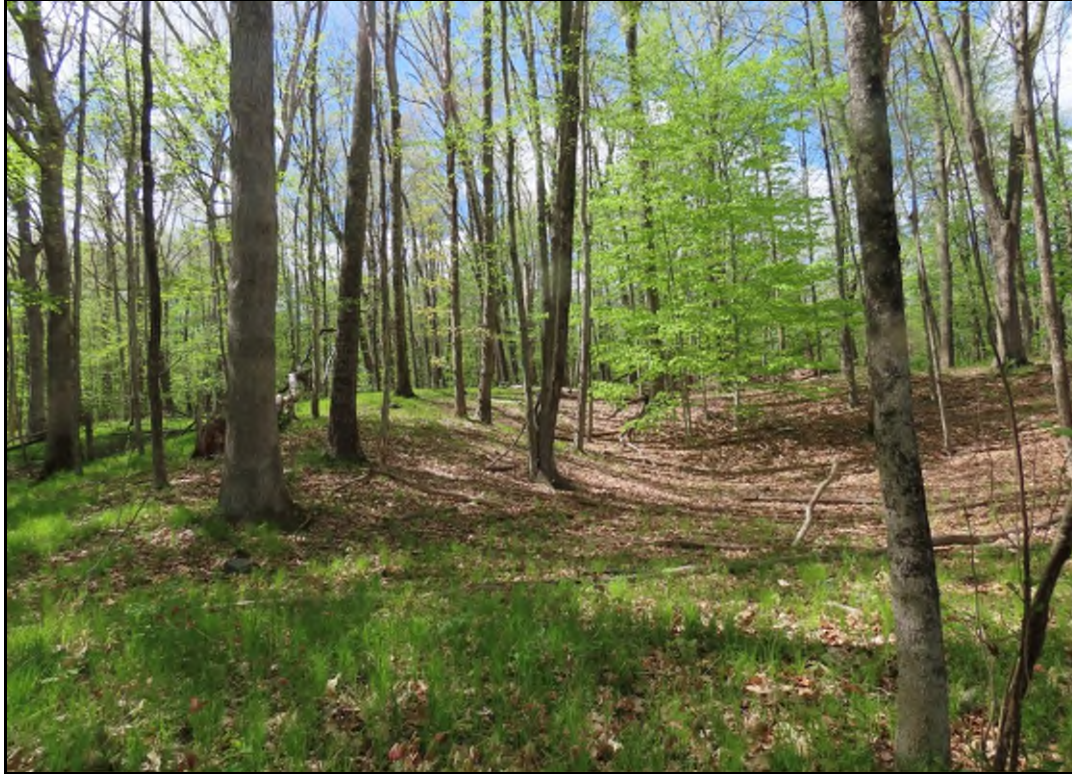
| <b>DATE:</b> September 28, 2023 | <b>FACING:</b> SOUTHWESTERLY | <b>PHOTO NO.:</b> 7 | |

| | | <p>View towards rail trail embankment. This forest is in the northern portion of the development, to the south of Vernal Pool 1 (WA). Note the undulating topography and the Penn sedge lawn in foreground and at left. Penn sedge can be left in place at the perimeter of the development, or transplanted, using a technique similar to sod installation.</p> | |

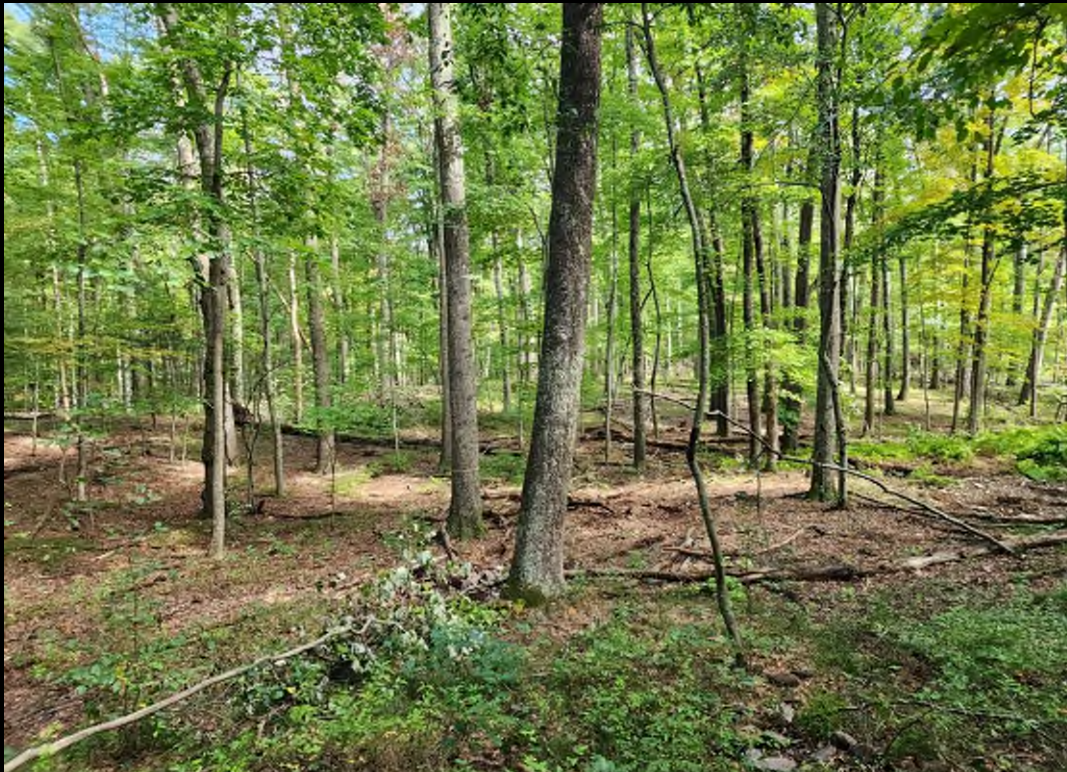
| <b>DATE:</b> September 28, 2023 | <b>FACING:</b> SOUTHERLY | <b>PHOTO NO.:</b> 9 | |

| | | <i>View of middle of proposed development footprint. Scarlet oaks are dominant, and downy shadbush is common. Both do well in a residential setting. Note patch of lowbush blueberry in lower right corner. Blueberry "sod" can also be transplanted, provided suitable soil is also moved.</i> | |

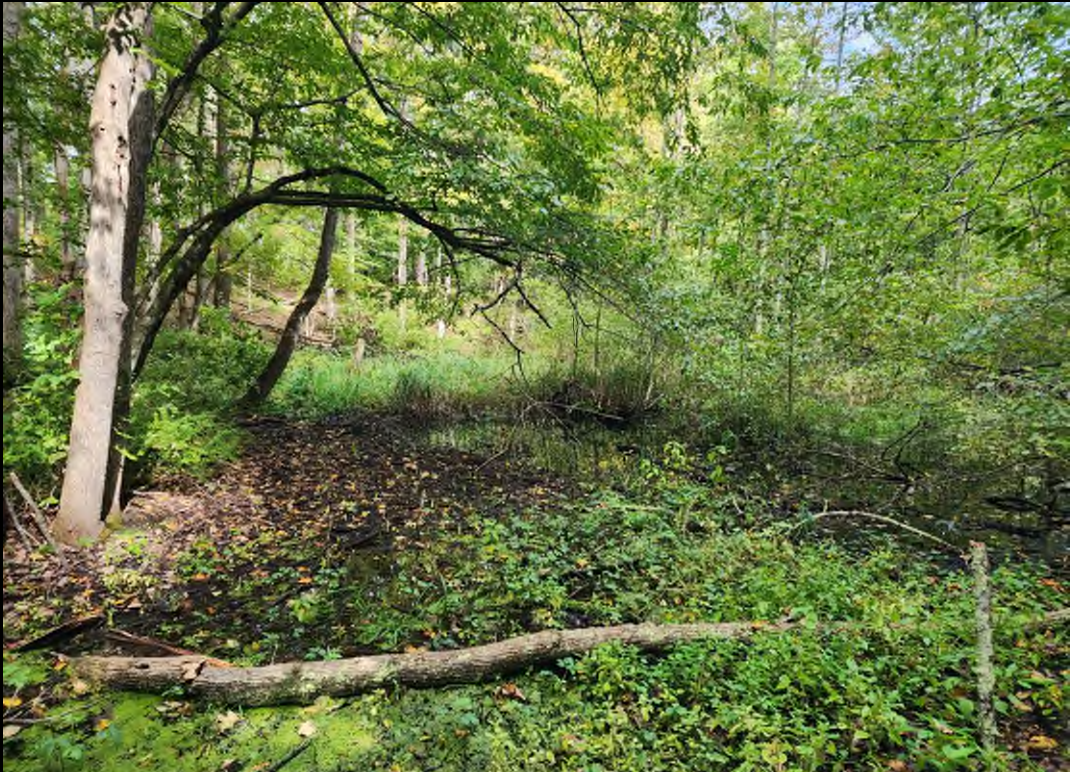
| <b>DATE:</b> September 28, 2023 | <b>FACING:</b> NORTHERLY | <b>PHOTO NO.:</b> 11 | |

| | | Vernal Pool 3 (Wetland B2), embedded in an ironwood and alder stand, is still held water in late September. Five spotted salamder egg masses were found here in 2014. Larval mayflies and fingernail clams were netted here in 2023. | |

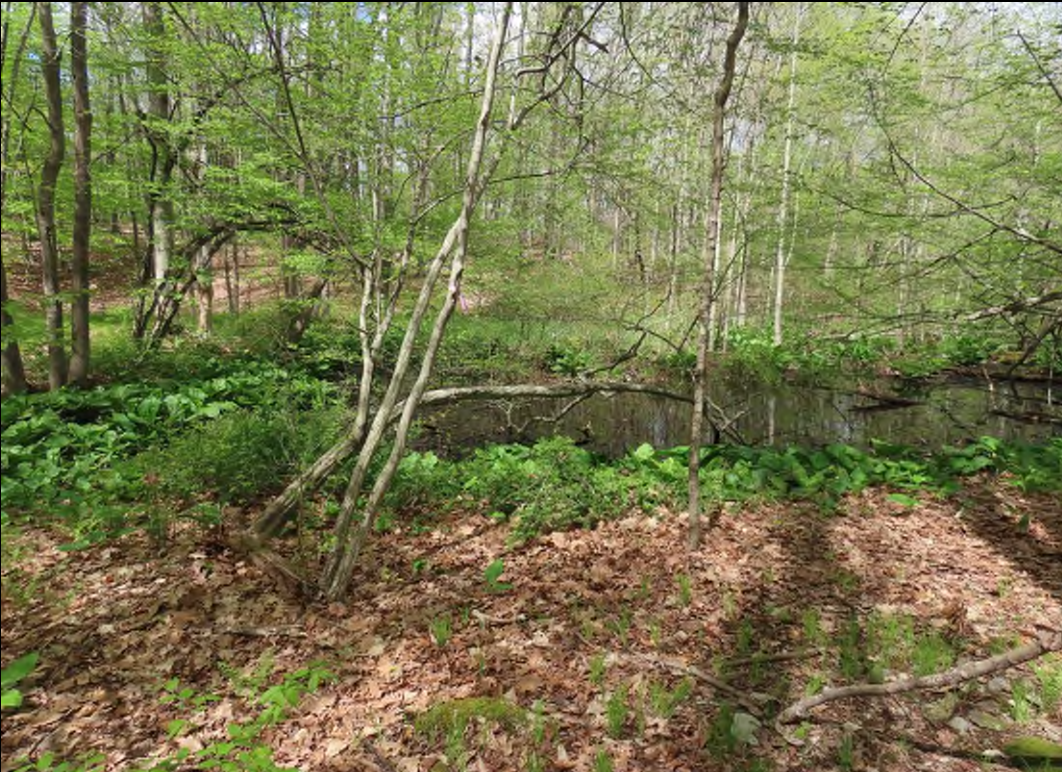
| <b>DATE:</b> May 13, 2022 | <b>FACING:</b> NORTHEASTERLY | <b>PHOTO NO.:</b> 13 | |

| | | <i>On-site portion of Wetland B2, with Vernal Pool 3, viewed from adjacent moderated well-drained forest at the edge of the project. Note the leaning ironwoods.</i> | |

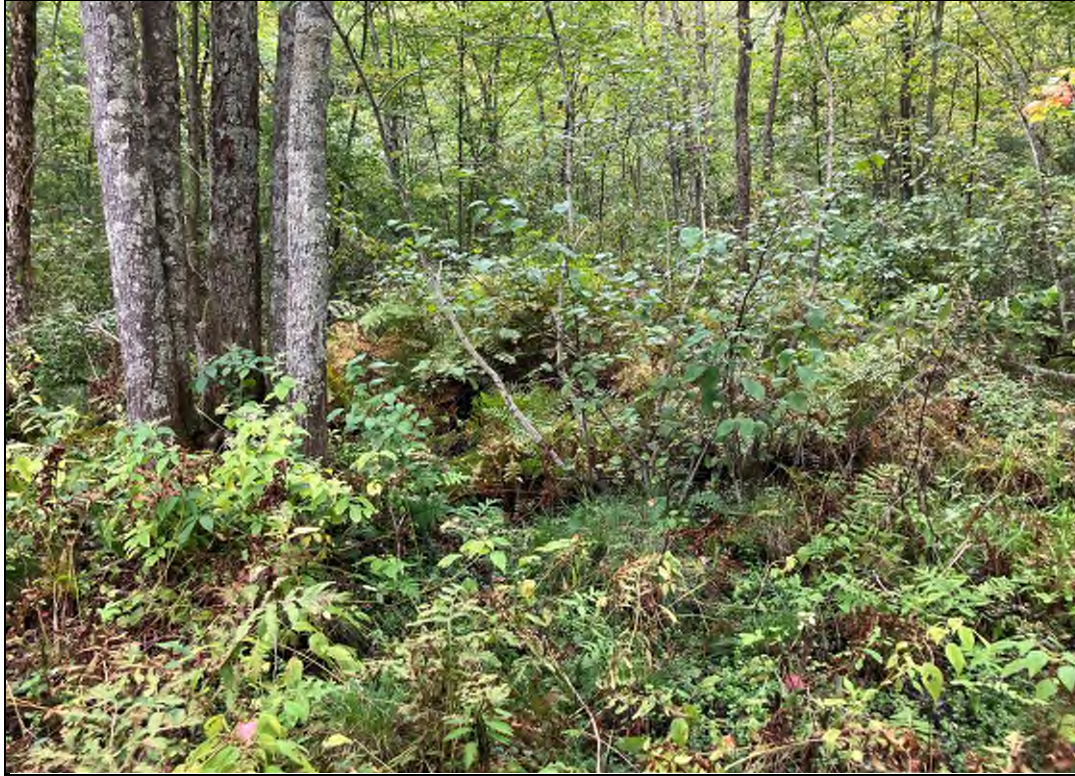
| <b>DATE:</b> September 28, 2023 | <b>FACING:</b> EASTERLY | <b>PHOTO NO.:</b> 15 | |

| | | <i>Living black ash cluster at edge of shrub swamp cover type in WB2, just offsite to the east. Sensitive fern is dominant in foreground.</i> | |

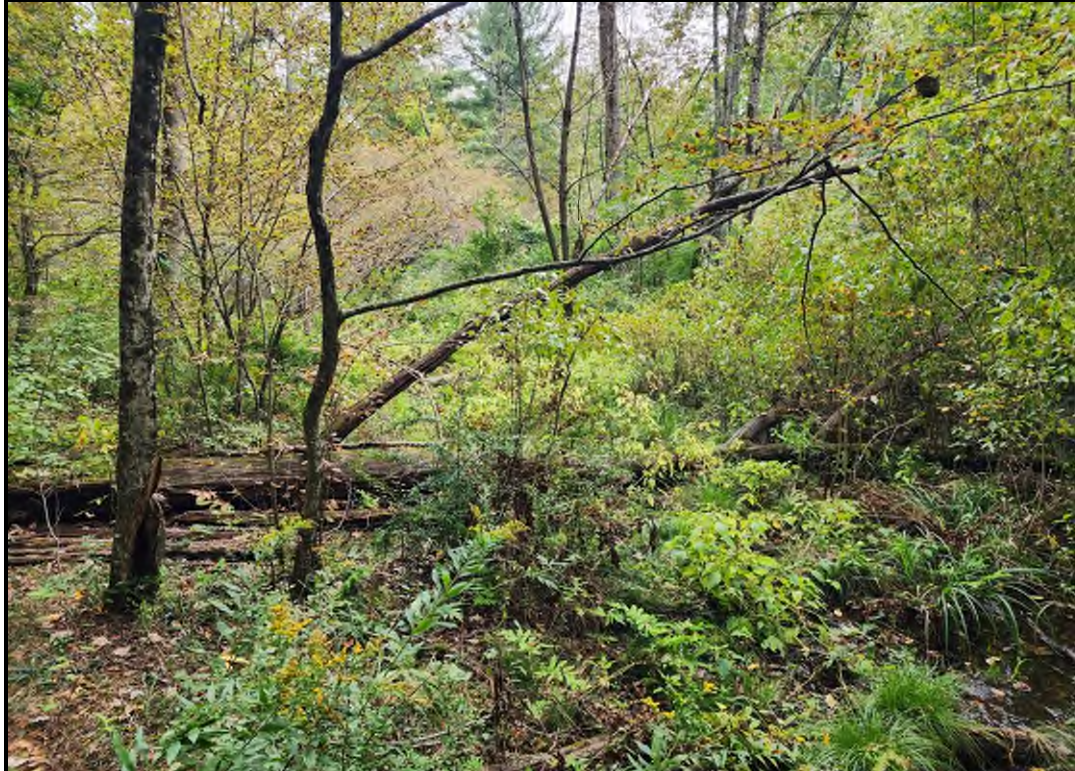
| <b>DATE:</b> September 28, 2023 | <b>FACING:</b> EASTERLY | <b>PHOTO NO.:</b> 16 | |

| | | Offsite, eastern portion of Wetland B2, closest to Spruce Swamp Creek. Vegetation on this seepage slope is dense and diverse, dominated by forbs and shrubs. | |

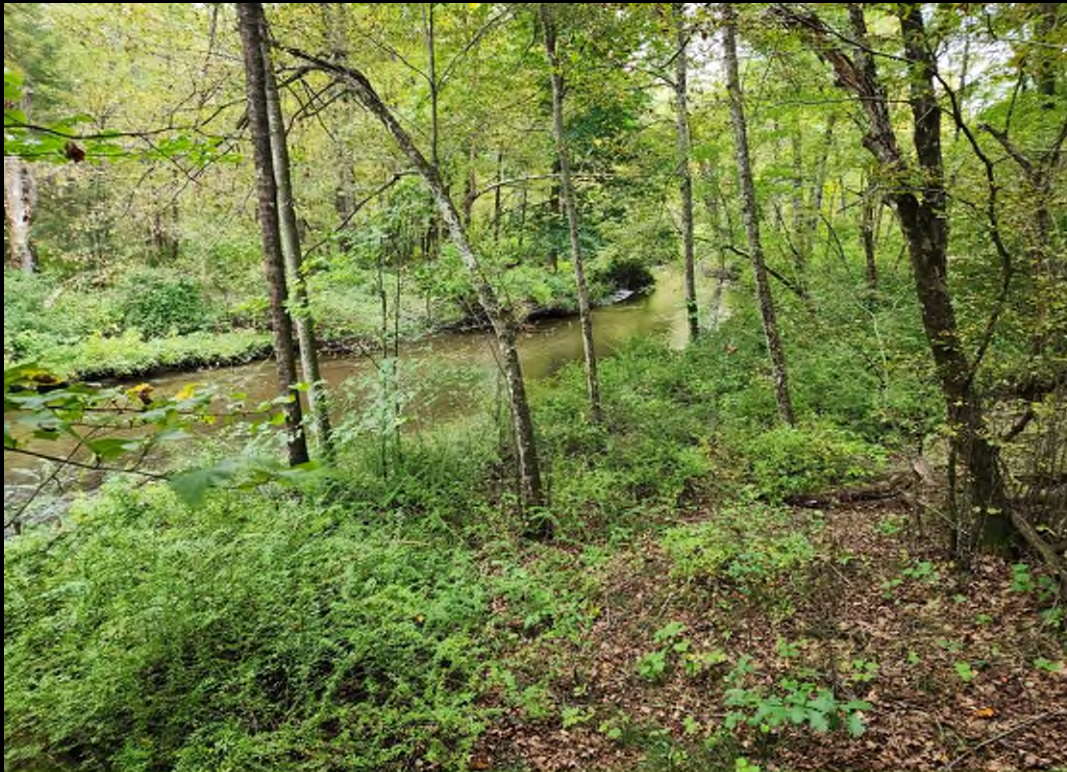
| <b>DATE:</b> September 28, 2023 | <b>FACING:</b> SOUTHERLY | <b>PHOTO NO.:</b> 17 | |

| | | <i>Riparian corridor along Spruce Swamp Creek, facing downstream. Note dense Japanese barberry on bank-top, stable, vegetated banks, somewhat turbid water, and lack of riffles.</i> | |

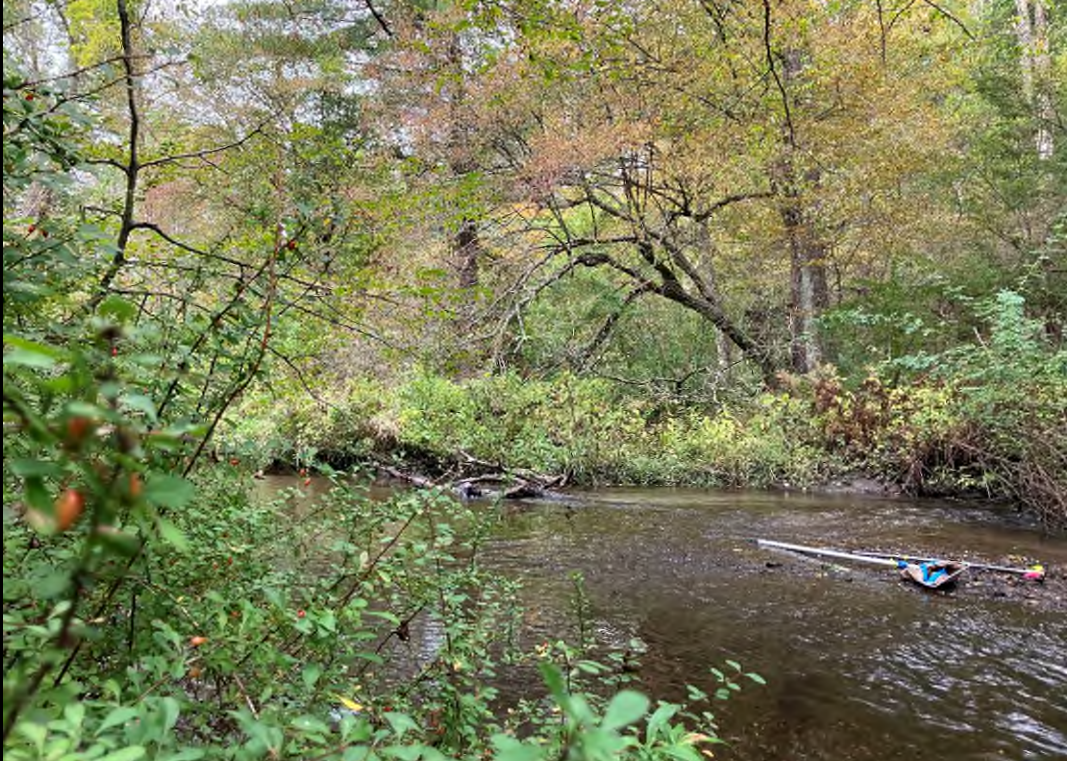
| <b>DATE:</b> September 28, 2023 | <b>FACING:</b> NORTHEASTERLY | <b>PHOTO NO.:</b> 18 | |

| | | <i>View accross Spruce Swamp Creek, adjacent to the hillside wetland (WB2). Note the exposed gravel bar within the channel. The substrate is largely sand with gravel. Habitat is not productive. Exploratory netting yielded few aquaitic insects, but they did include several pollution intolerant taxa, consistent with the creek's largely undeveloped watershed.</i> | |

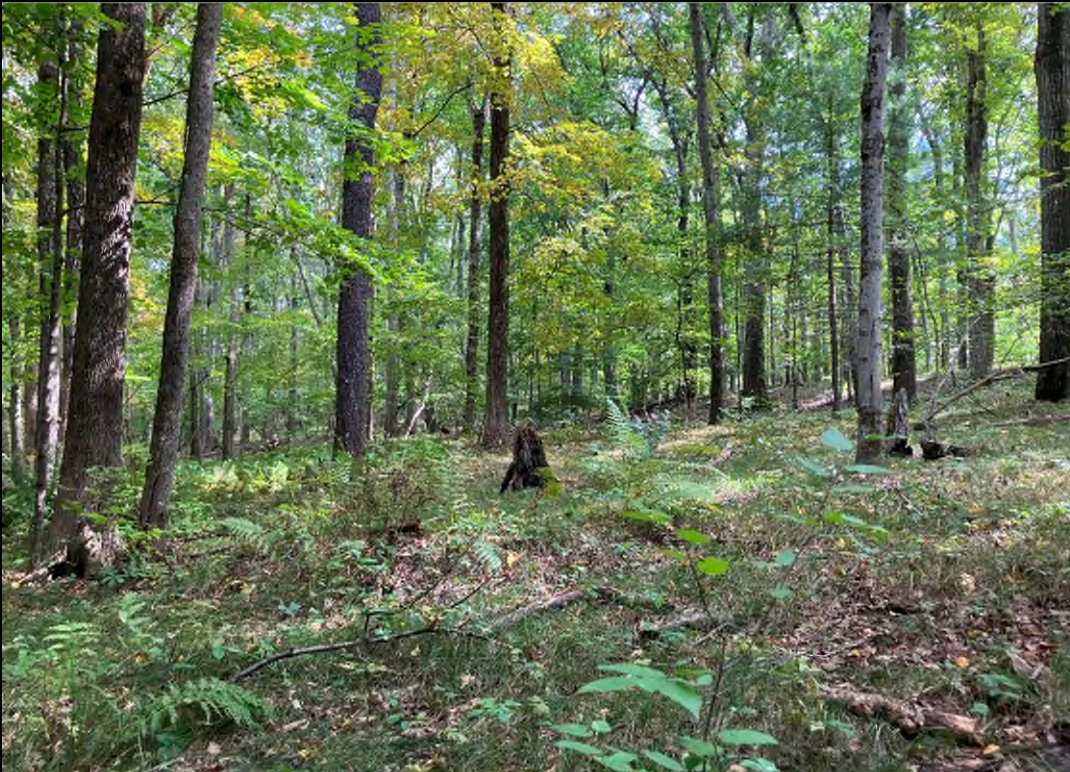
| <b>DATE:</b> September 28, 2023 | <b>FACING:</b> SOUTHERLY | <b>PHOTO NO.:</b> 19 | |

| | | <i>Protected riparian corridor along Spruce Swamp Creek, offsite, east of the proposed project. This is highly suitable terrestrial habitat for vernal pool amphibians.</i> | |
