Salisbury Road Safety Audit

US 44 (Canaan Road): Salisbury School Crossing (Site 1)

US 44 (Canaan Road): Cobble Road and Appalachian Trail (Site 2)

CT 41 (Sharon Road): Sidewalk Terminus to The Hotchkiss School at North Road (Site 3)

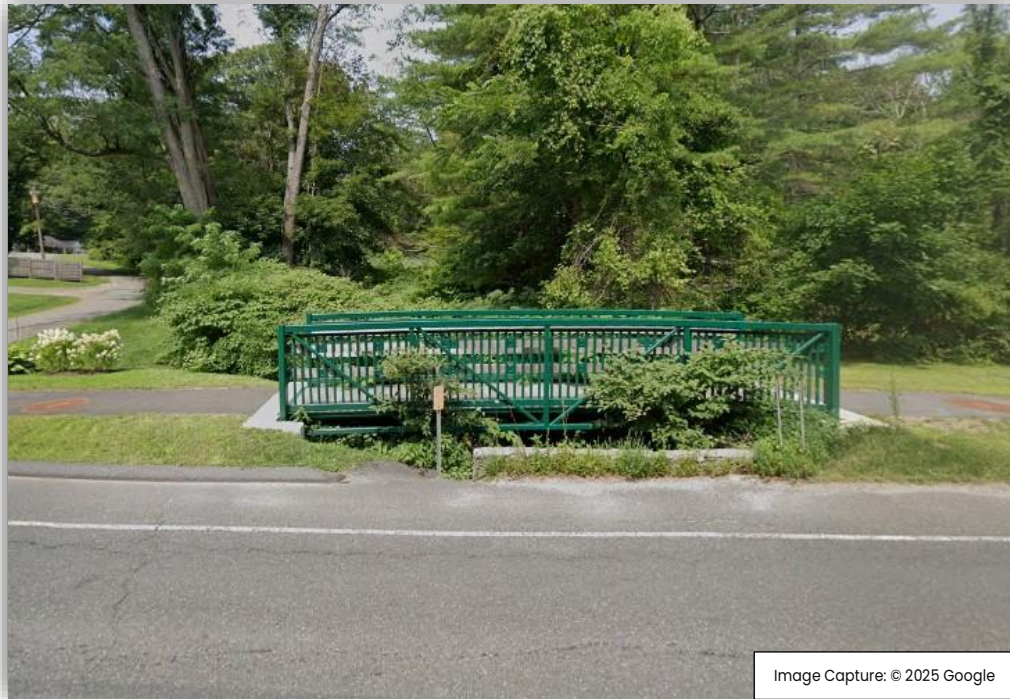
The Town of Salisbury was granted funds from CTDOT’s [Community Connectivity Grant Program](#) in 2018 to construct a sidewalk, pedestrian signal and crosswalk, and a pedestrian bridge across the Pettee Brook, on US 44/CT 41 (at approximately 200 Main Street). This bridge allows for better pedestrian connectivity between Salisbury Village and Lakeville Village centers, located approximately 1.5 miles Southwest of the Cobble Road intersection (Site 2) and 1 mile Northeast of the sidewalk terminus on CT 41 (across 90 Sharon Road) (Site 3). These measures are intended to increase connectivity across US 44 and CT 41, as well as increase safety for planned emergency evacuation measures.

Image 1: CCGP funded pedestrian bridge on the north side of US 44/CT 41

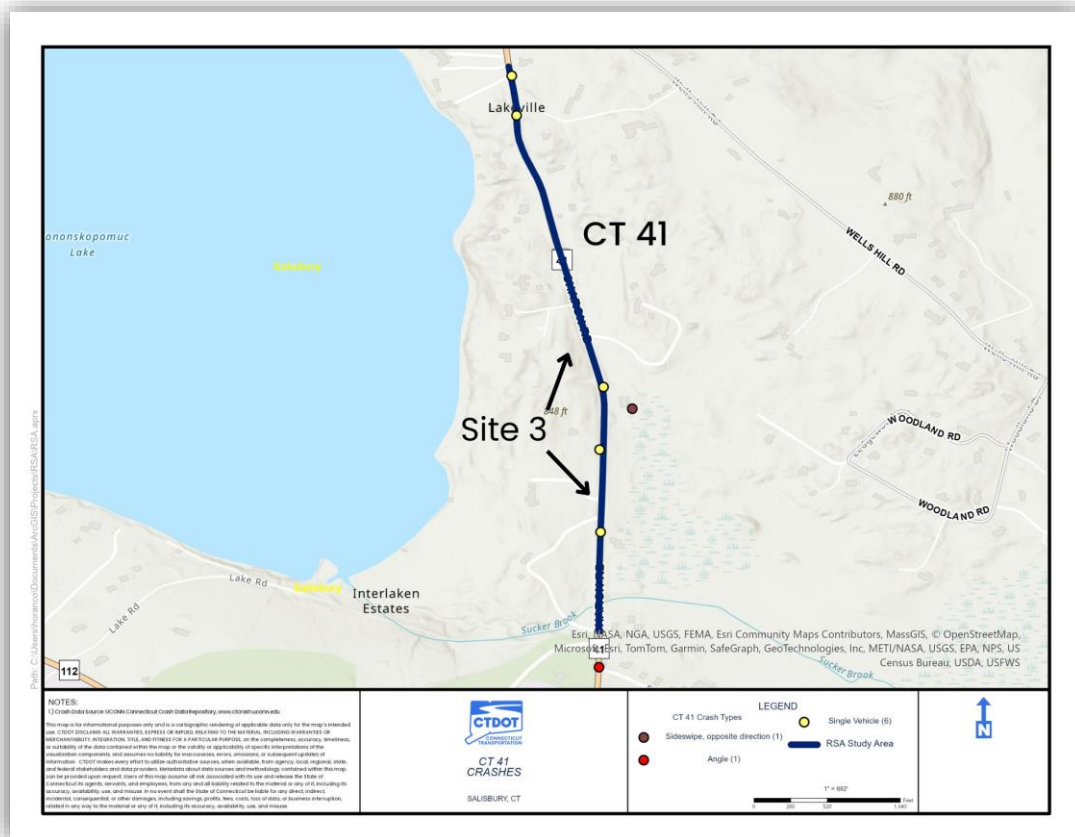
Crashes by Severity/Type: Most common crashes on CT 41 were single vehicle crashes. There was one serious injury which was the result of an angled crash (see figures 10 and 11 for reference). There were no reported crashes involving pedestrians or cyclists in the study area.

Figure 11: Crash Type Map CT 41 (Site 3)

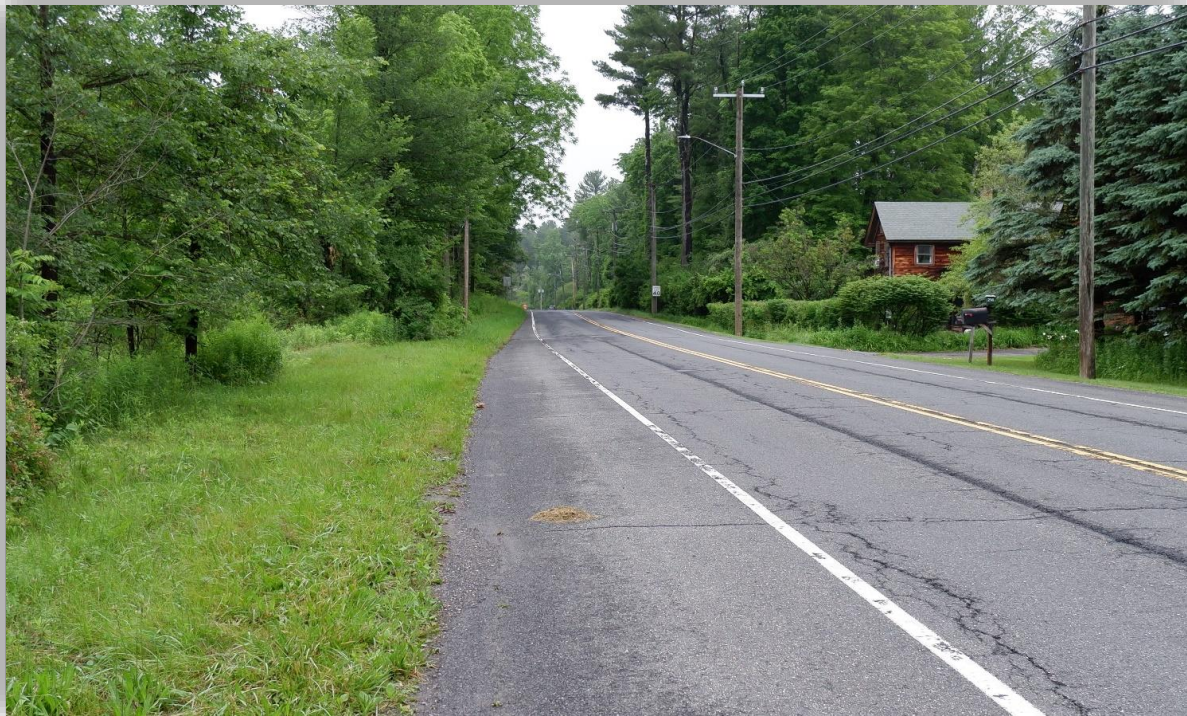
- The Hotchkiss School leaders noted that speeding vehicles and lack of shoulder and sidewalks are issues with CT 41, making the route into Lakeville center dangerous for students who travel by non-vehicular modes (Image 2).
- The Hotchkiss School leaders noted that many students walk into Lakeville Center throughout the day.
- Town officials noted that a third of the property owners along CT 41 have been contacted by the town and support a sidewalk project along their property. Town officials also noted that the town would maintain the sidewalks once constructed.
- According to school officials, The Hotchkiss School currently has 600 students enrolled with an additional 300-400 people living, working, and/or attending the school campus, totaling about 900-1000 people during operating hours in the school year (See Figure 14).

Image 2: CT 41 facing north towards Lakeville center, displaying narrowing shoulder width and lack of sidewalk.

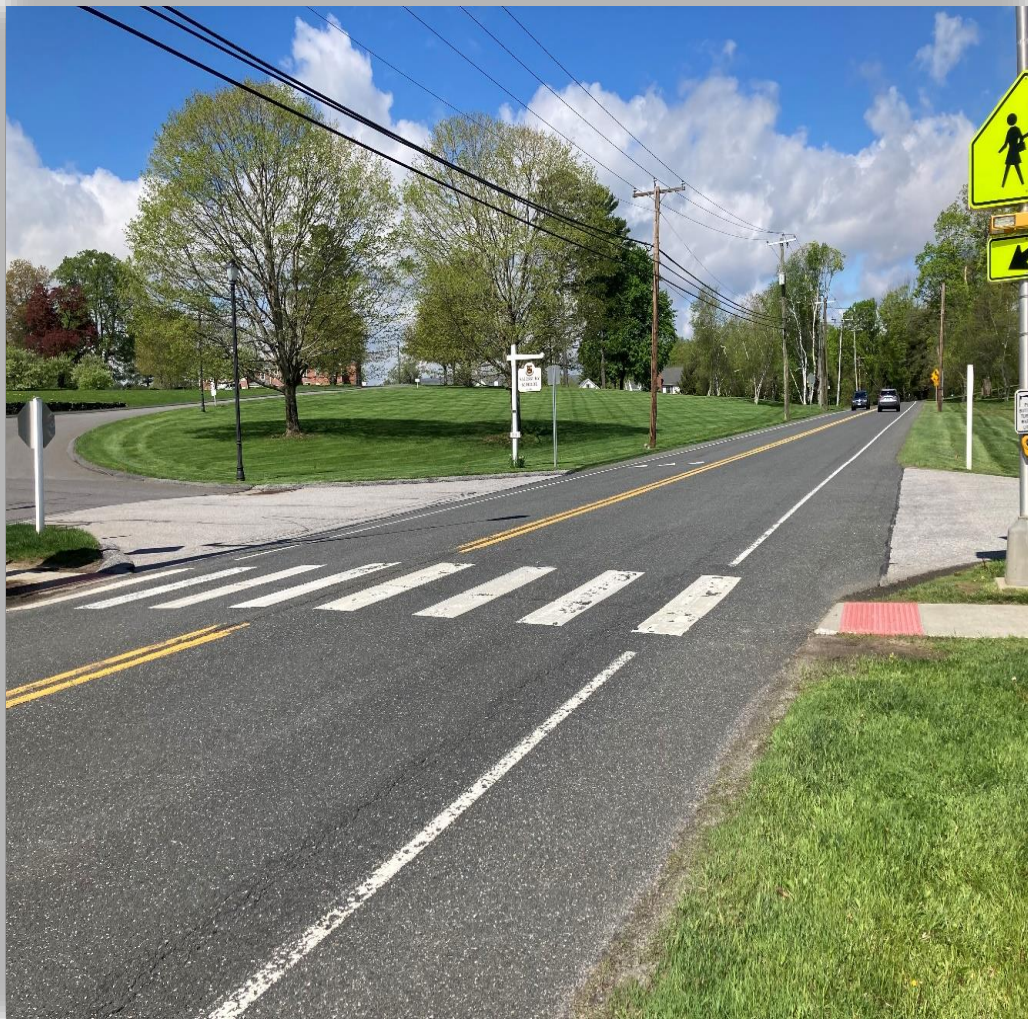
- School crosswalk and some pavement markings are faded.
- Pedestrian and bicycle features require better safety improvements for students to comfortably cross US 44 and travel the general area of the school.
- There is one streetlight and a lamppost used as pedestrian lighting at the school crosswalk.
- The team noted a need for tree trimming near signage.
- The team noted a cluster of signage that may cause confusion for drivers as they approach the Salisbury School.

Image 3: Entrance to Salisbury School on US 44 with existing RRFB

- 1.) Consider upgrading current RRFB with illumination improvements to both sides of the crossing.
 - **Next Step:** Newer RRFB have illuminators attached. Recommend contacting manufacturer to inquire about illumination add on to existing structure.

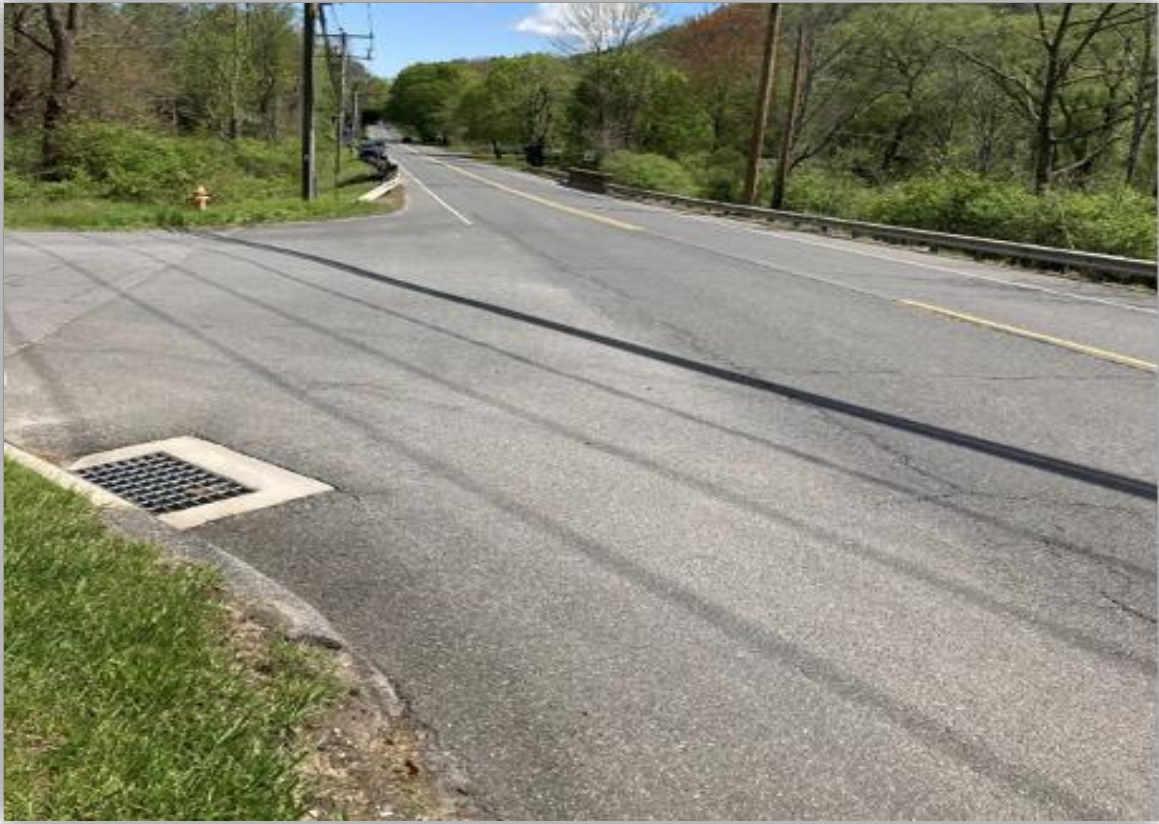
- This location experiences periodic pedestrian activity with Appalachian Trail hikers walking on the roadway to continue the pathway of the trail.
- There are “pedestrian next ¼ mile” signs on both sides of the roadway, but no specific signage identifying the route as an Appalachian Trail corridor, as well as no crosswalks or pedestrian infrastructure.

Image 4: Intersection of Cobble Road and US 44 near Appalachian Trail

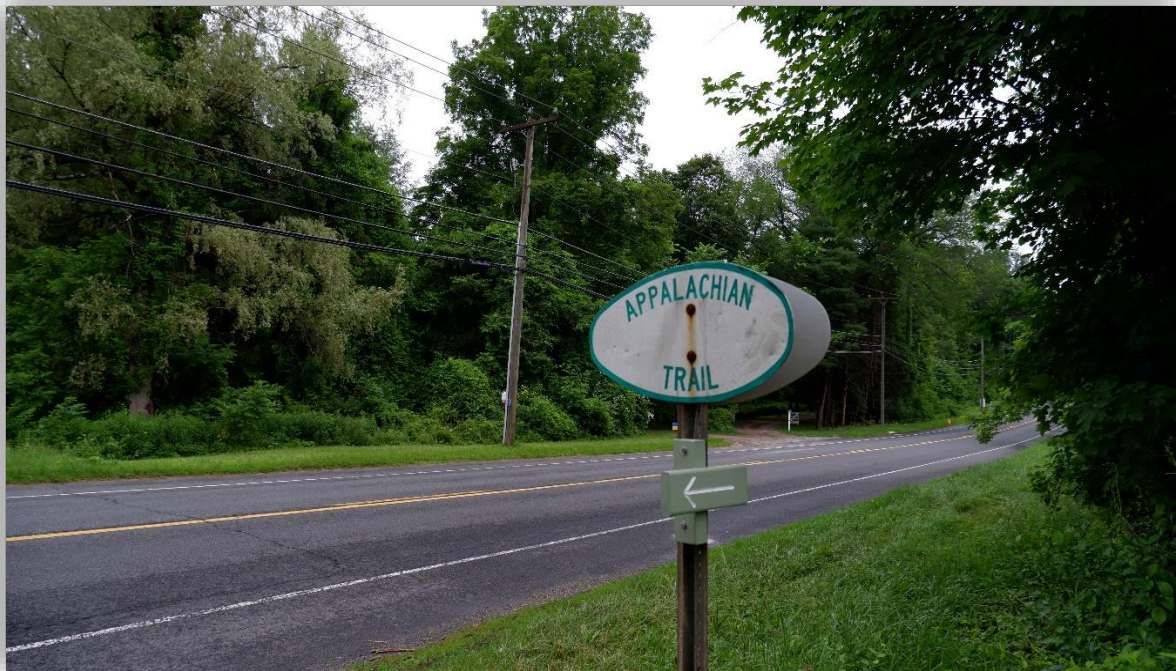
- There is a sign identifying the Appalachian trail to hikers walking down Cobble Road. The trail route directs hikers down Cobble Road and across US 44. Another sign directs hikers into town.

Image 5: Appalachian Trail Marker along US 44, just north of Cobble Road intersection

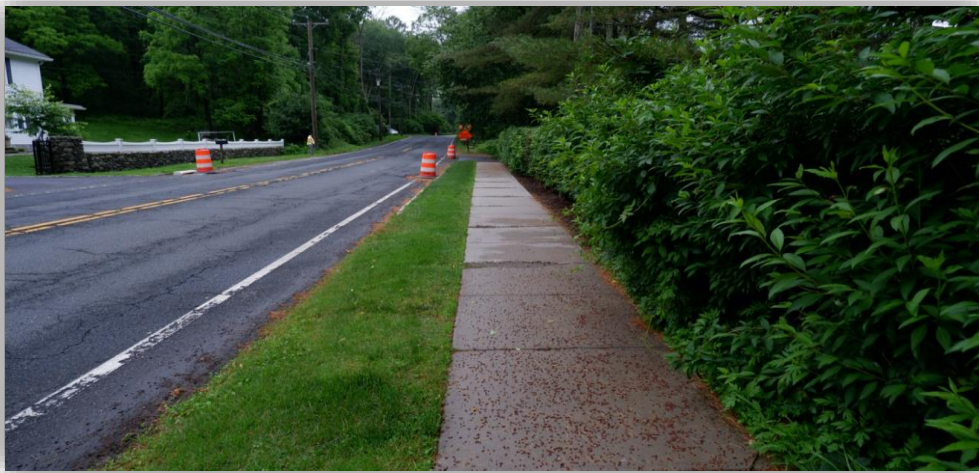
- Town and school officials expressed a desire to fill the sidewalk gap between the end of the current sidewalk to The Hotchkiss School at North Road to improve pedestrian safety.
- CT 41 has 12-foot lanes with shoulder widths varying drastically from 1 foot to 8 feet throughout the study area. In some areas, shoulder widths are less than 1 foot.
- Participants observed two sets of joggers and one pair of bicyclists on CT 41.
- Participants noted a clustering of signage that could be spaced out.
- Participants noted the steep grade along CT 41 which could present issues when exploring the feasibility of a sidewalk.
- The sidewalk on CT 41 ends abruptly prior to reaching The Hotchkiss School. A total of approximately 0.80-mile sidewalk gap currently exists from the current terminus to North Street.

Image 7: Sidewalk Terminus on CT 41 (across from 90 Sharon Road).

- 1.) Explore the feasibility of constructing a sidewalk to connect the Hotchkiss School at North Road to the sidewalk terminus (image 7) on CT 41.
 - **Next Step:** Municipality to continue to pursue sidewalk development with plan review and approval, identifying funding opportunities, and plan for property acquisitions/easements. Municipality to continue to explore possible [State](#) and [Regional](#) funding opportunities for design and construction. A list of state funding sources can be found on the CTDOT website here: [Bicycle and Pedestrian - State Managed Funding Opportunities](#)

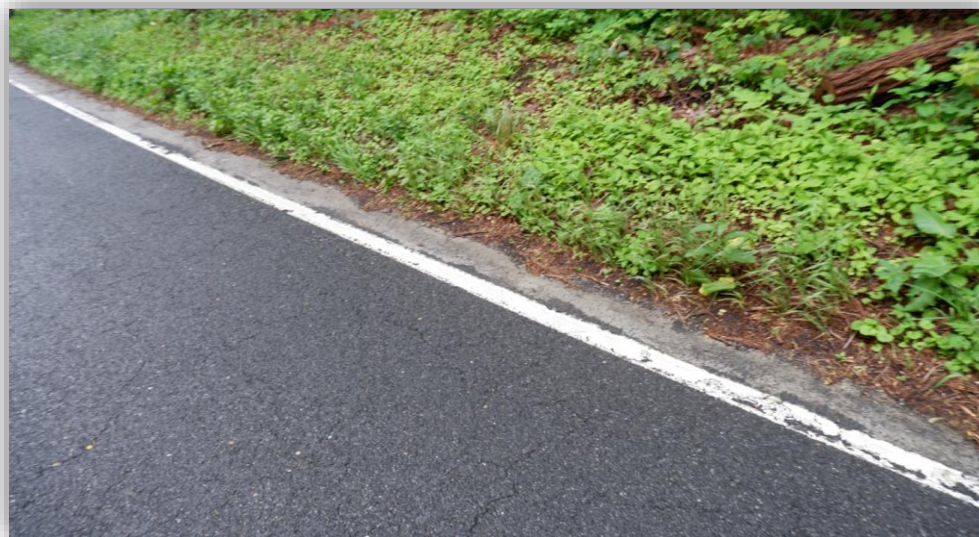
Image 8: Shoulders on CT 41 (Sharon Road) near The Hotchkiss School at North Road less than 1-foot wide
