Lakeville Train Station

Issued: February 23, 2023

CROSSKEY ARCHITECTS, LLC
750 Main Street, Suite 150
Hartford, CT 06103

Structural Condition Assessment

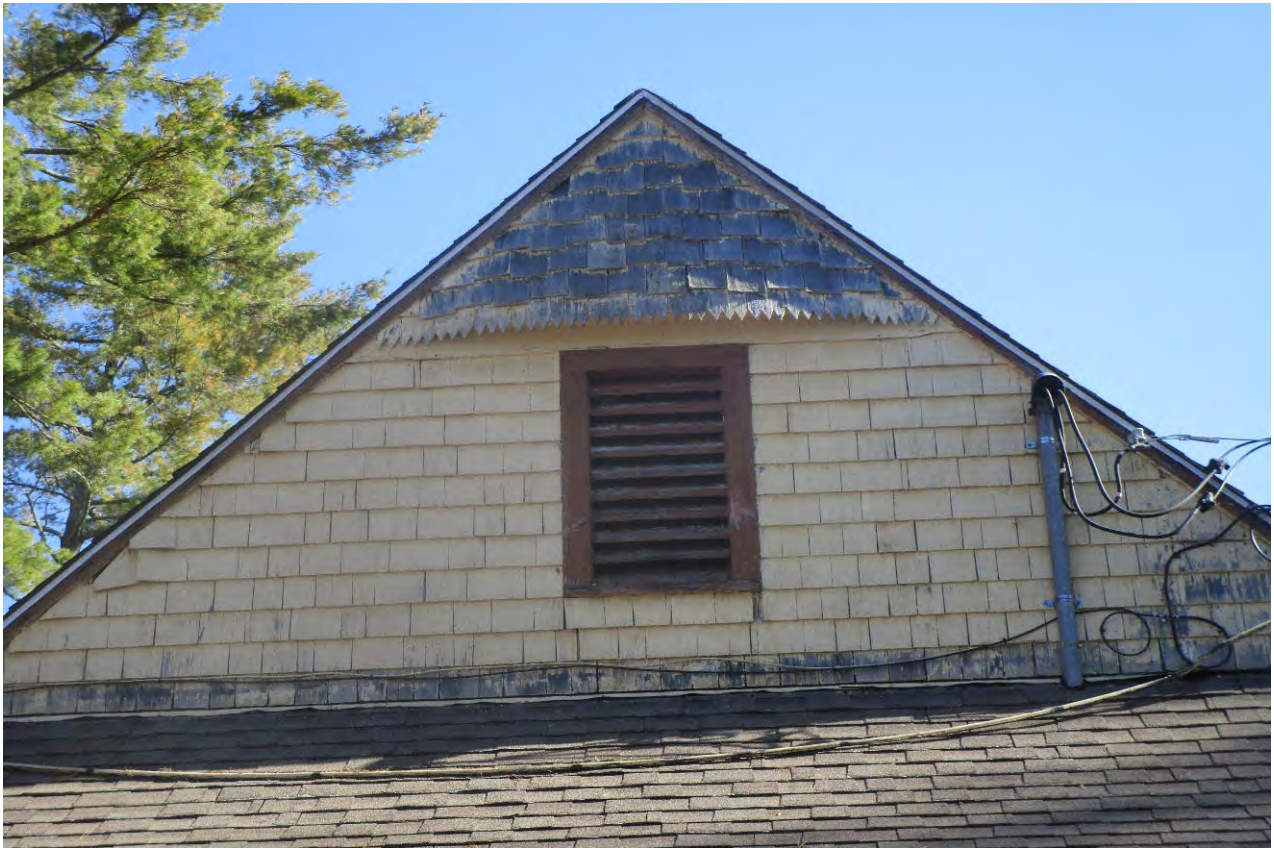
6. WEST ELEVATION ROOF GABLE AND LOUVER.

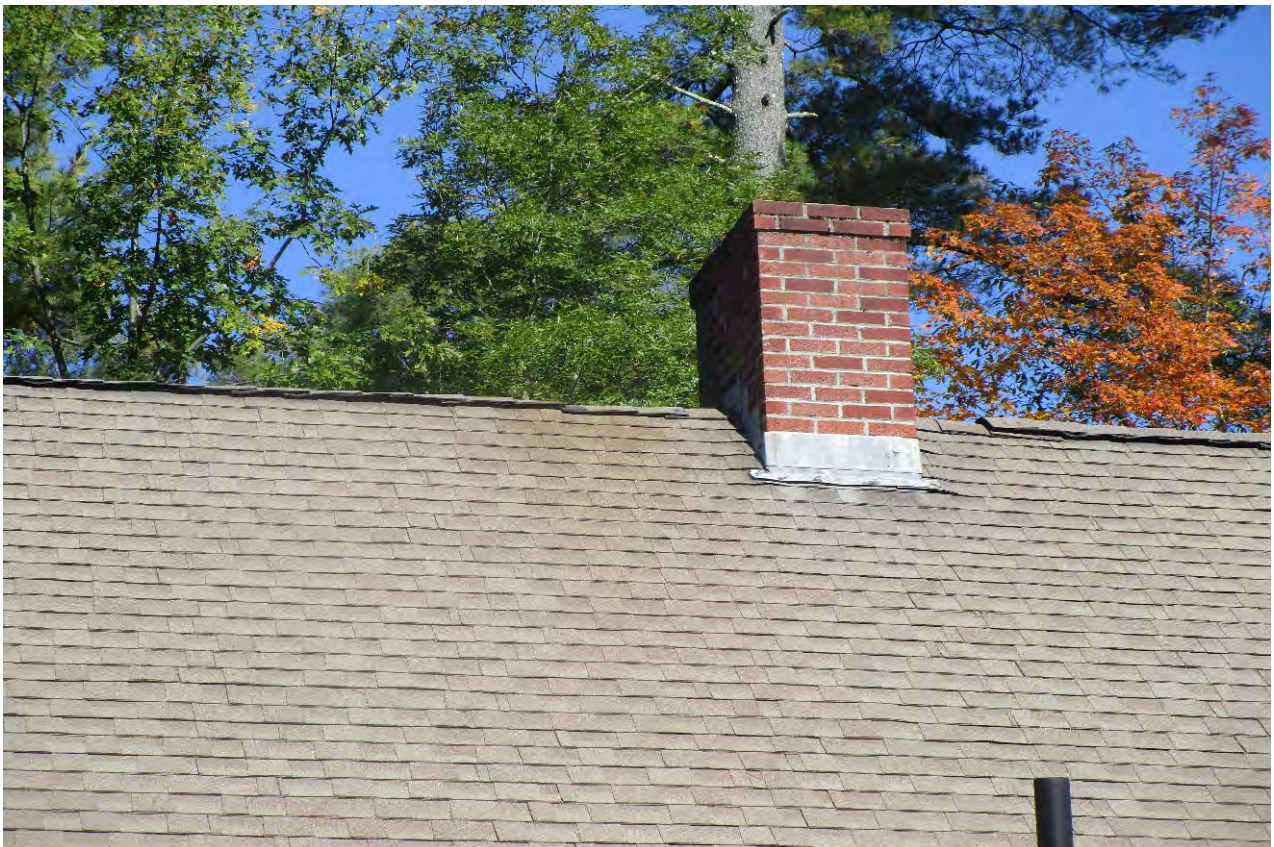
7. SOUTH ELEVATION CHIMNEY.

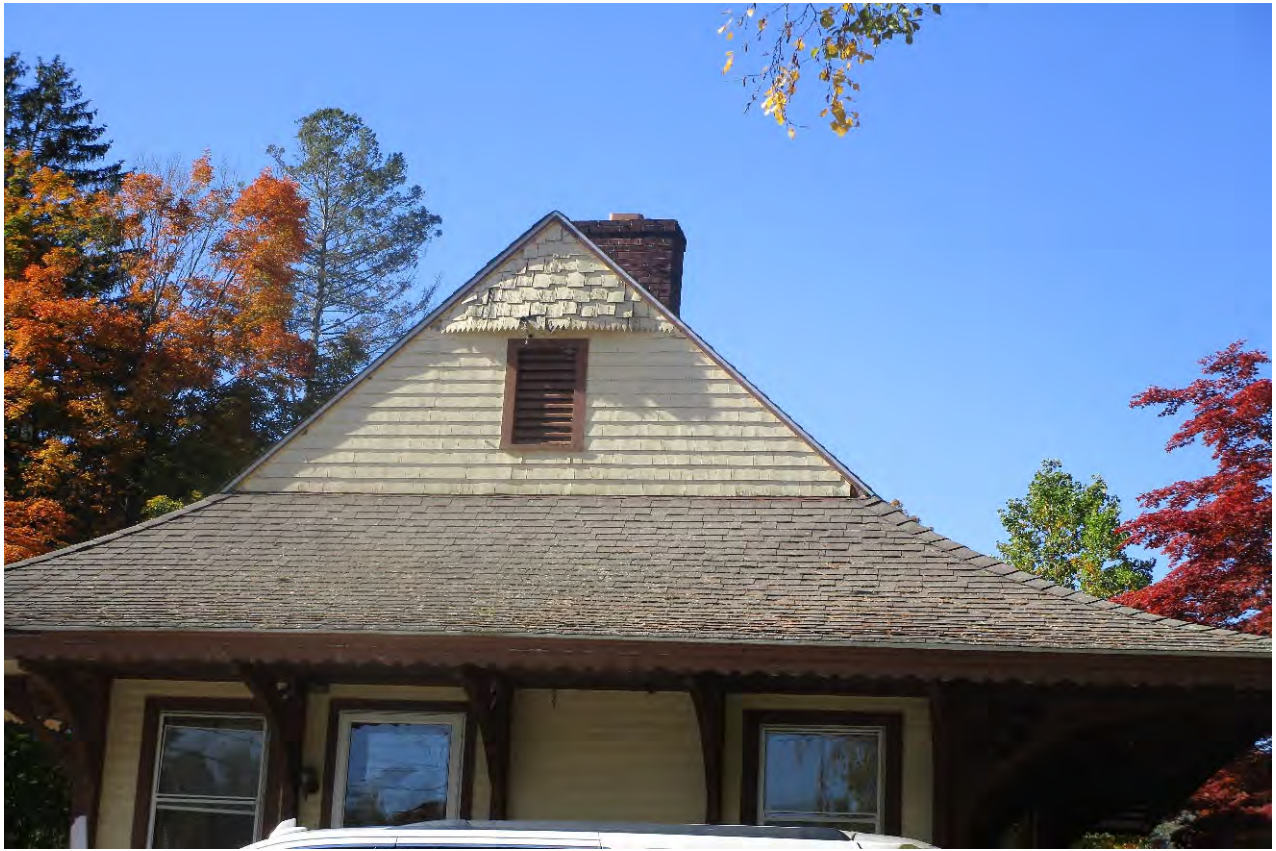
10. WEST ELEVATION ROOF GABLE AND LOUVER.

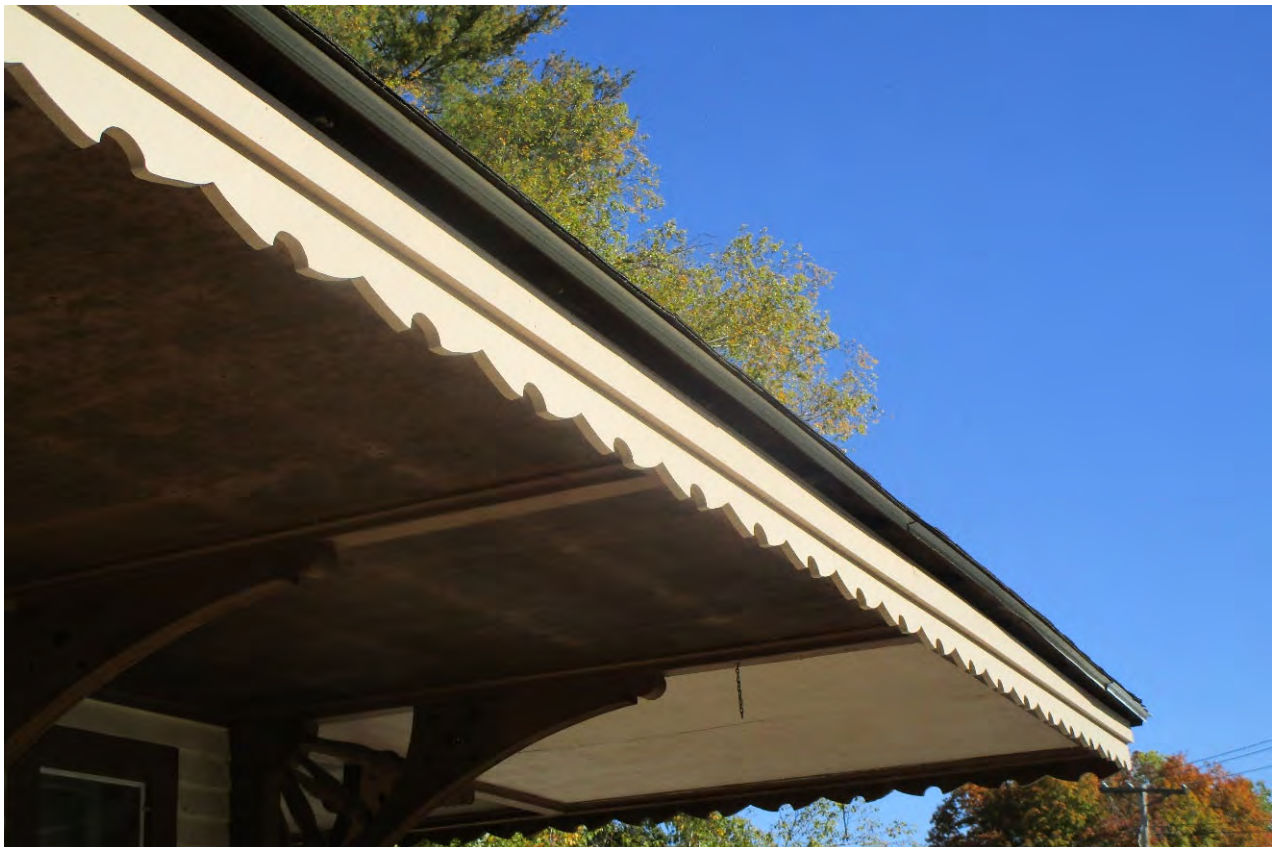
11. DECORATIVE ROOF FRIEZE BOARD.

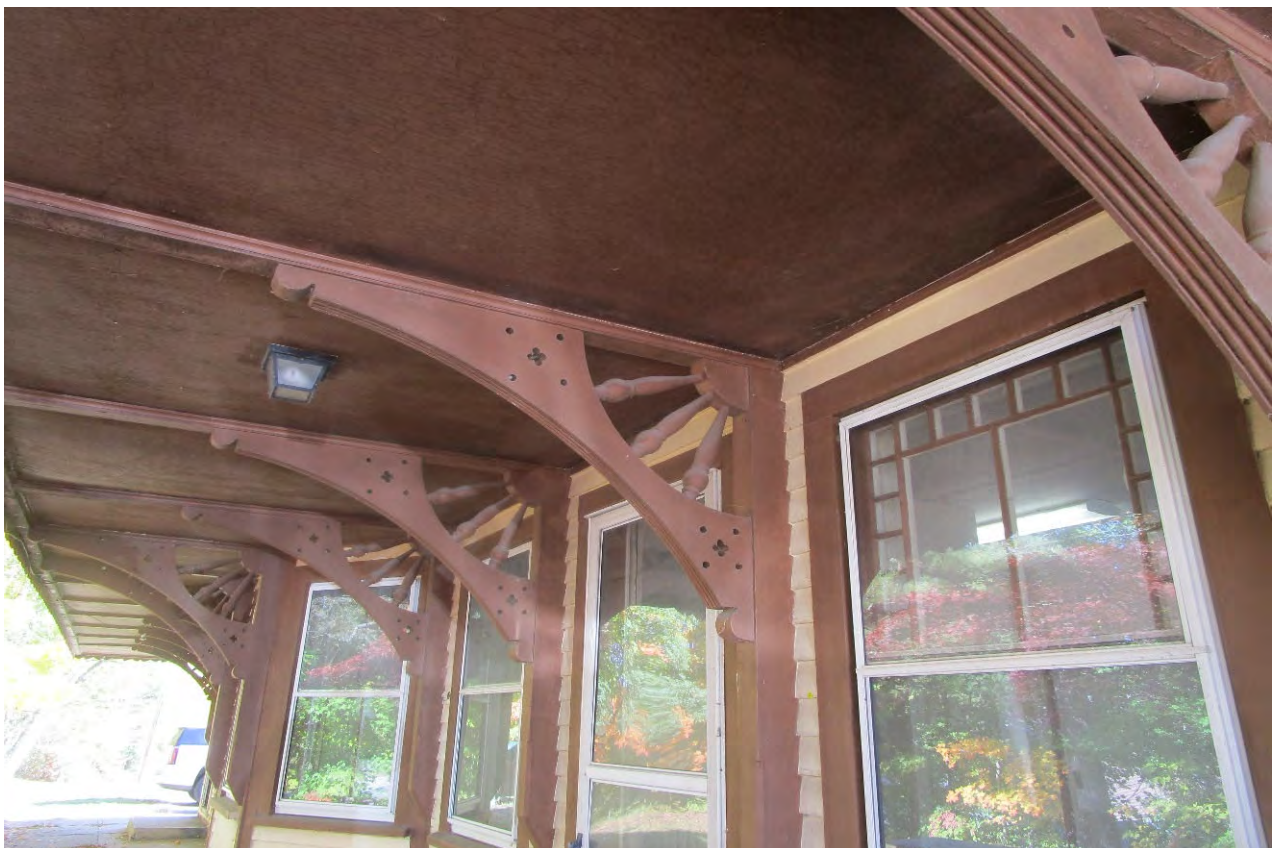
13. ROOF OVERHANG AND ROOF BRACKETS.

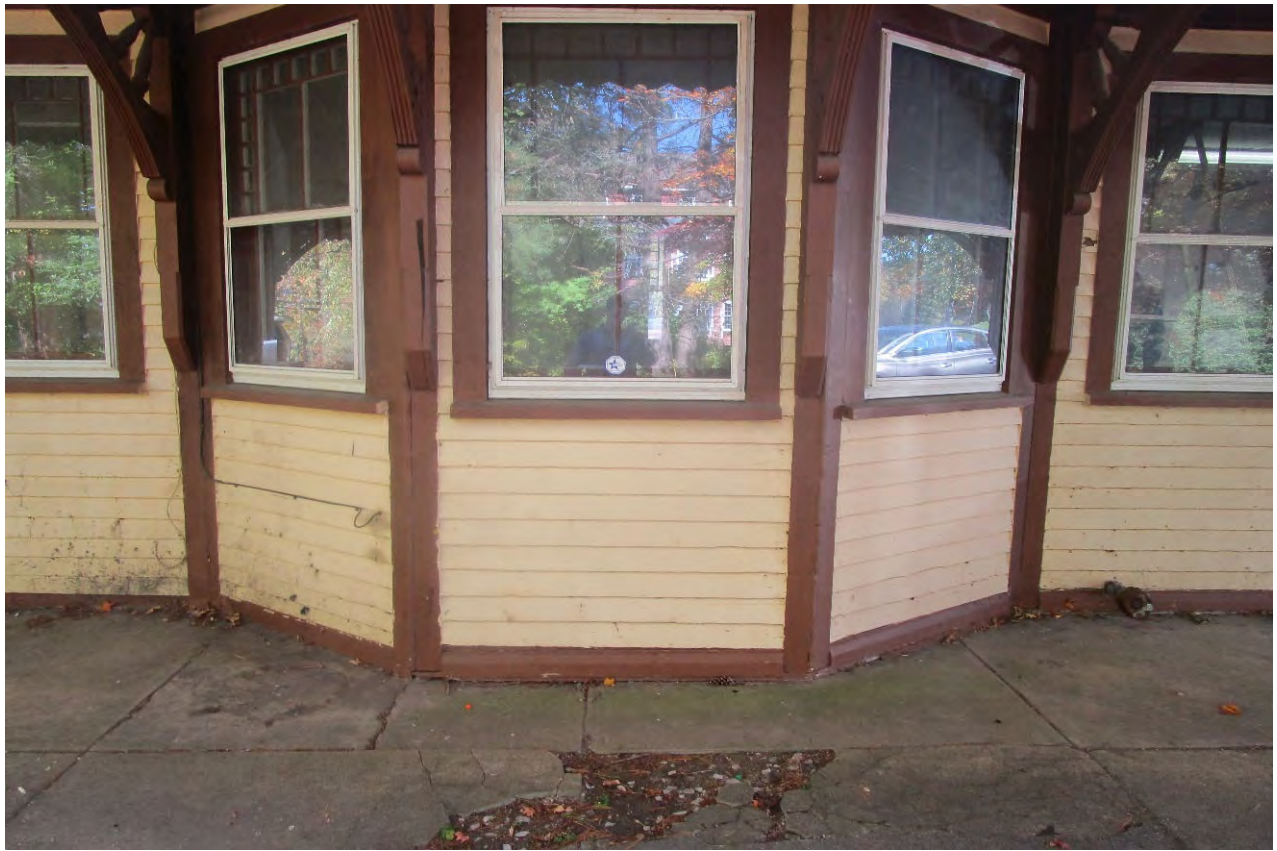
14. NORTH ELEVATION ORIGINAL WOOD WINDOWS.

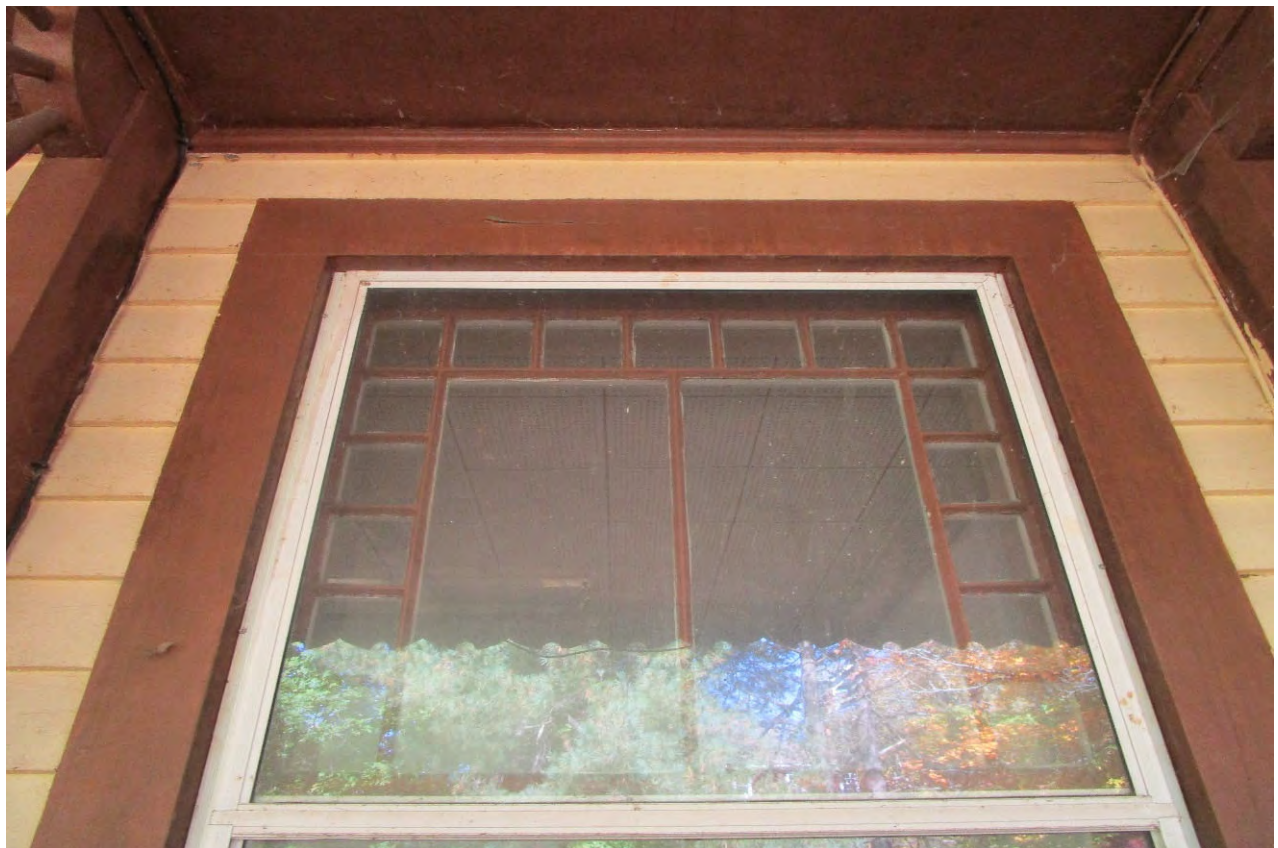
15. NORTH ELEVATION ORIGINAL WOOD WINDOW UPPER SASH.

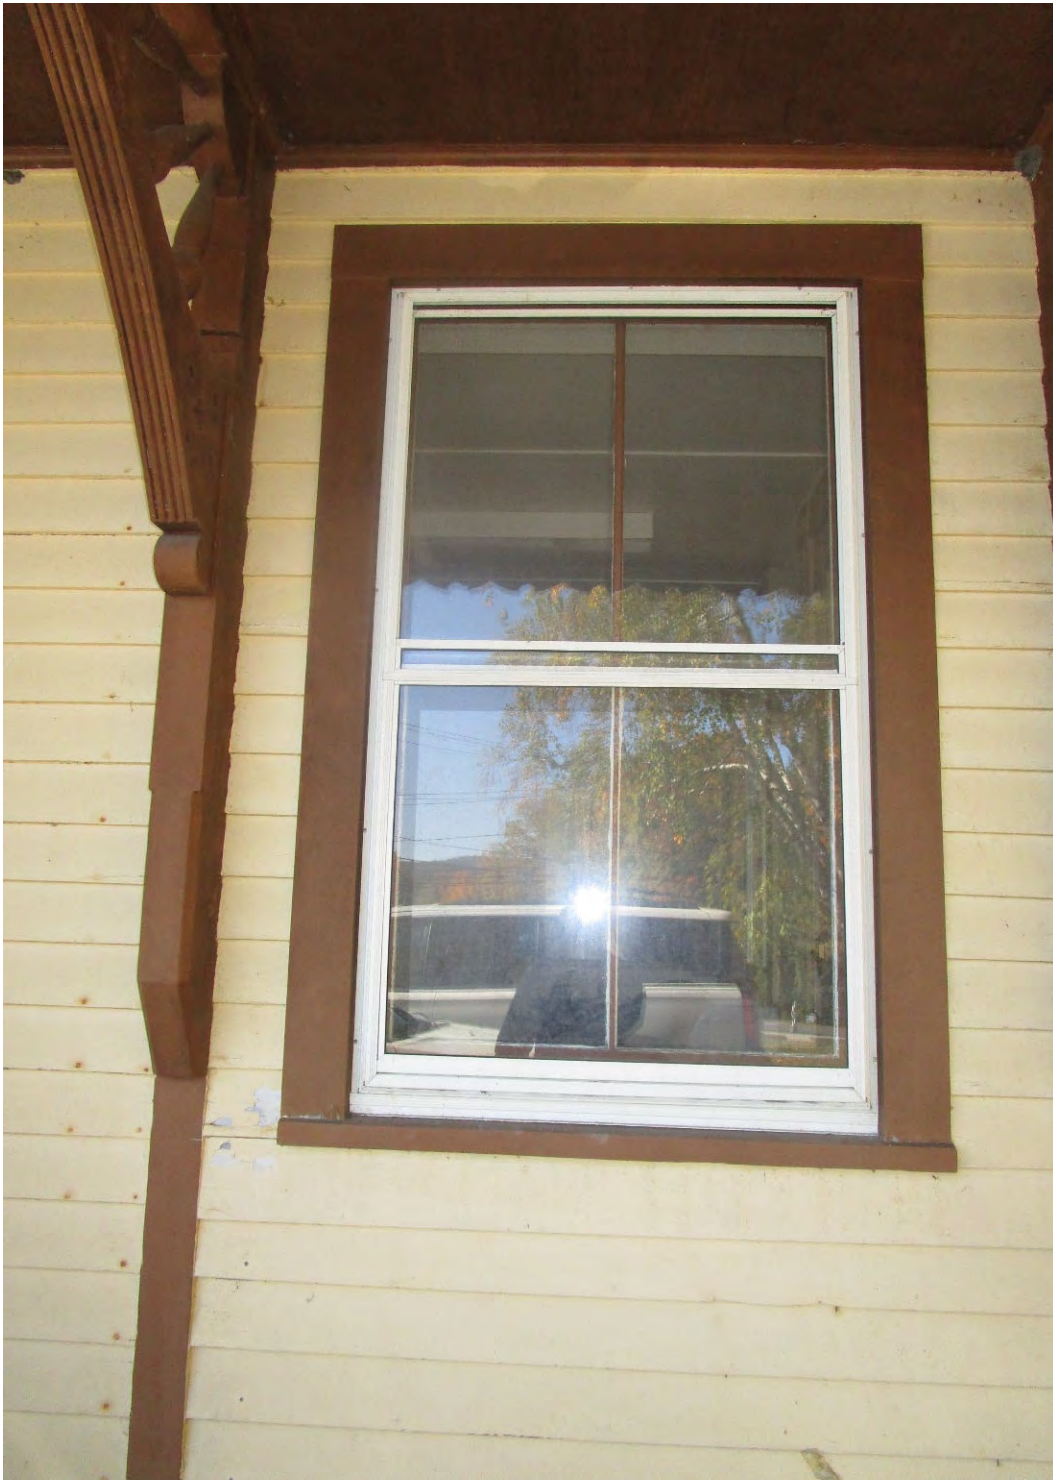
16. EAST ELEVATION REPLACEMENT WINDOW.

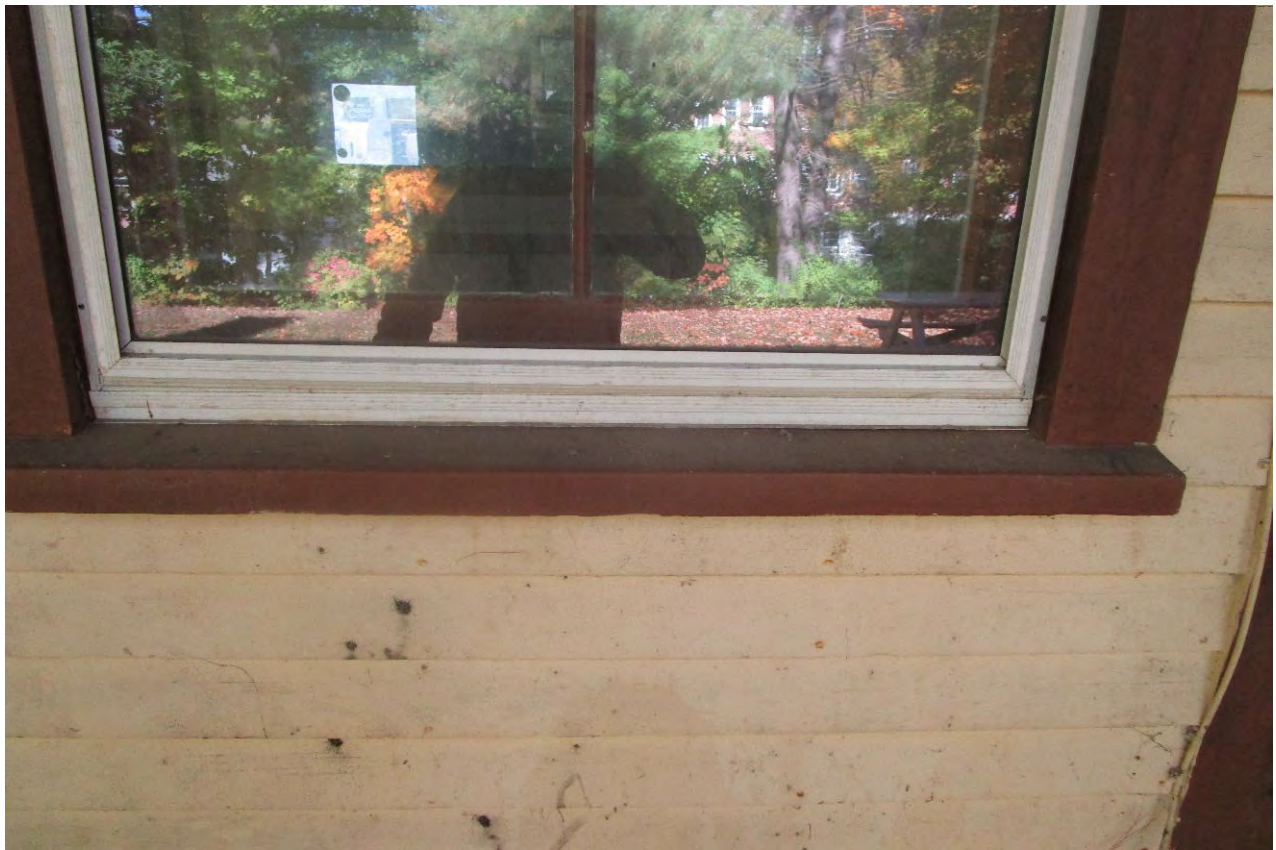
17. NORTH ELEVATION ORIGINAL WINDOW AND SILL.

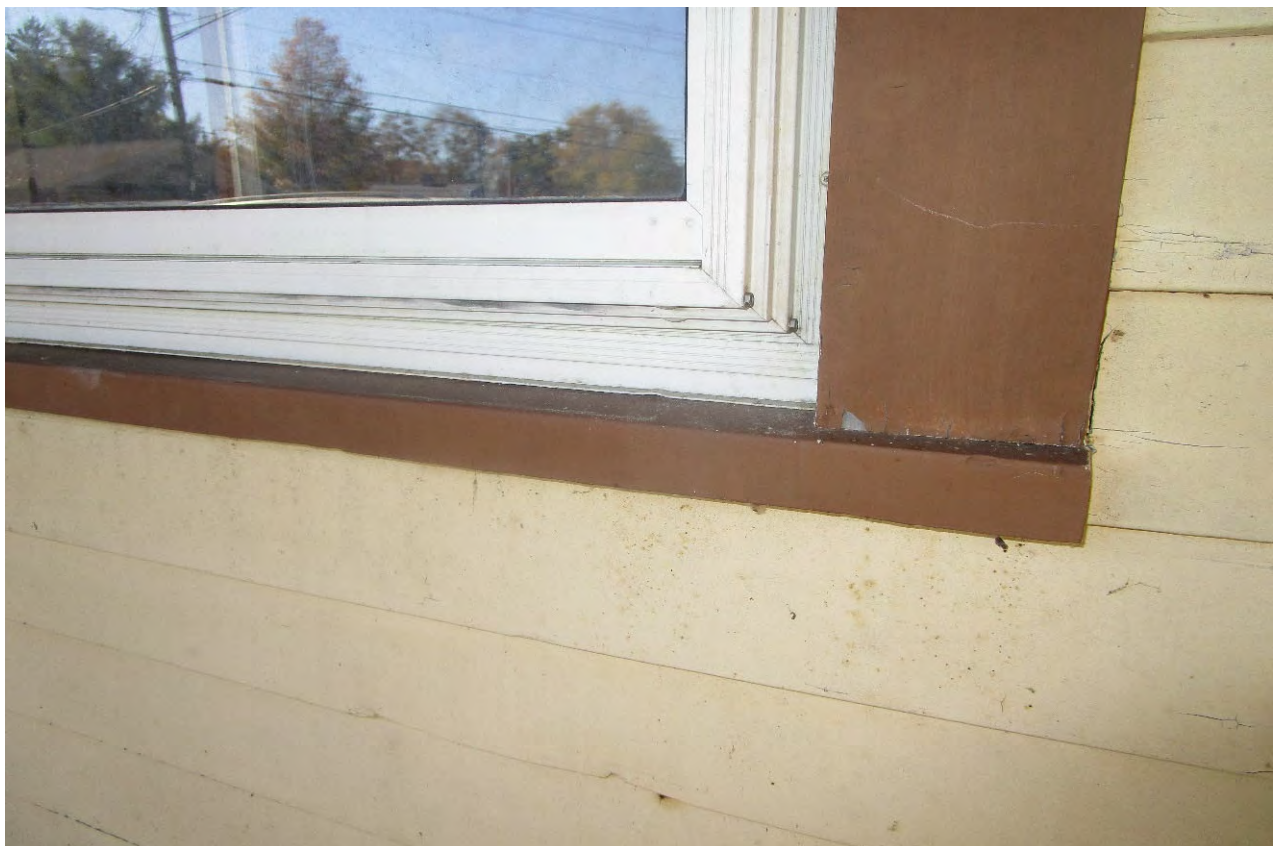
18. EAST ELEVATION REPLACEMENT WINDOW AND SILL.

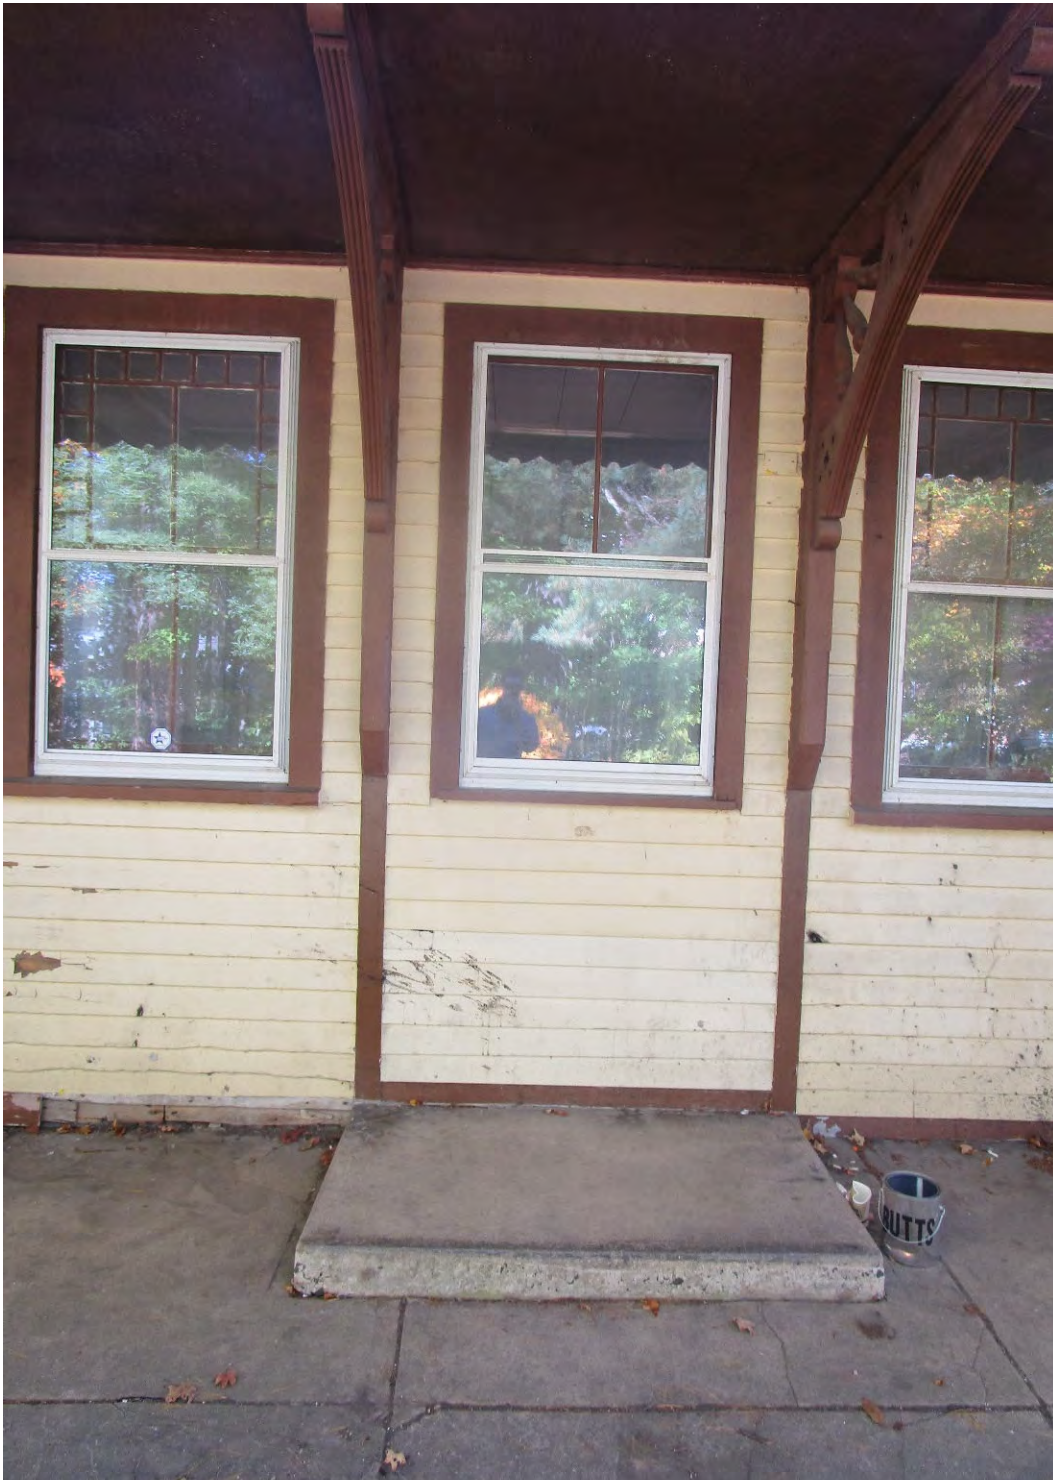
19. NORTH ELEVATION INFILLED OPENING.

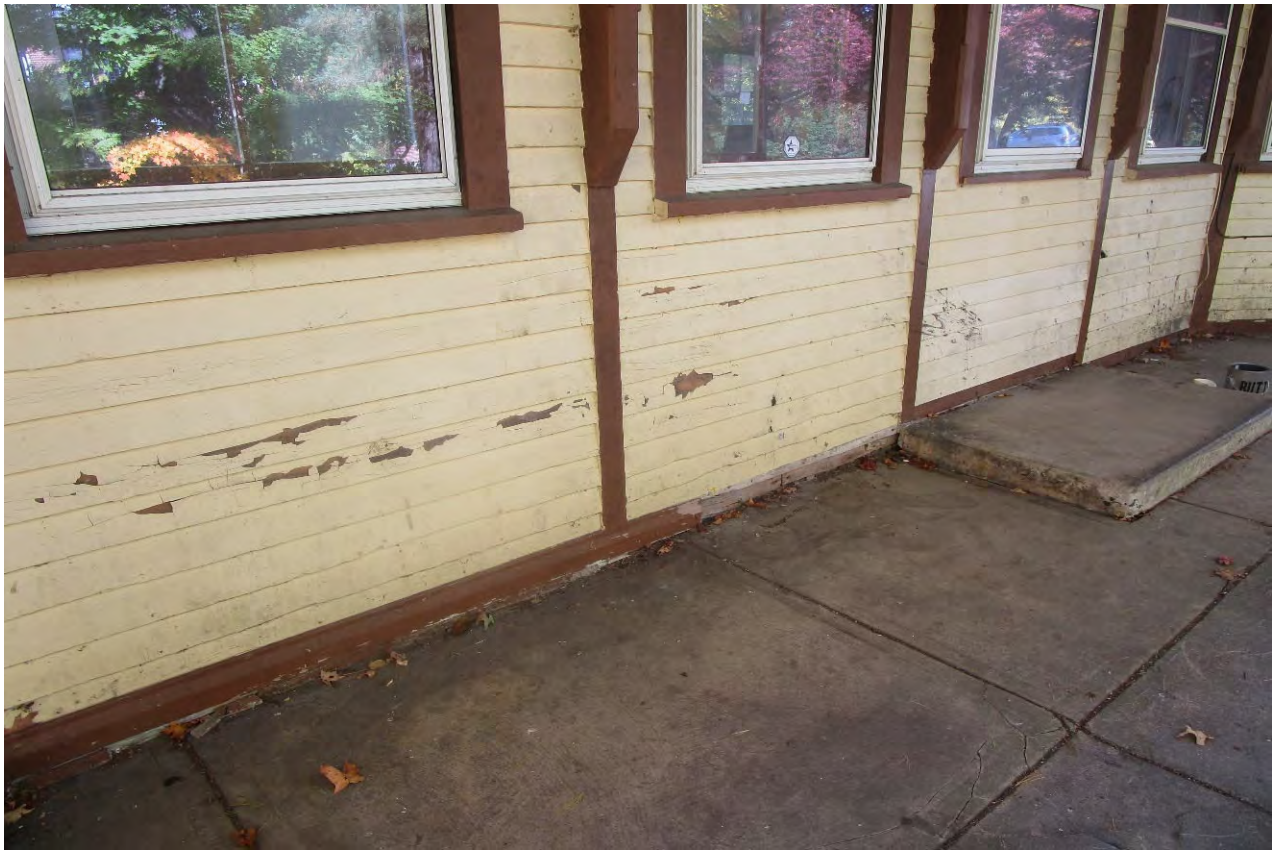
20. NORTH ELEVATION CLAPBOARD SIDING.

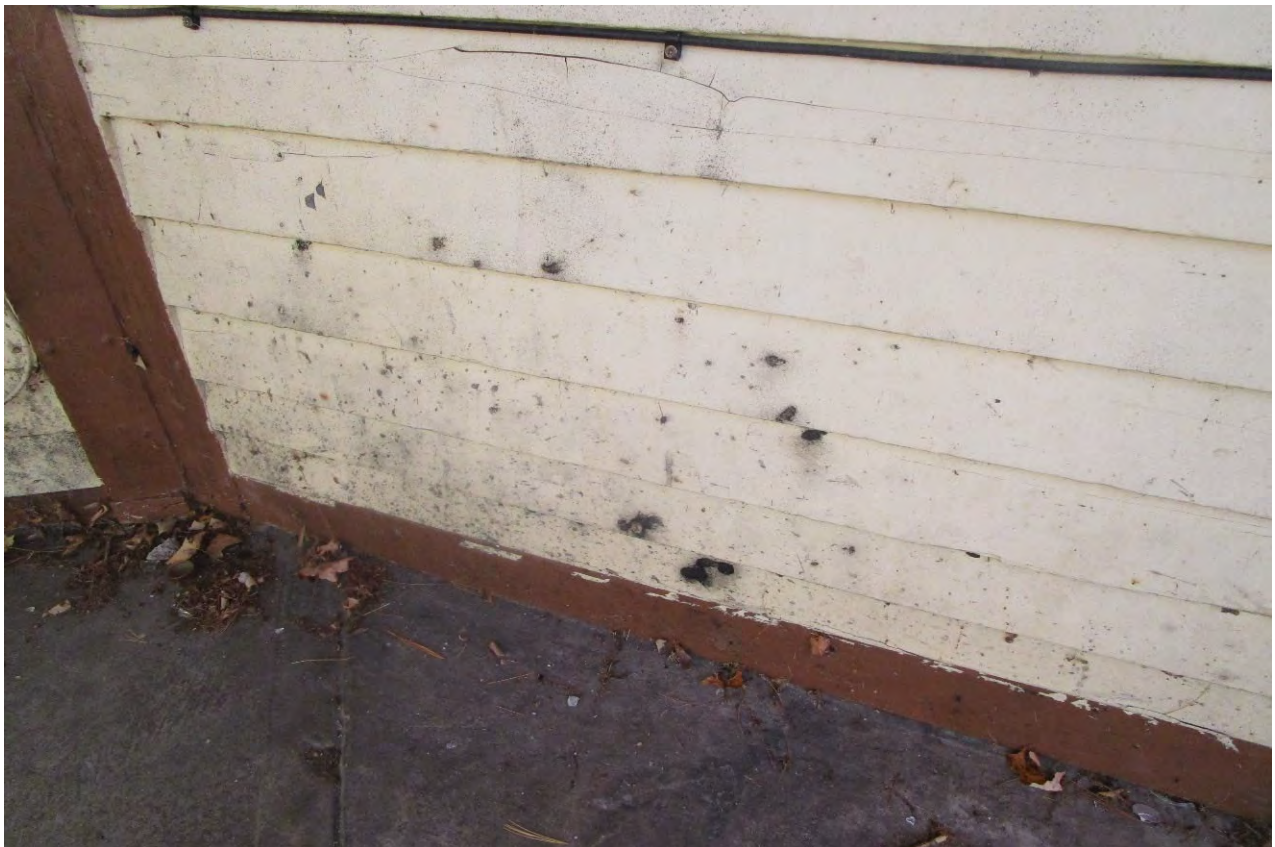
21. NORTH ELEVATION CLAPBOARD SIDING.

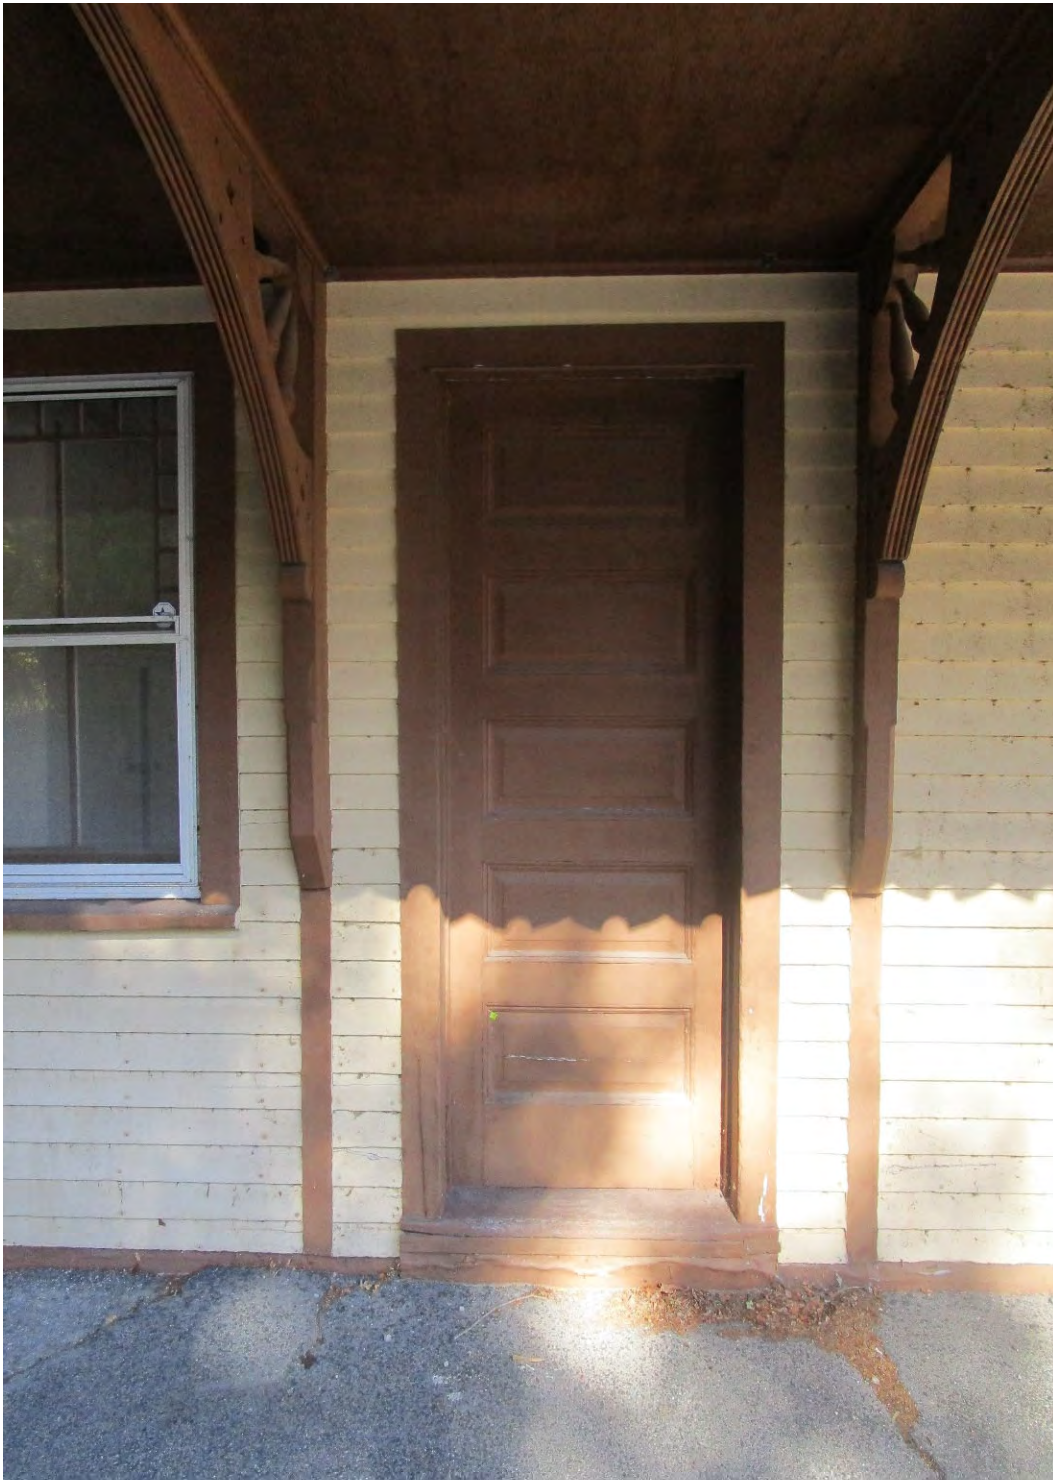
22. SOUTH ELEVATION DOOR.

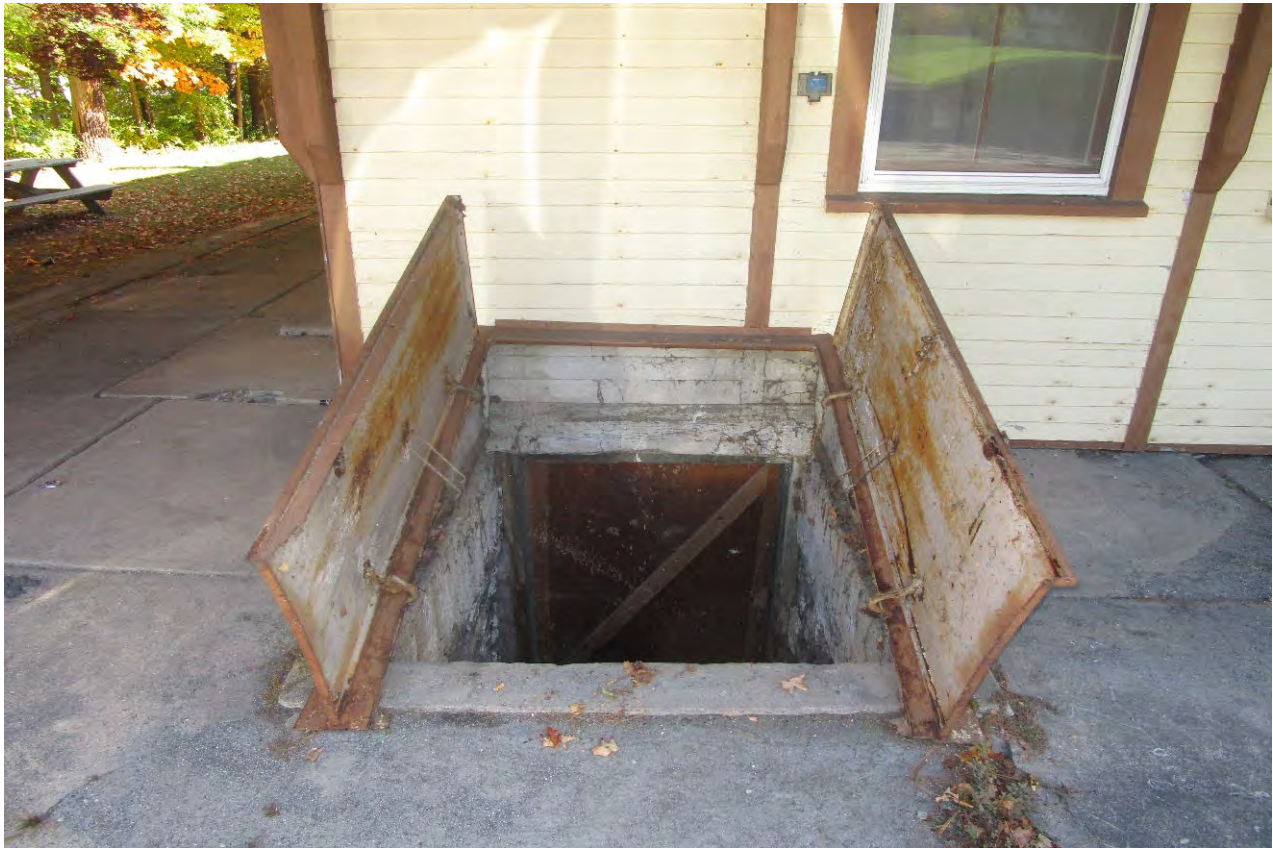
23. WEST ELEVATION BULKHEAD BASEMENT DOORS.

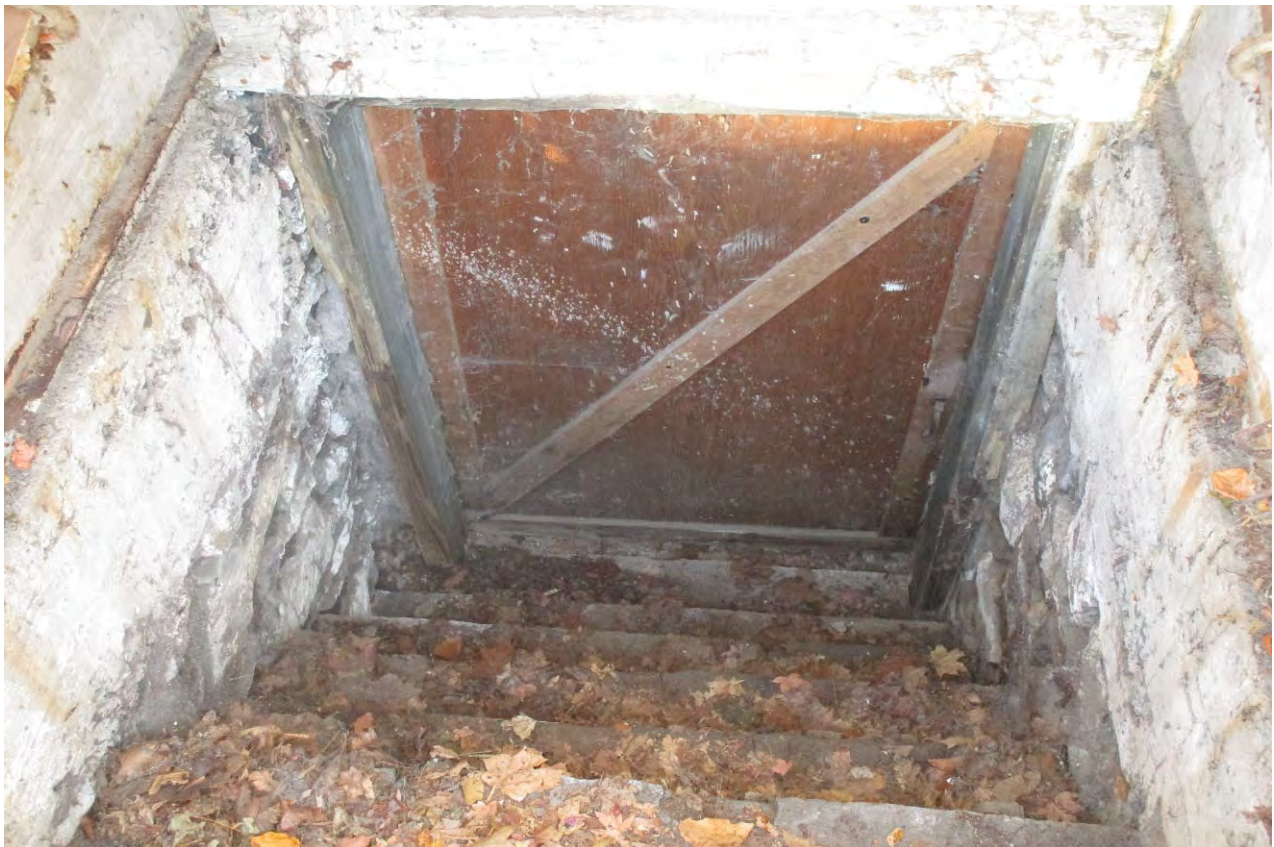
24. WEST ELEVATION BASEMENT STAIRS.

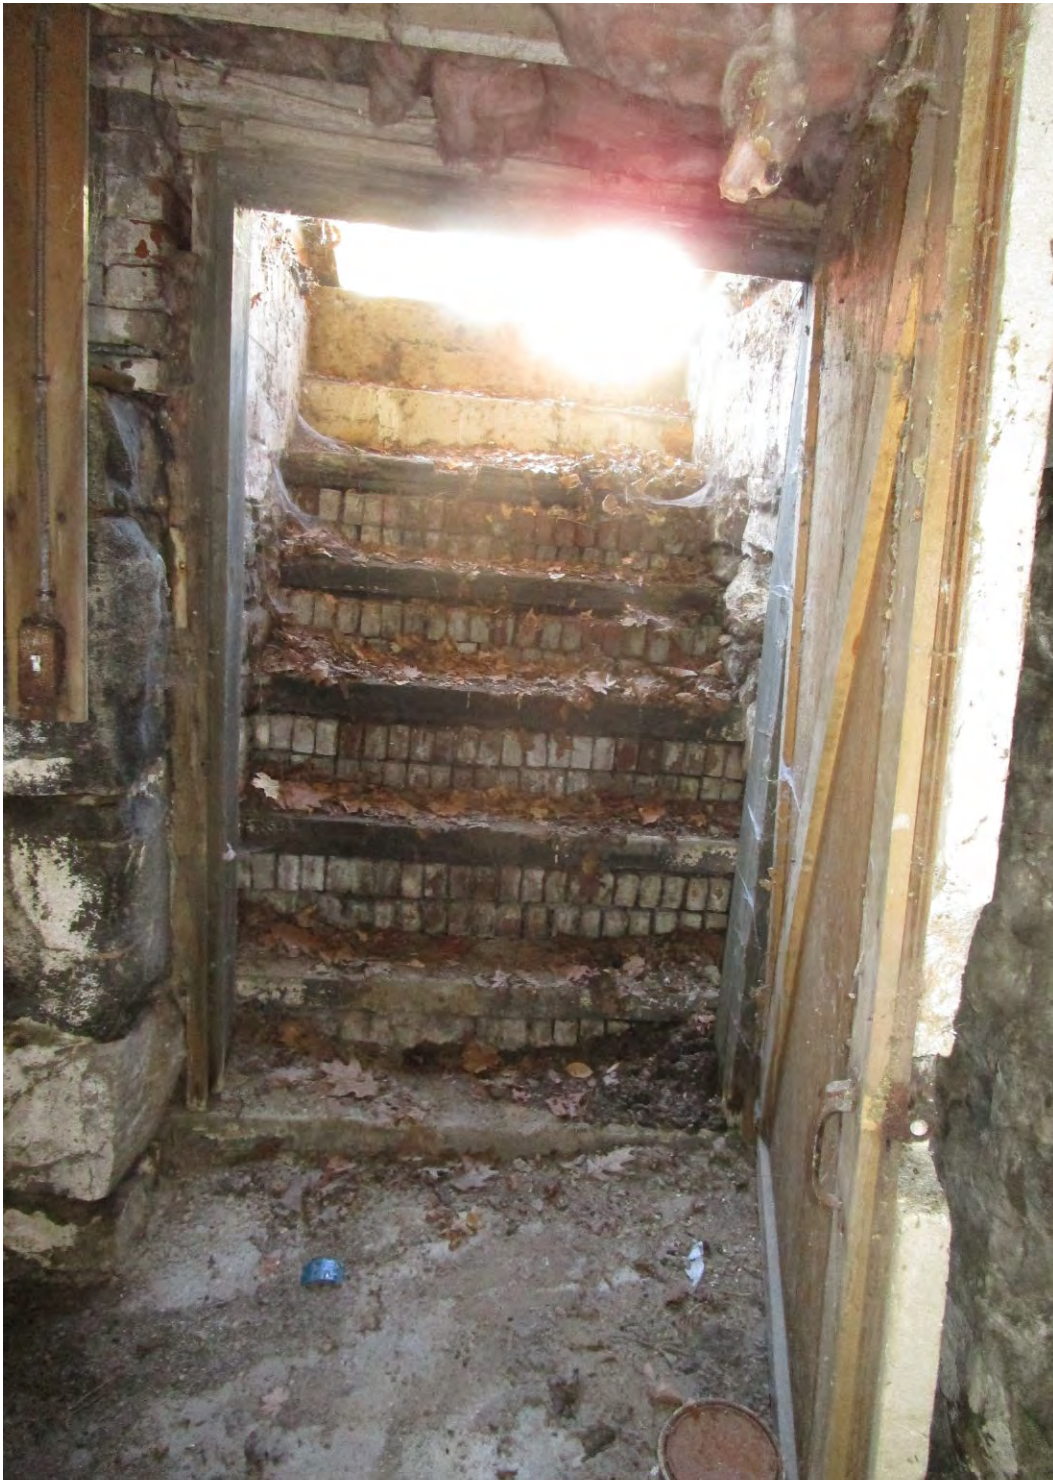
25. MASONRY BASEMENT STAIRS.

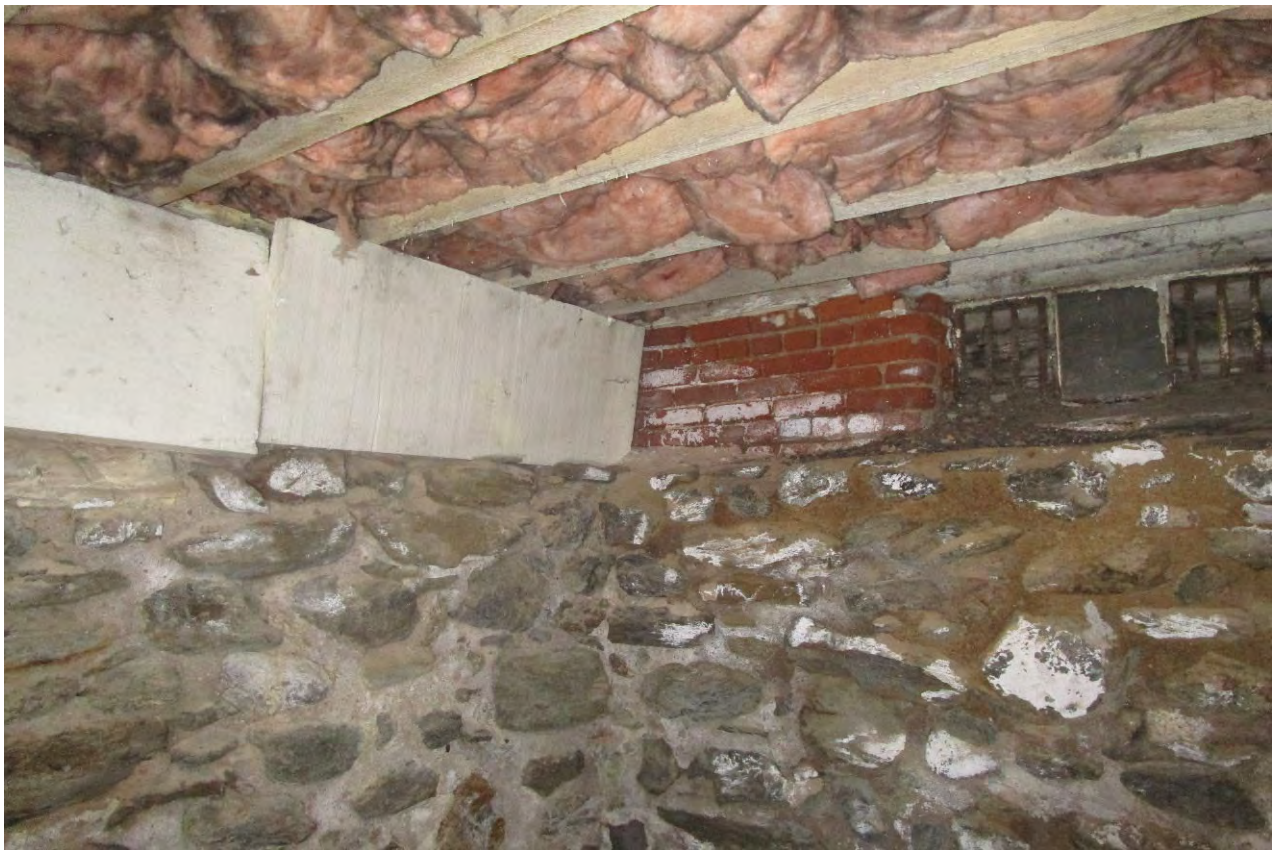
31. FORMER STEEL WINDOW OPENING.

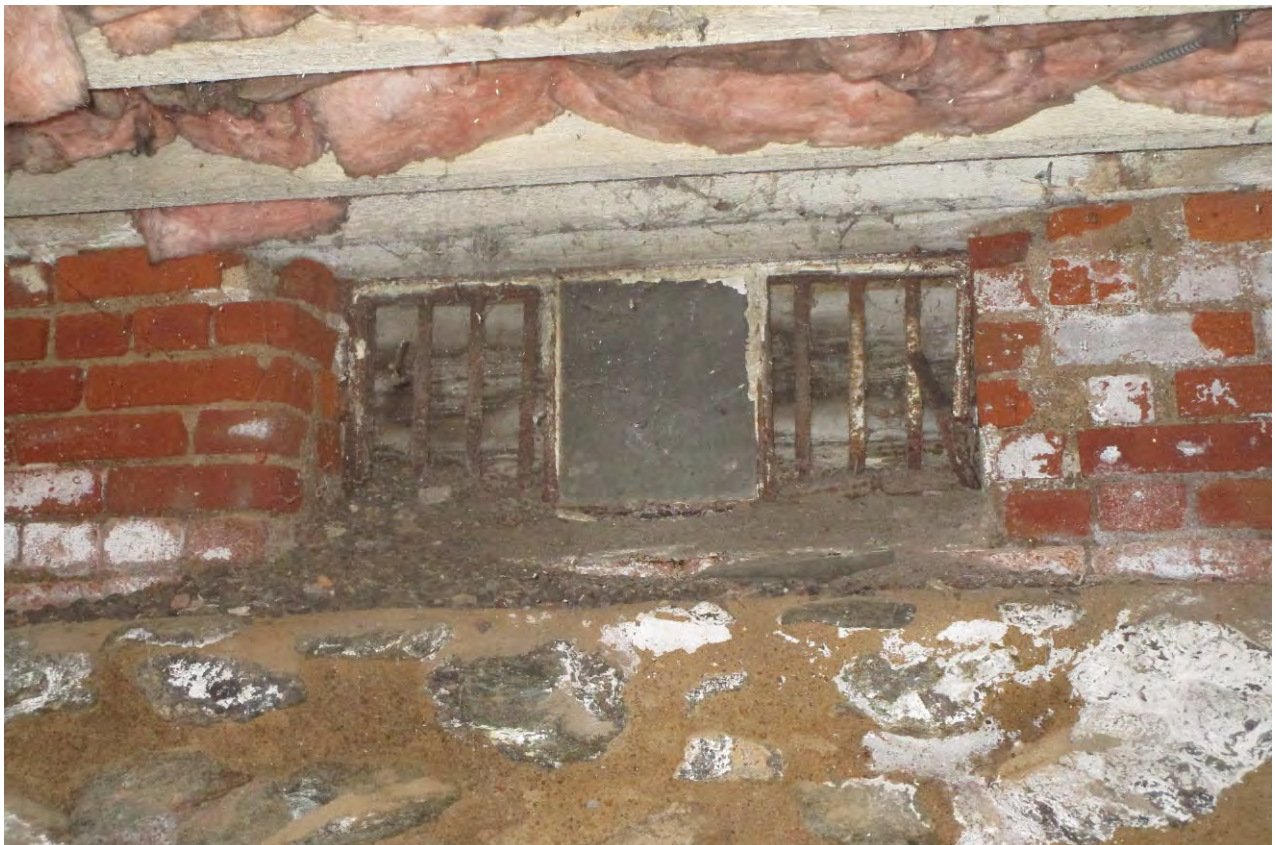
32. FORMER STEEL WINDOW OPENING.
