Lakeville Train Station

Issued: February 23, 2023

CROSSKEY ARCHITECTS, LLC
750 Main Street, Suite 150
Hartford, CT 06103

Structural Condition Assessment

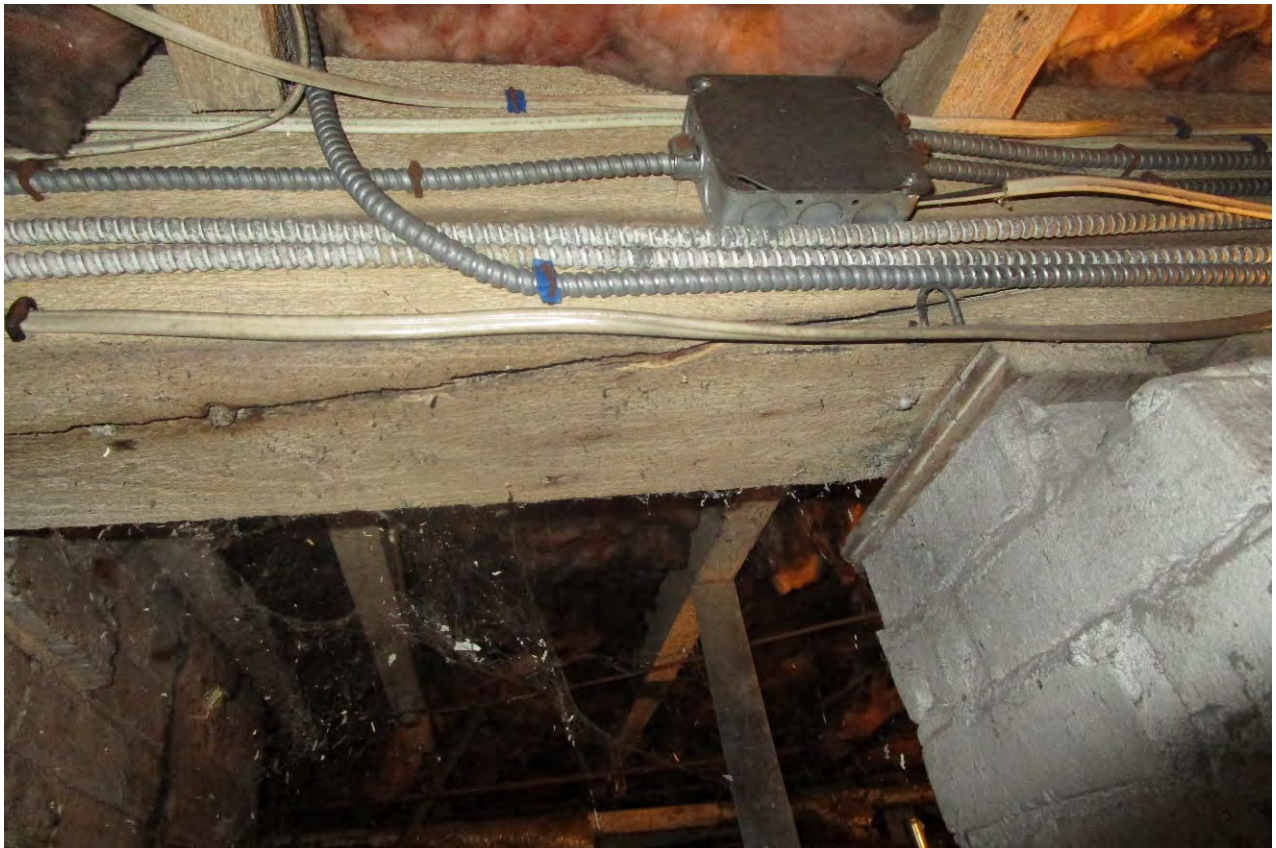
33. VIEW OF FLOOR FRAMING AND BRICK PIER.

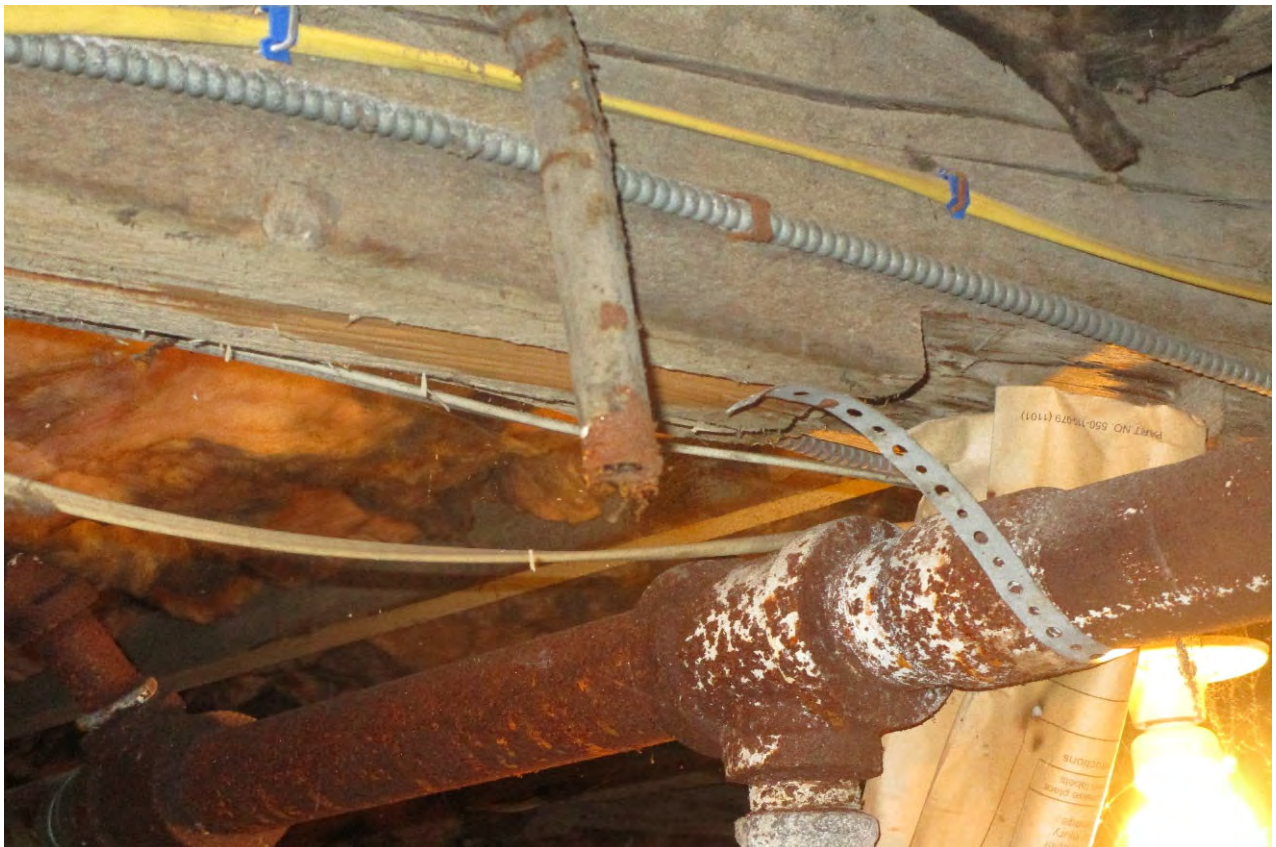
34. VIEW OF FLOOR FRAMING.

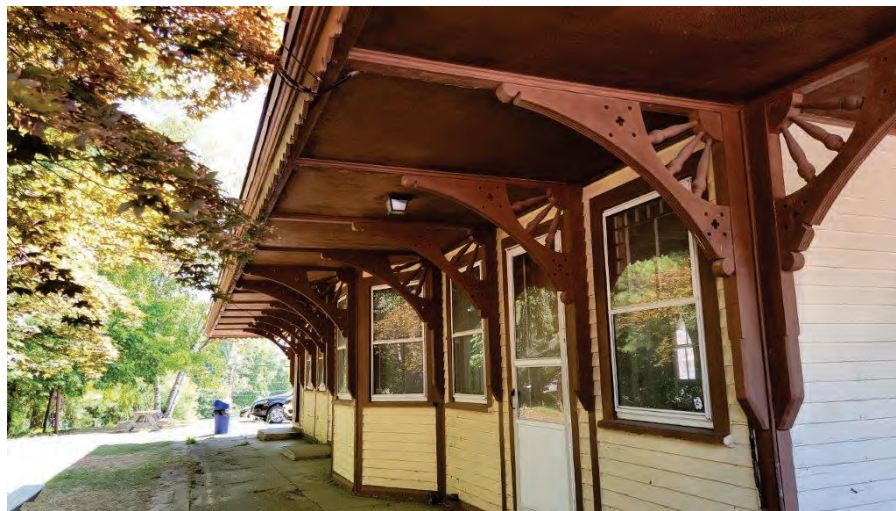
2. North wall of station showing 8 foot overhang and brackets.

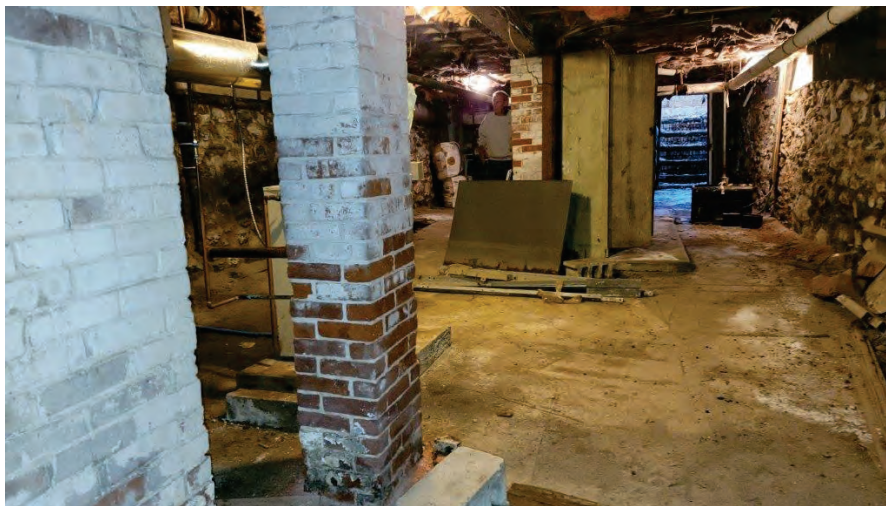
3. Basement view looking west. Brick chimney base and pier in foreground.

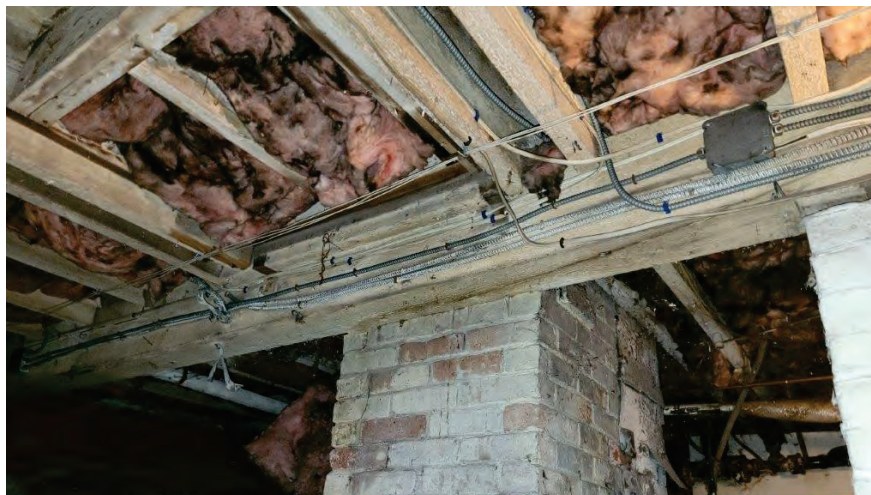
6. Center beam passing by chimney base.

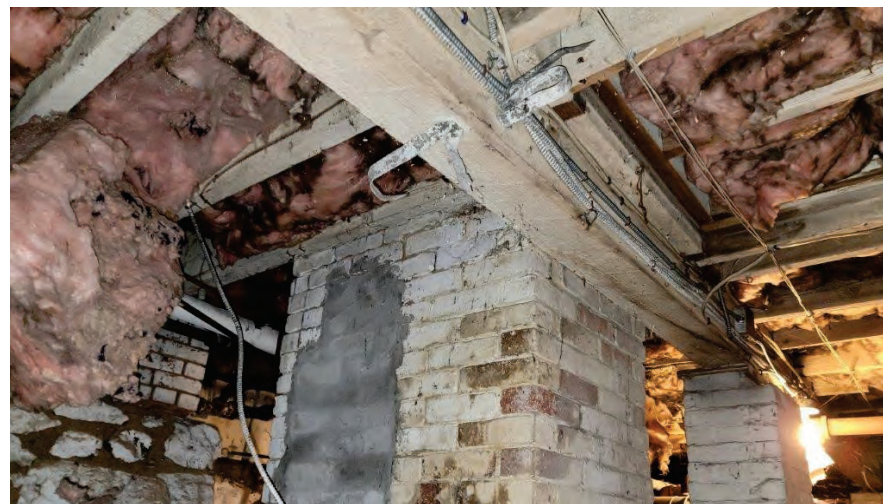
9. View of floor framing at chimney base and brick pier.

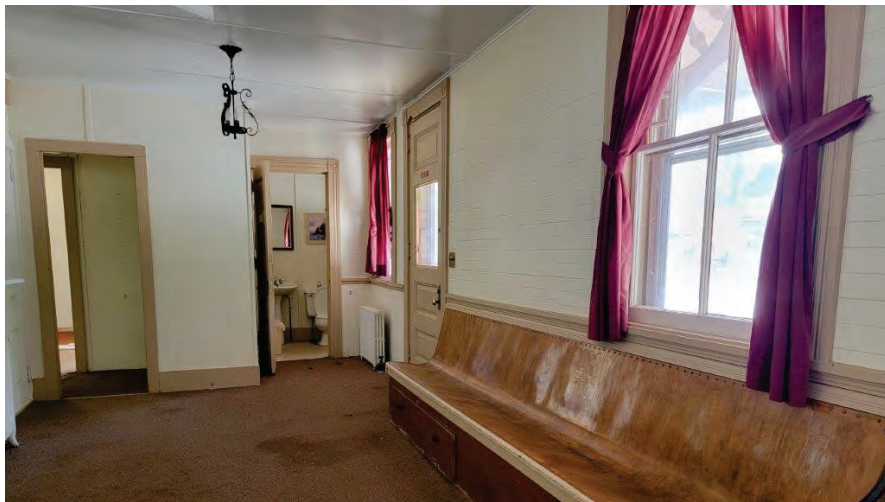
14. Existing dropped ceiling conceals original ornate ceiling.

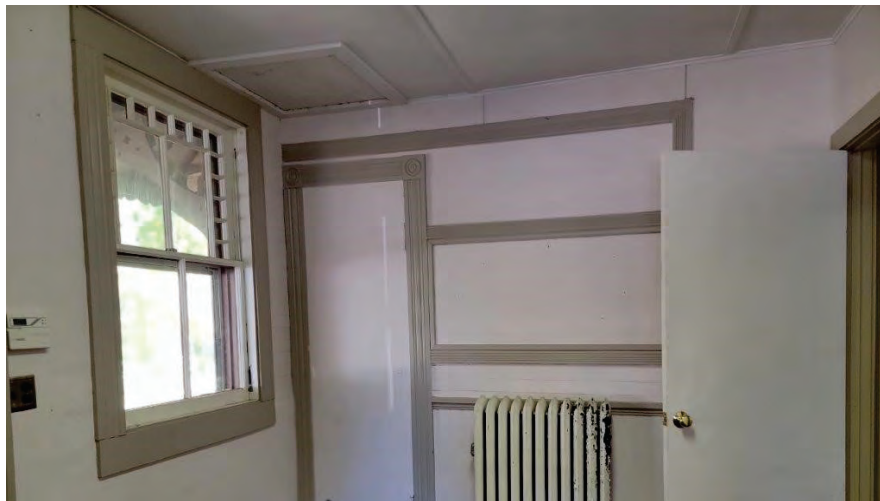
15. Access panel to space above dropped ceiling is in the corner.

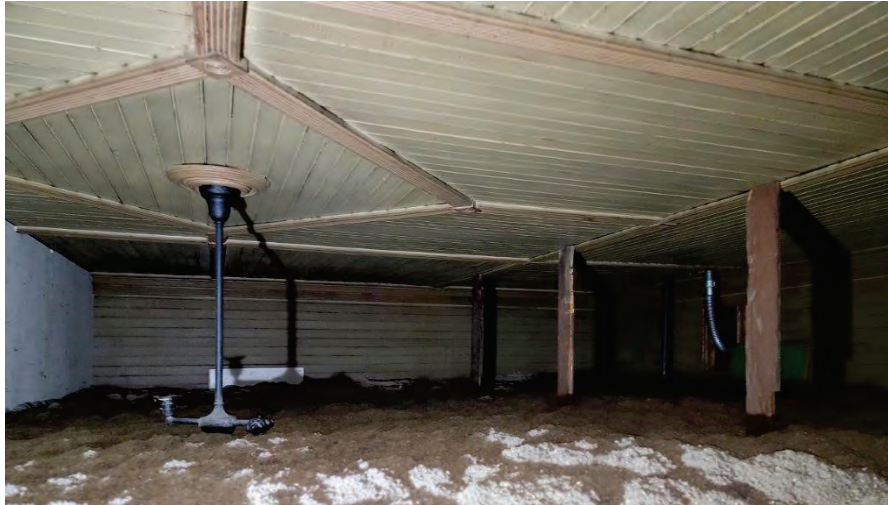
16. Original ceiling and light fixture remains above dropped ceiling.

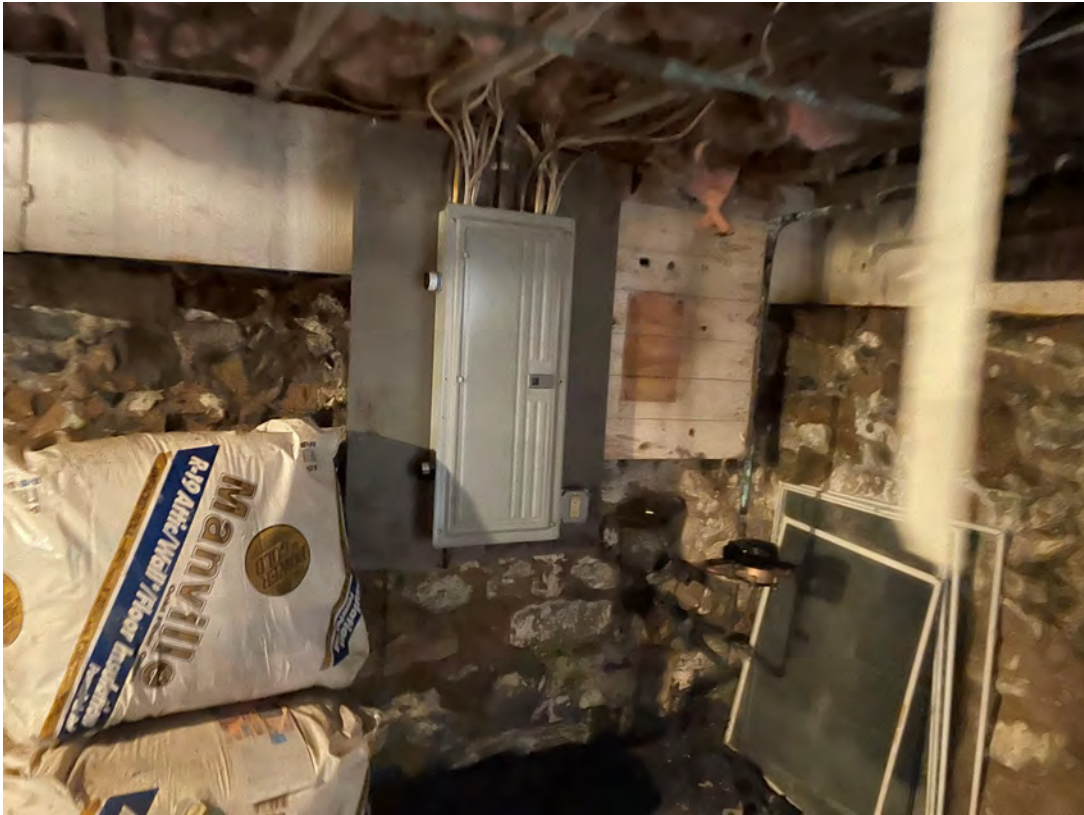
Figure 2 - Electric Panel

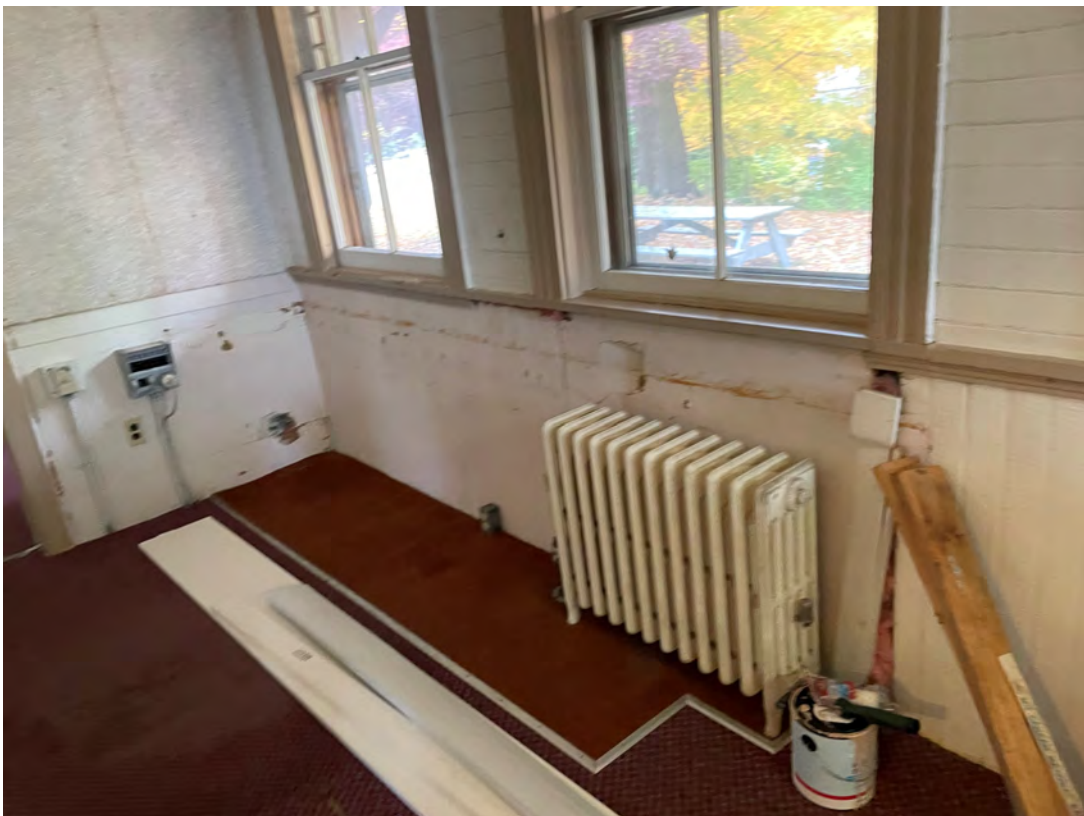
Figure 3 - Cast iron radiator & Generator Fuse Panel

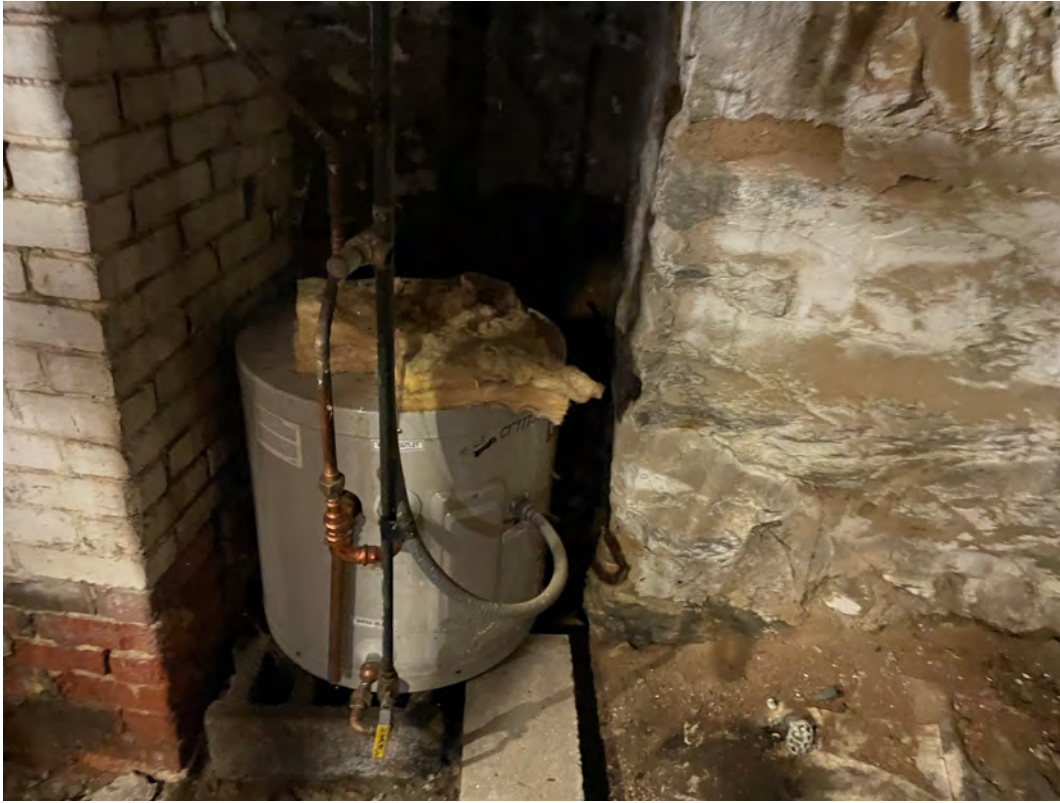
Figure 4 - Water Heater

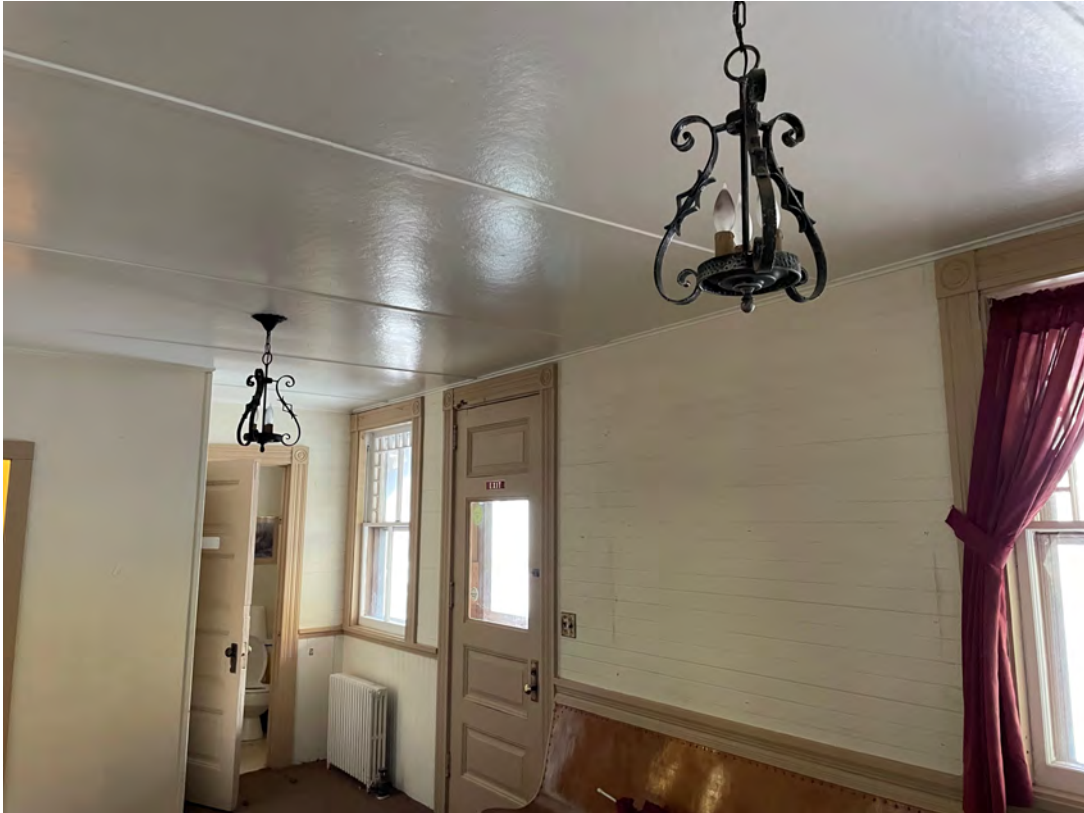
Figure 5 - Typical Interior Lighting

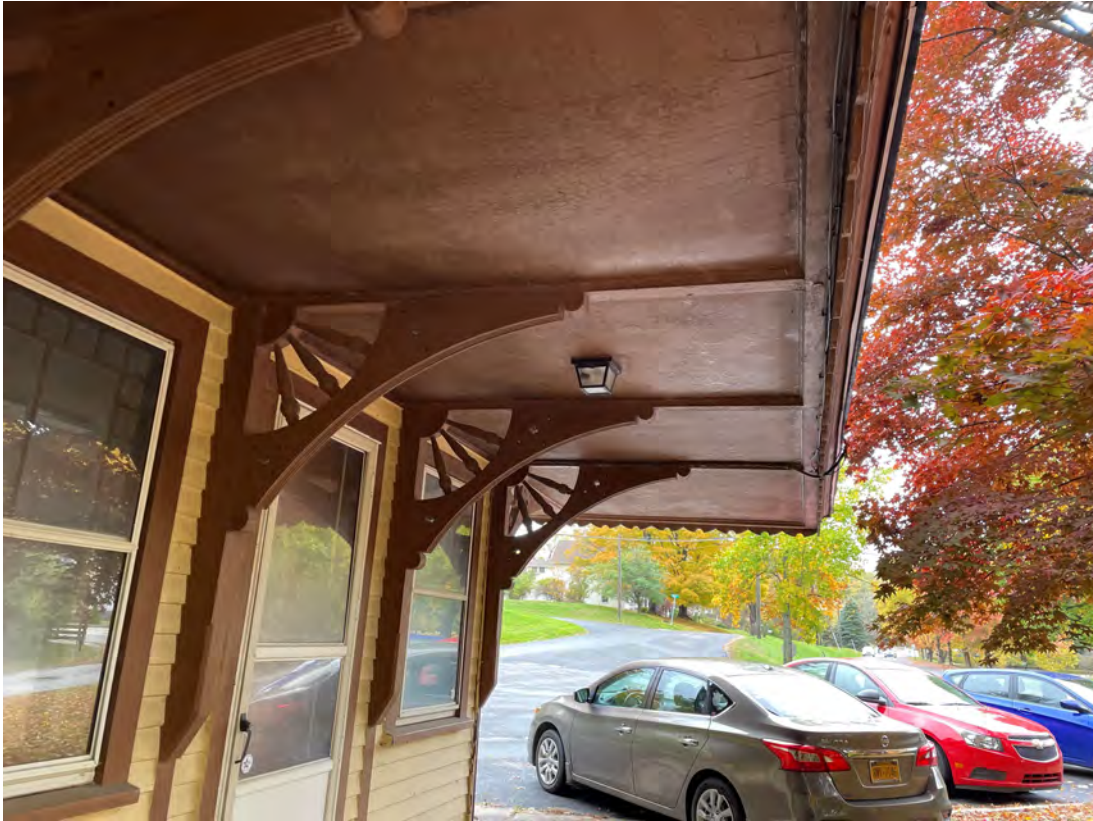
Figure 6 - Typical Exterior Lighting
